SURVEY OF BRIDGE SITE
ON SLIDING CLAY FOUNDATION
THESIS FOR THE DEGREE OF C. L.
Louis Frank Levin
1930

INDEX

Page
Title	1
Introduction	2-3
History	4-8
Subject Matter	9-14
Level Tabulations	15-16
Photographs	17-20
Location Sketch	
Federal Aid Plan & Profile	
Approach Plan	
Reference Polygon Plan	
Base Line & Abutment Plan

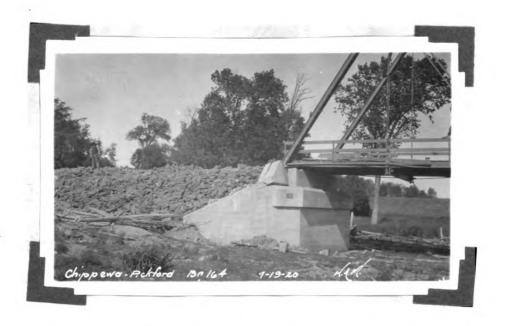
On July 19, 1920, when the back-fill on the North end was largely completed, movement had taken place sufficiently to break off entirely the concrete dirt wall at the North end of the truss. Steps were taken immediately to have the back-fill removed, and this work was let to W. J. Clegg of Pickford who used the material to raise the Township road grade immediately to the West. On the 21st. of August, 1920 an Approach Plan was prepared calling for timber construction in place of the back-fill. A photograph taken on September 9, 1920, while preliminary work was under way, shows that the bridge had moved approximately 3 feet 6 inches. Another view shows that on December 2, 1920 the fill had been entirely removed and the approach structure nearly completed.

This view shows the fill practically completed, and movement has already begun. Note that back-wall is already broken.

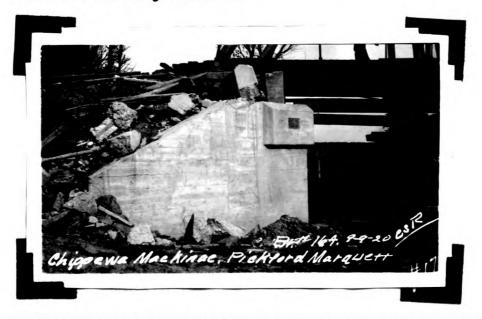
This view shows cribbing in place for new support to bridge contemplating removal of fill, and building of timber approach. 6'-5" face of abutment to pin. About 3'-6" net movement.

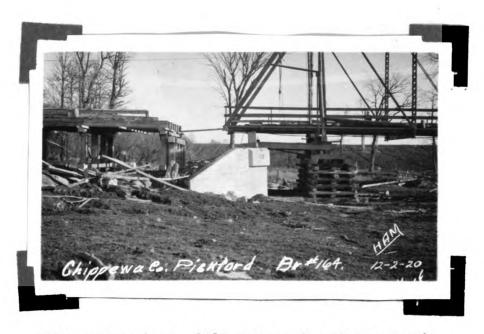
This view shows fill removed and approach partly completed.

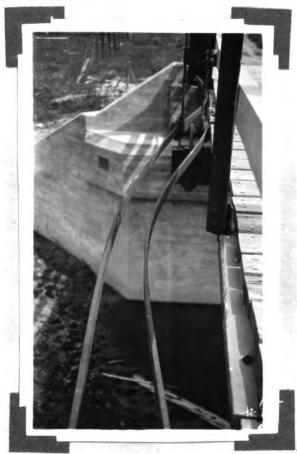
The writer first came in contact with this bridge matter as a foundation problem in 1921. Due to the repeated movements of this bridge and the buckling it had received, it was in such a weakened condition that on June 10th. the passing of a 10-ton roller caused the failure of a floor-beam hanger. Some of the views accompanying this Thesis will show clearly the buckling which has been taking place in the bridge members. In 1924 the Northeast end post was found cracked badly about midway. Evidently this had existed for some time owing to the appearance of the crack which was rusted and quite open.

This view shows buckled lower chord, and has been repeated many times.

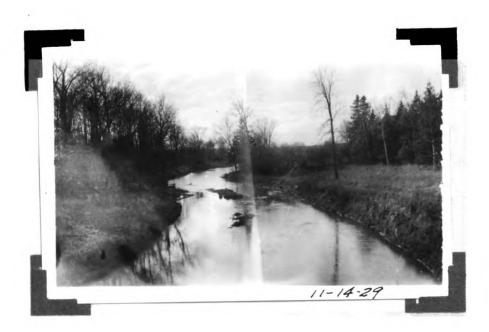
A sample of this clay was sent to the Soils Testing
Laboratory of the Bureau of Public Roads, and the results
are published herewith. The writer's opinion of the reason
for the unusual action of this bridge area is the fact
that this clay is easily washed, and this, combined with
the strong flow of the river in the Spring, scours out the
river bed allowing the sides to slide in. There is evidence
of this sliding in the clay island pushed upon the middle
of the stream as shown in the photographs, which are a part
of this Thesis.

This view shows river bottom raised apparently by side hill pressure.

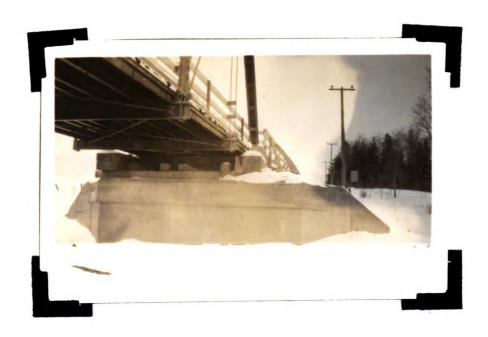
This view shows lateral movement which has taken place in North Abutment.

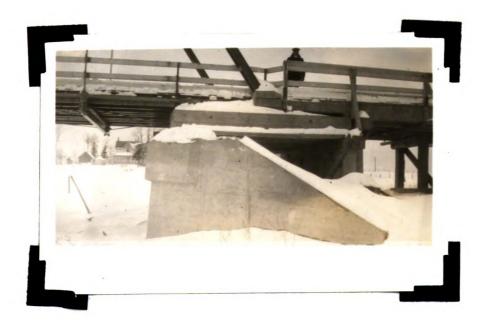
Now consider the fact that originally the Truss pin was 3 feet back from the face of the abutment, and see by the "Approach Plan" how this distance has increased until on February 7, 1930 a total movement of 6.8 feet was shown. From this should be deducted the movement of the bridge itself to the North, which would make a net movement of slightly over 6 feet. It is significant also that in 1920 the distance from the center of the first pile bent to face of abutment, as nearly as can be scaled from the photograph, was about 17.5 feet, whereas now it is 18.8 feet, which shows that the movement of the abutment has been faster than that of the trestle. However, the fact that the distance from the South pile bent to the Truss Pin has been decreased more than the bridge has moved to the North, shows that the entire approach must have moved also. This is also borne out by inspection of the several rows of pile which originally supported the timber approach, but do so no longer because each row has moved toward the river. Those nearer the river moving a greater amount than those shoreward.

This view shows longitudinal movement in North Abutment.
