SIMULATION AND ANALYSIS OF
OLDSMOBILE DIVISION G. M. C.
HOOD DAMAGE

Thesis for the Degree of M. S.
MICHIGAN STATE UNIVERSITY

Leonard Joseph Meyer

1968

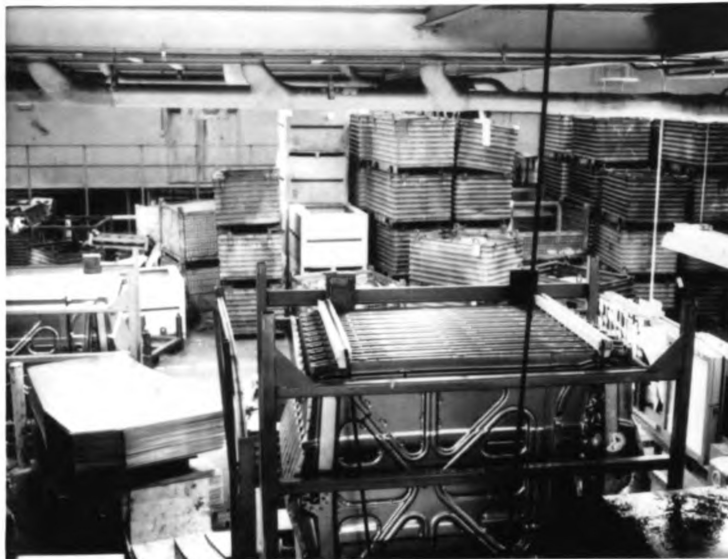
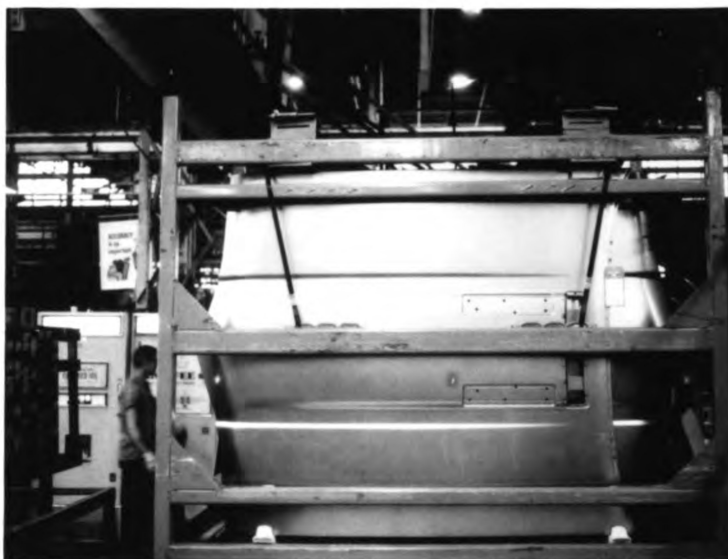
Fig. 1.--Original Banding Locations

Following these tests the bands were repositioned to check if breakage, due to band tension, could be reduced.

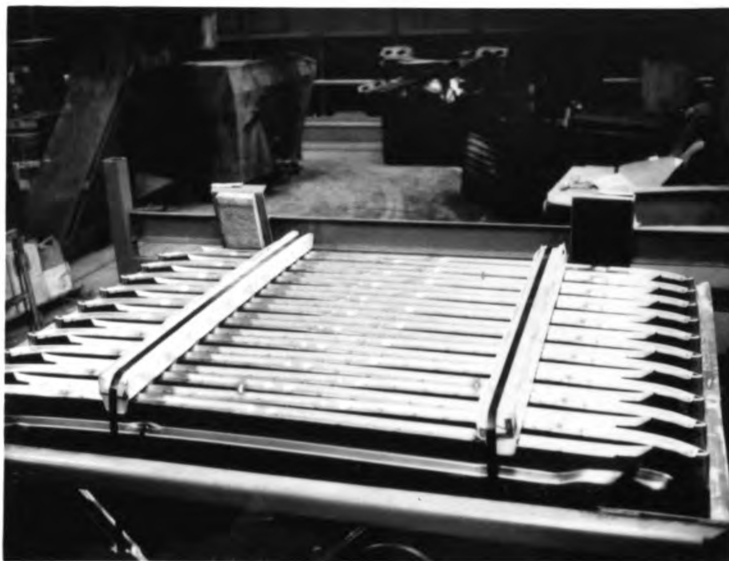
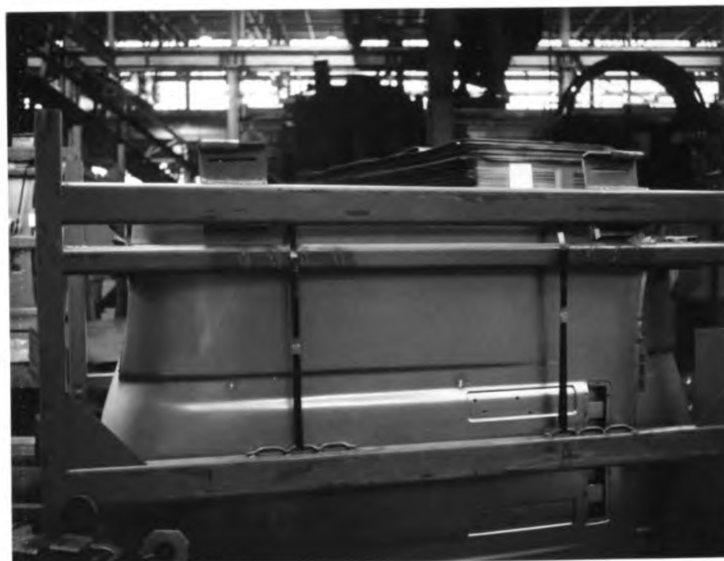
Fig. 2.--Banding Relocations

Table 4a and 4b gave almost identical results with both indicating that band repositioning offered possibilities for consideration; however, even though the results afforded some recognition over 3a and 3b it was not enough to warrant complete change-over. Minor alterations to the hood spacers would have to be made, first, before changes could have been made. To extend the test with hope of validating the change-over a new three-quarter by .035 inch banding was ordered. It was felt that this more flexible

band would offer longer periods of staying intact; therefore, it would warrant the banding repositioning, and divider alterations. Due to the slow arrival of the new banding material the testing of banded hood racks ended here.

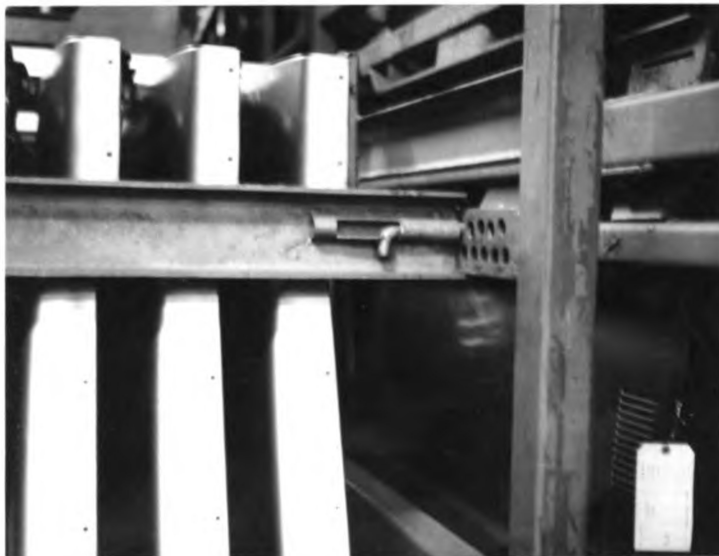
Fig. 3.--Impact Bar Locking Device

When the testing reached 220cpm and the impact bar released it was felt that the test was successful in duplicating one cause which attributed to hood damage; however, inspection of the bar indicated it had a defective locking mechanism originally. This result would have left the test a failure if the new impact bar would have stayed locked

During the testing no changes were made on the impact bar locking device due to limited time; however, Figure 3, page 15, has a photograph of the current locking device and Figure 4, page 16, has the two proposed change-over drawings, scaled to $1/2" = 1"$. Figure 4a proposal has used the same housing for the locking pin; however, modifications

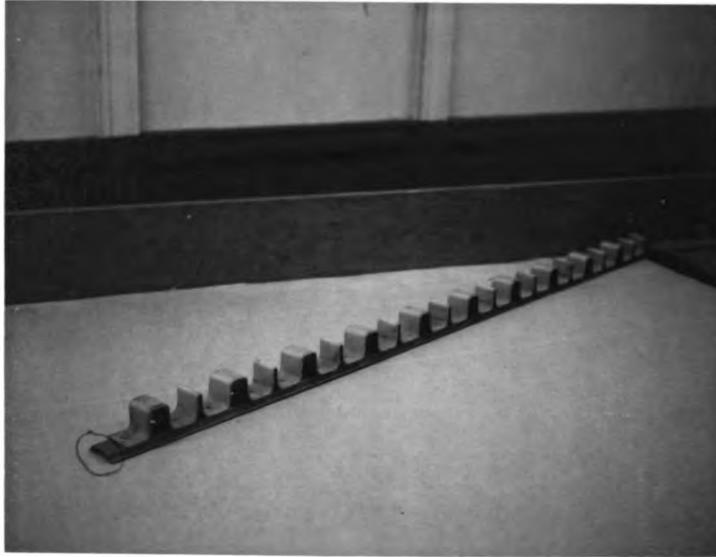
Fig. 5.--Plastic Coated Metal Hood Spacer

As presented above, the testing was limited to a short running time and a short range of cycle settings. This was attributed to large holes produced in the aluminum bars through wear from loose bolts, and also as a result of the wear into the end of the metal divider during the test period--wear is illustrated in figure 5, page 19. The wear on the parts can be attributed to the force of the hoods moving the insert backward and forward. This sliding

motion was always abruptly stopped by the insert slamming into the vertical bar holding the insert and bar in position. As the slamming continued the hoods shook with an increasing momentum; as a result, caused increased damage to the insert.

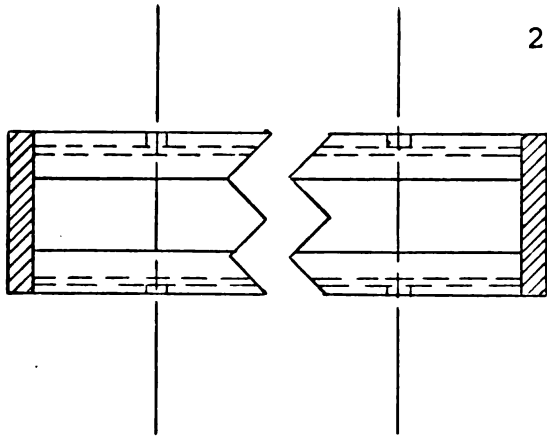
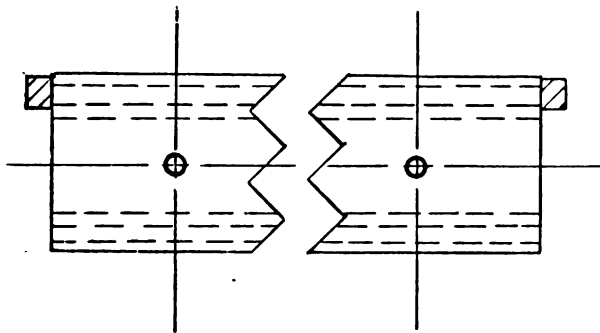
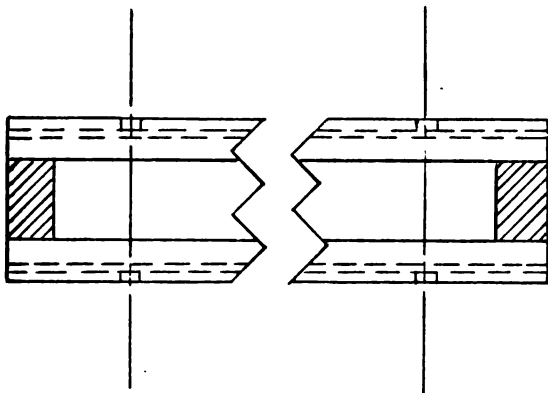
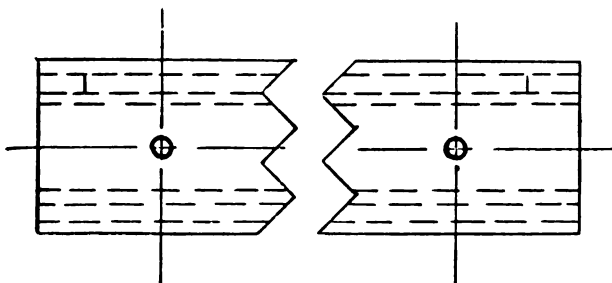
Fig. 6.--Aluminum Bar Revisions

The new revision limited the hood motion to a short backward and forward motion; as a result, the hoods shook less violently. The test proceeded along with indications of appearing to offer positive results, when at 230 cpm three of the four slugs were broken from their welds. The testing was stopped and the hoods were checked for any damage. Along the top of the hoods, where the insert held the hoods apart, there were small repairable dents. A visual inspection of the insert revealed the apparent cause of the damage. The plastic, which coated the metal, started to flow and formed a little ball on the end of each

After an elapsed time of three minutes into the 220 cpm test the weld on the left retention bar broke loose. The test was terminated, at this point, and the hoods were checked for visible damage; however, there were no indications of any damage. Testing was terminated here as a result of the limited availability of the testing facilities.

Table 6 below was a continuation of table 5 with the exception of a revision made on the aluminum bar. The revision consisted of welding an aluminum slug across the slot at the end of the bar. This had the affect of

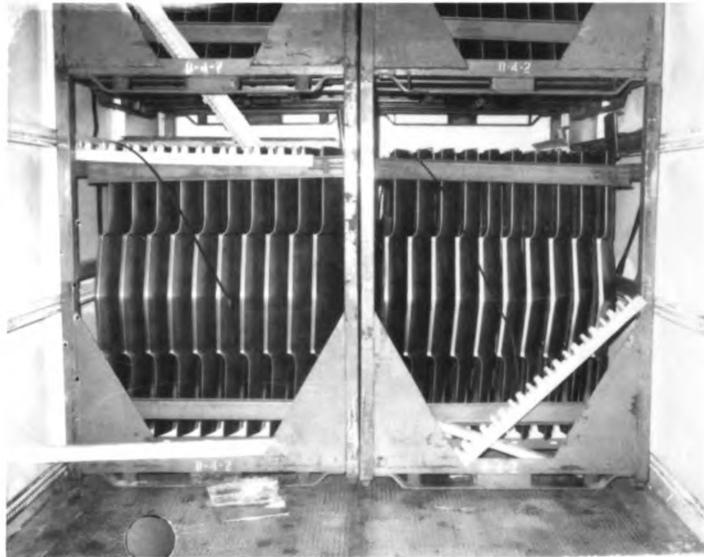
a. Broken Bands

2) Broken banding and releasing impact bars were the main constituents contributing to hood damage.

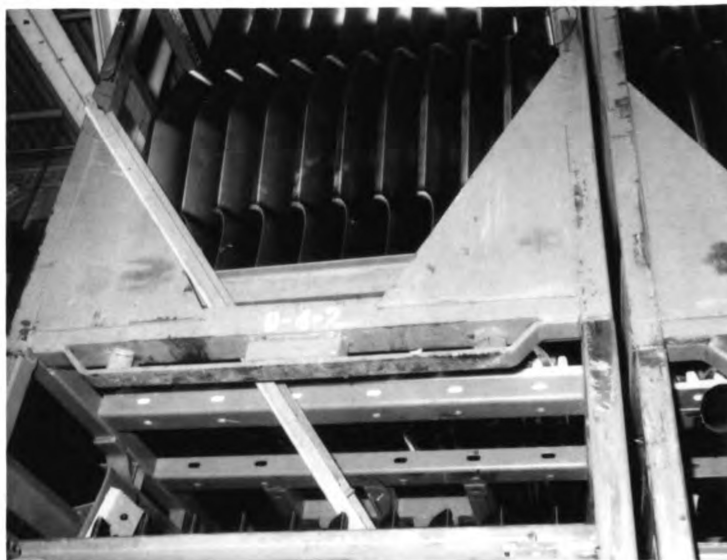
b. Released Impact Bar

The major problem area lies in the packing of the hoods. It was discovered upon frequent trips to the packing area that impact bars were not always locked. On occasion, when pins offered sliding resistance, the lock was left open rather than being forced shut or having the impact bar replaced with efficient locking devices.

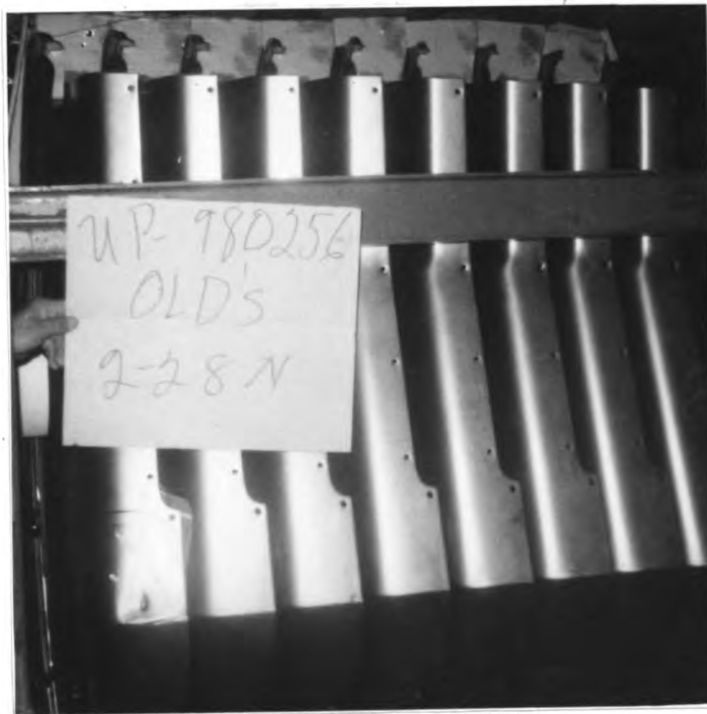
d. Poor Materials
Handling

Close surveillance of rack handling will not always rectify conditions as these. Handlers have to be

constantly made aware of the consequences of laxness. To date this has not been a serious problem; however, it cannot be left unconsidered if damage reduction is to be completely achieved.
