MOISTURE RELATED DETERIORATION OF THE WOOD TRUSS SYSTEM:
A SURVEY OF NATURALLY VENTILATED DAIRY BARNS IN MICHIGAN

A THESIS

Submitted to
Michigan State University
in partial fulfillment of the requirements
for the degree of

1985

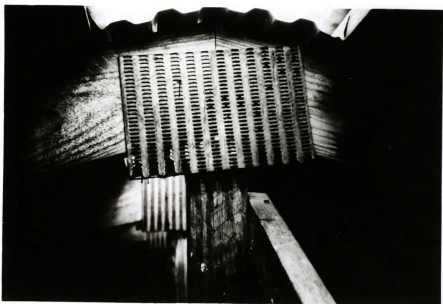
Figure 4.2. Failure at the Wood-Metal Fastener Connection, Barn J.

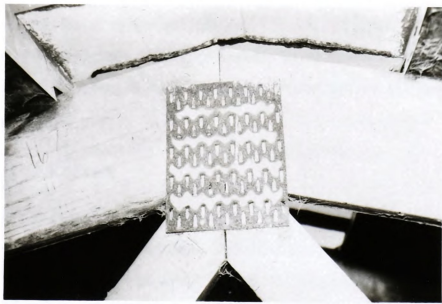
Figure 4.3. Metal Fastener Corrosion, Barn G.

NOTES: Metal ridge gusset plates and flashing at the ridge indicate extensive corrosion. Four 0.91m (36") intake, fans have been installed to improve summer ventilation, two fans in each endwall.

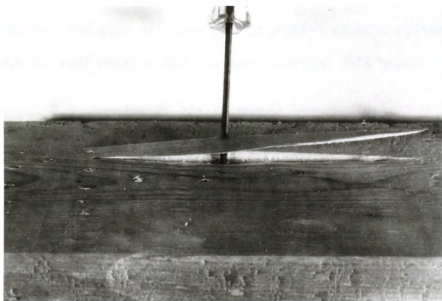
Figure 4.4. Pick test. Clean break indicates wood free of decay.

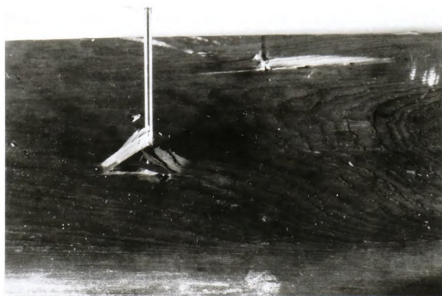
Figure 4.5. Pick test. Brash break indicates presence of decay.
