EVALUATION OF CORROSION
IN
COPPER WATER TUBING

Thesis for the Degree of M. S.
MICHIGAN STATE UNIVERSITY
Arthur L. Plumley

1957

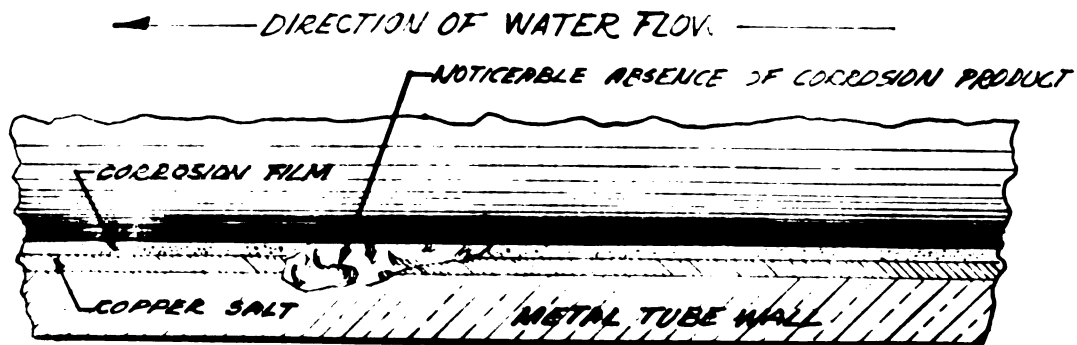
Figure 1. Impingement Type Corrosion

Erosion-corrosion or Impingement Corrosion — Erosion is usually regarded as a destructive process involving concurrent removal of material. Impingement or erosion-corrosion is usually characterized by rapid and repeated destruction of protective surface films in the presence of rapidly moving, turbulent liquids. Copper tubing suffers impingement attack in systems where the velocity of the water is unusually high and/or turbulent, and where no protective film is formed or the initially formed film has been loosened. Because the flow is subject to construction irregularities and turbulence, attack usually predominated in local areas or sections near the inlet end of the tubing, but may extend the entire length of an installation. Entrained air bubbles, breaking as they contact the surface of the tubing, act as accelerators of this type of corrosion which may be easily identified by its crescent-shaped, elongated pits, frequently undercut in the downstream direction. (Figure 1)

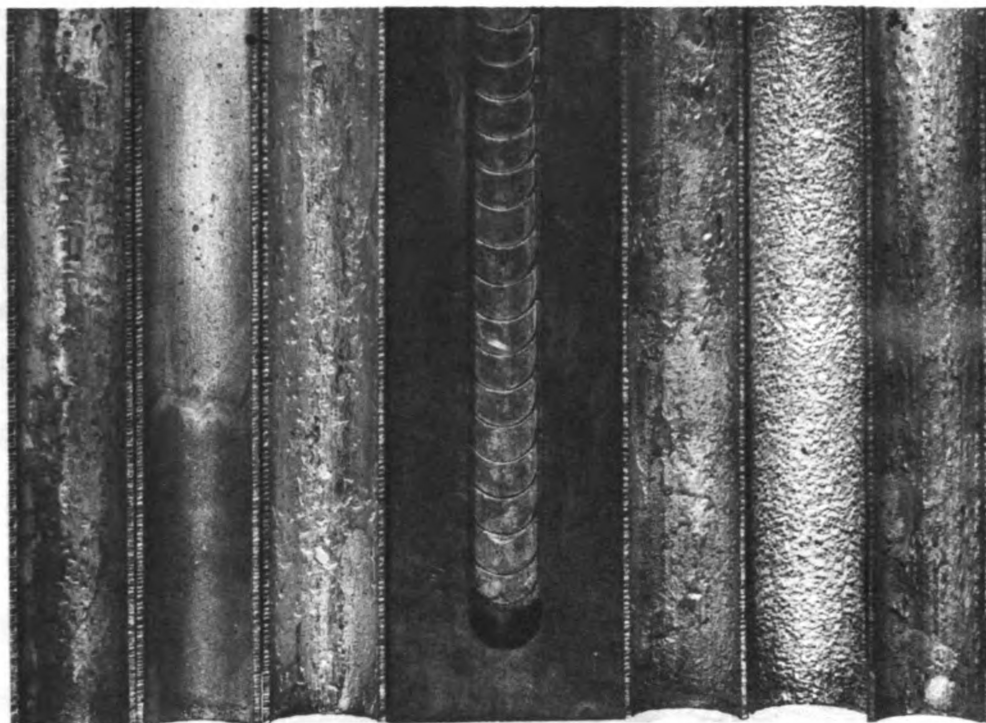
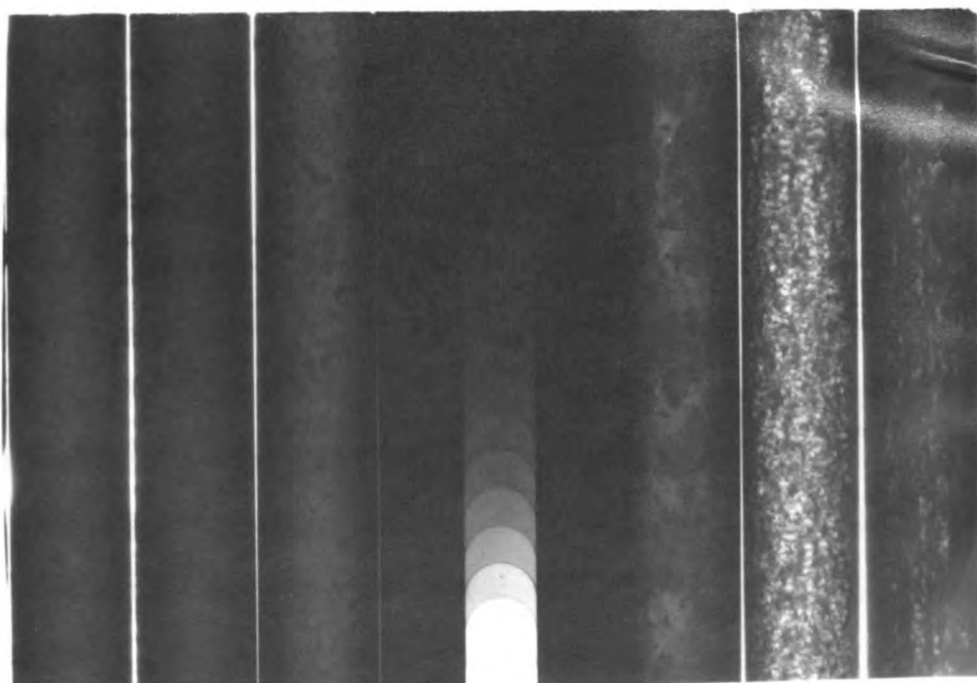
Figure 9. Photograph and Radiograph of Corroded Specimens with Step Wedge

The photograph and radiograph (Figure 9) are prints of the same set of corroded tubing samples. The complementary nature of the two methods is evident; the photograph shows the general shape and location of pitting, whereas the radiograph reveals the extent of corrosion. The light spots on the radiographic print correspond to the greatest depth of penetration by corrosion.
