AN INVESTIGATION OF THE NEEDLE
LIKE STRUCTURE IN HIGH SPEED STEEL

Thesis for the Degree of Met. E.

Walter G. Hildorf

June 1927

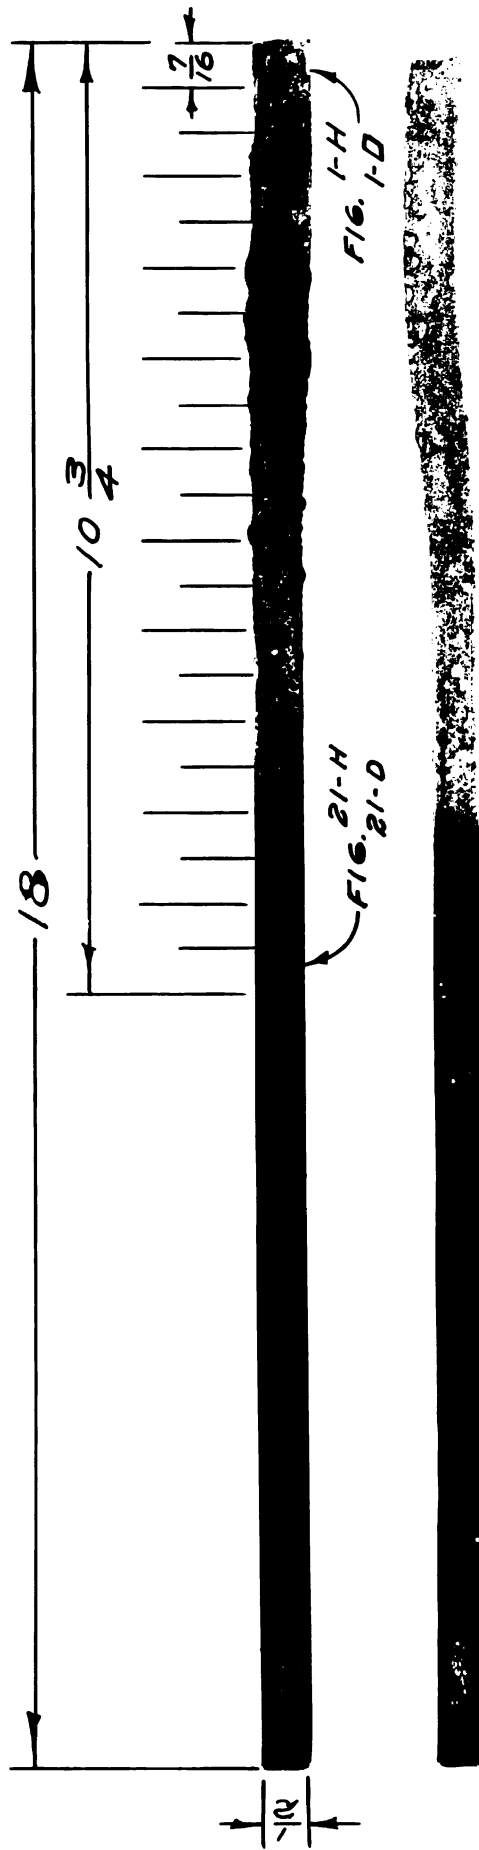
FIG. 1-A

HIGH SPEED STEEL SAMPLES USED IN THIS INVESTIGATION.

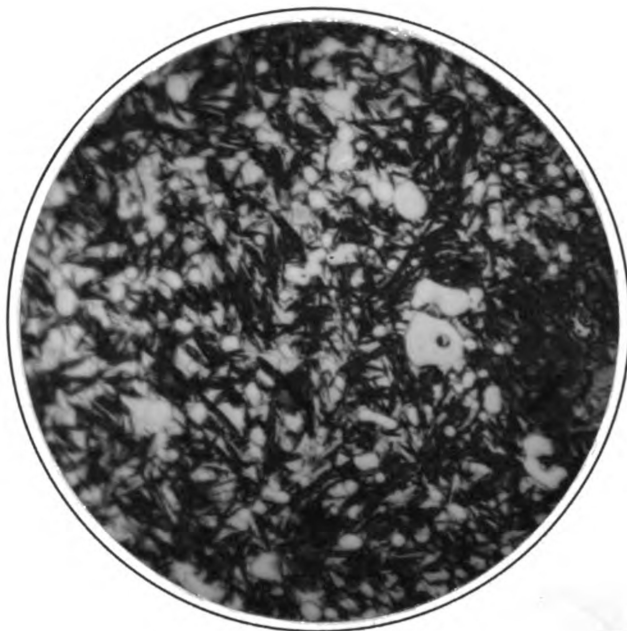
A typical needle like structure is shown in Fig. 1. The reader should not confuse this structure with a martensitic structure which is also of a needle like type. Our observations lead us to believe that this structure is separate and distinct from a martensitic structure. A study of the following photomicrographs will aid in making this clear.

This shows a typical needle like structure. It is believed that this structure is not martensite. Compare it with Figs. 2-D and 3-D and also with martensitic structures as shown in The Metallography of Steel and Cast Iron by H. M. Howe and in The Metallography and Heat Treatment of Iron and Steel by Albert Sauveur.

Since this structure is usually not over .005 in. deep it can usually be removed by leaving enough stock on both sides of the cutting edges so that .005 in. may be ground away after hardening and tempering. However, this is difficult and expensive and in some cases even impossible without special grinding machines.

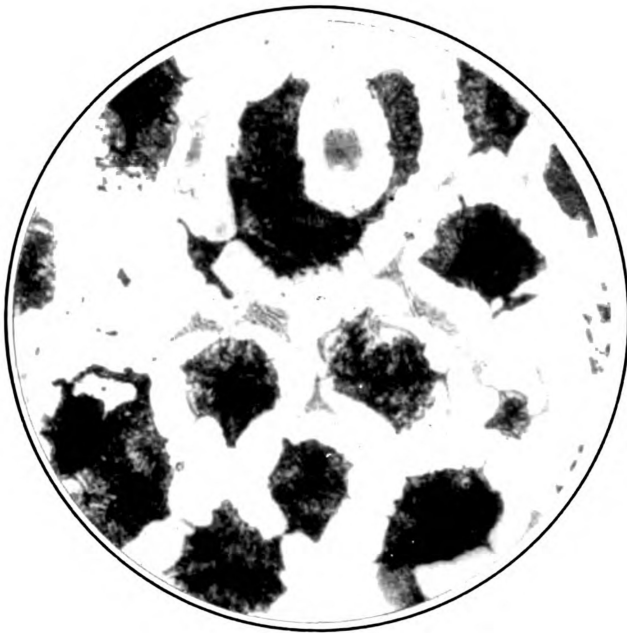
Fig. 1-H

A study of the hardened samples failed to reveal any needle like structure. However, there are several very interesting things brought out in this series of photographs which it might be well to mention. The overheating extended to about Fig. 11-H. This is

Rockwell hardness ----- 62.6
 Depth of needle like
 structure ----- None
 Badly overheated

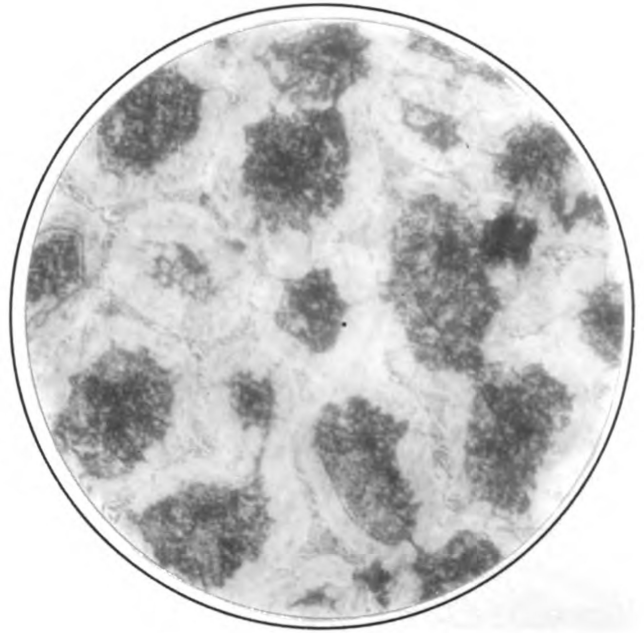
The tempered samples showed no needle like structure in the first sample, Fig. 1-D, but it was very evident from Fig. 2-D to and including Fig. 17-D. The depth of the needle like structure varied from .005 in. in Fig. 2-D to .0005 in. in Fig. 17-D. This series of photographs also shows several very interesting features, which probably have no bearing on the needle like structure, but are of general interest. The carbides exist in the form of cubes and also in narrow irregular shaped bands from Fig. 1-D to Fig. 11-D, beyond this they exist mainly as spheres.

Rockwell hardness ----- 62.6
 Depth of needle like
 structure ----- None
 Badly overheated

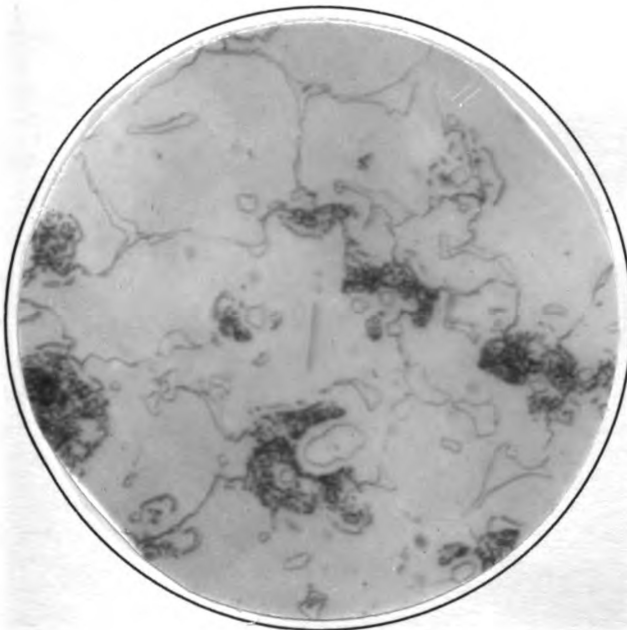
Fig. 2-H

Rockwell hardness ----- 64.8
 Depth of needle like
 structure ----- None
 Carbides are mainly in the
 grain boundaries

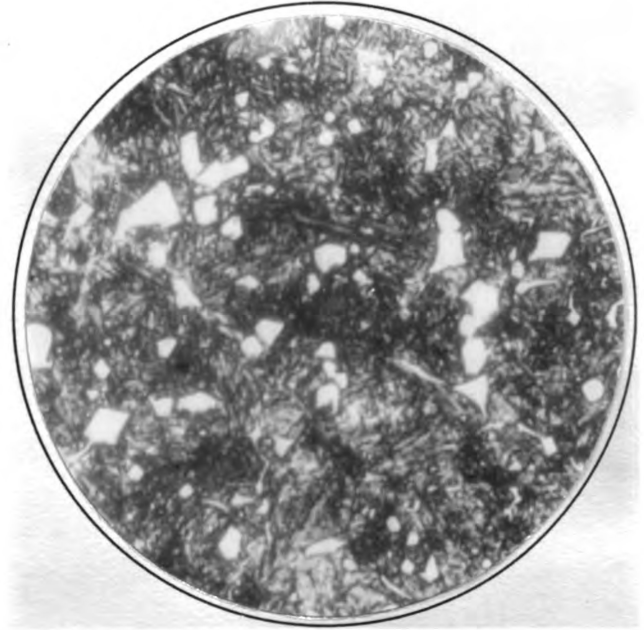
The martensitic structure is present in a large number of the samples for example Fig. 2-D shows this structure. A large number of the samples show the outlines of the austenite grains.

Rockwell hardness ----- 62.6
 Depth of needle like
 structure ----- .005"
 Structure is martensitic

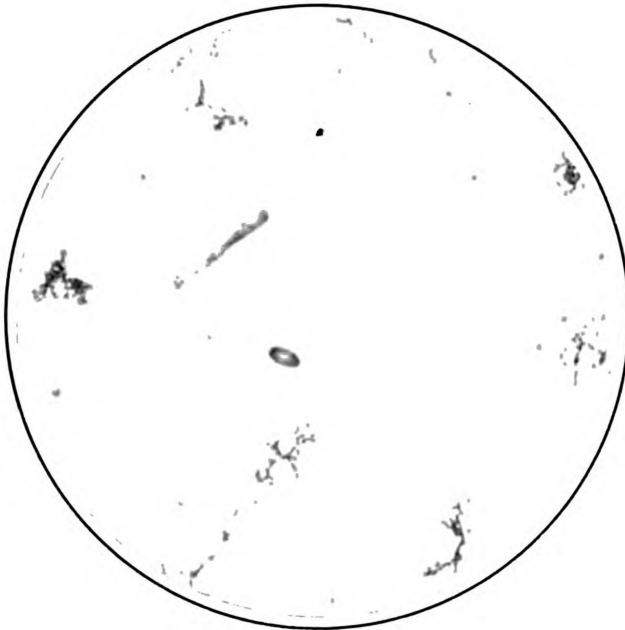
Fig. 3-H

Rockwell hardness ----- 64.5
 Depth of needle like
 structure ----- None

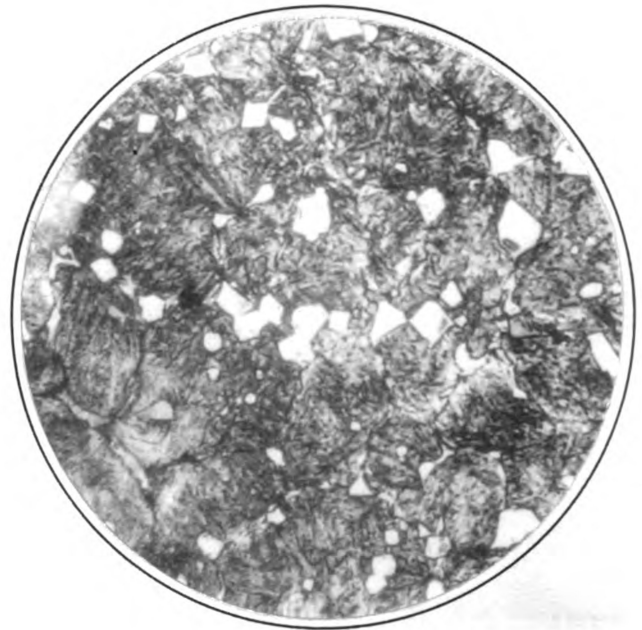
Fig. 3-D

Rockwell hardness ----- 62.8
 Depth of needle like
 structure ----- .004"
 Structure is martensitic

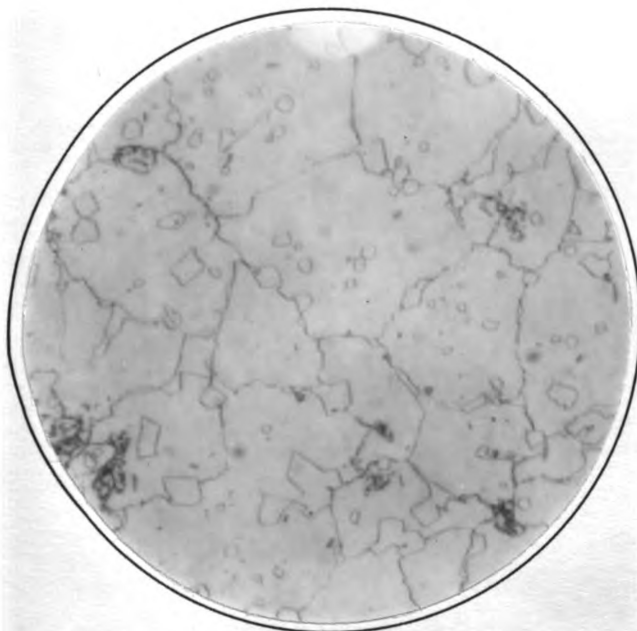
Fig. 4-H

Rockwell hardness ----- 63.8
 Depth of needle like
 structure ----- None

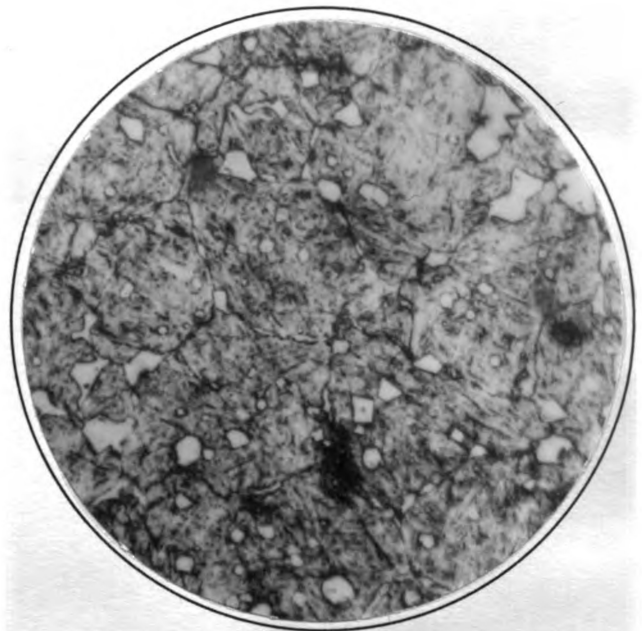
Fig. 4-D

Rockwell hardness ----- 61.5
 Depth of needle like
 structure ----- .0025"
 The outline of the austenite
 grains is still present

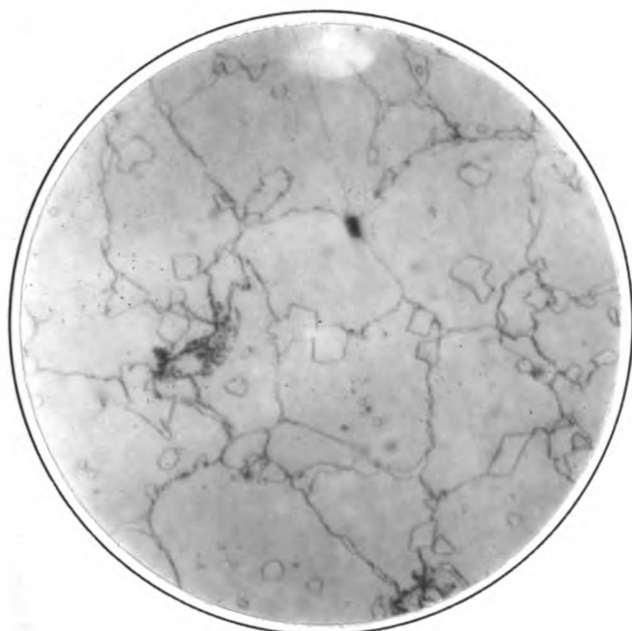
Fig. 5-H

Rockwell hardness ----- 64
 Depth of needle like
 structure ----- None

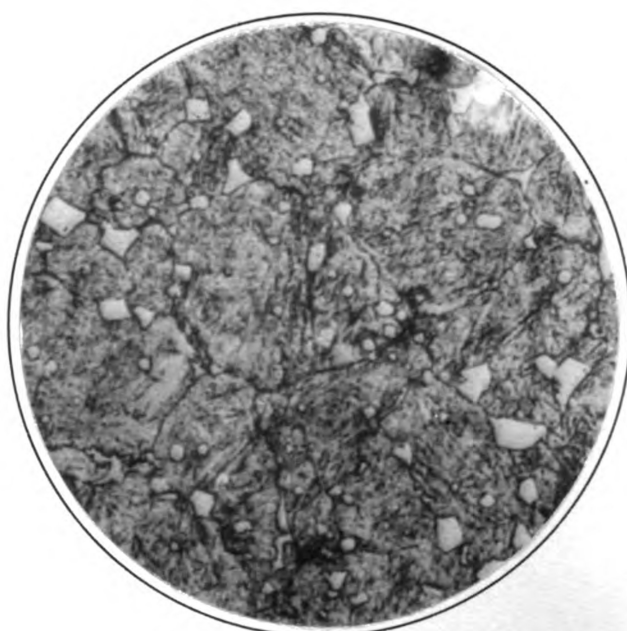
Fig. 5-D

Rockwell hardness ----- 62.8
 Depth of needle like
 structure ----- .002"

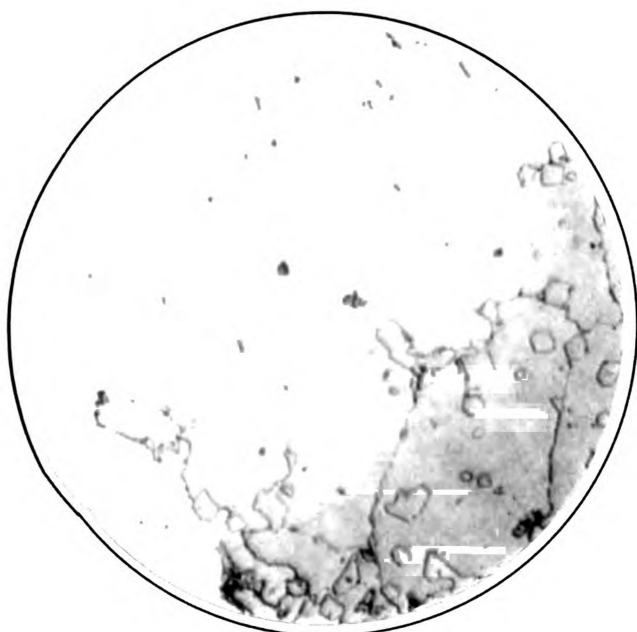
Fig. 6-H

Rockwell hardness ----- 64.6
 Depth of needle like
 structure ----- none

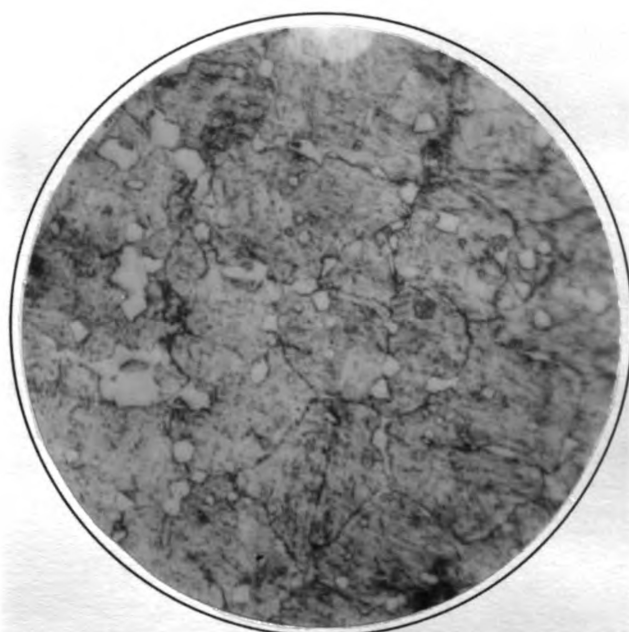
Fig. 6-D

Rockwell hardness ----- 62
 Depth of needle like
 structure ----- .003"

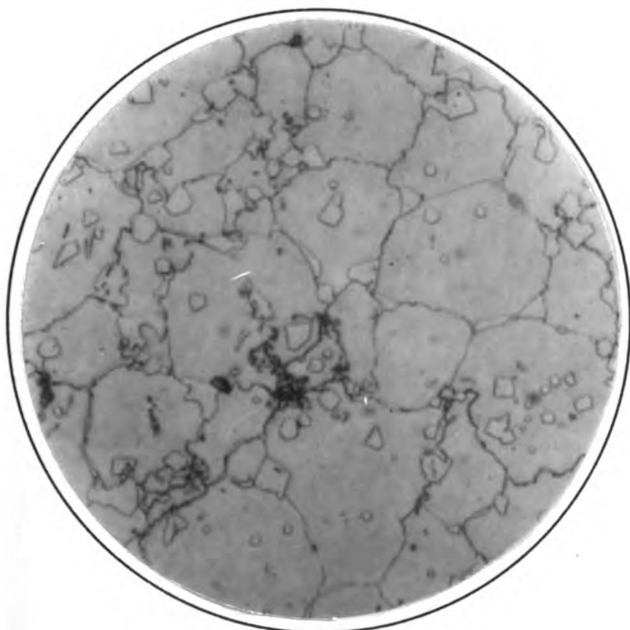
Fig. 7-H

Rockwell hardness ----- 64
 Depth of needle like
 structure ----- None

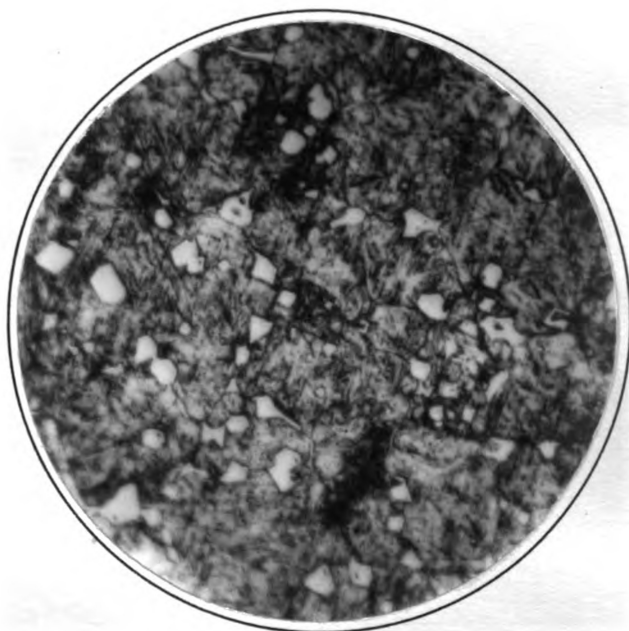
Fig. 8-D

Rockwell hardness ----- 61.8
 Depth of needle like
 structure ----- .002"

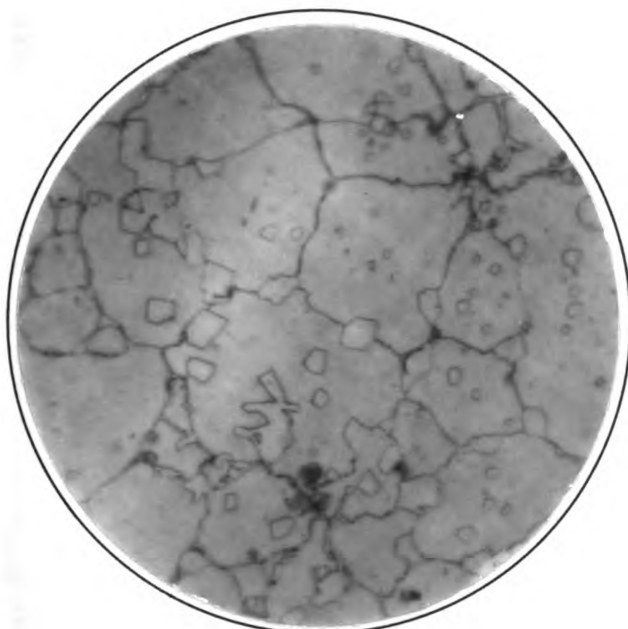
Fig. 9-H

Rockwell hardness ----- 64.2
 Depth of needle like
 structure ----- None

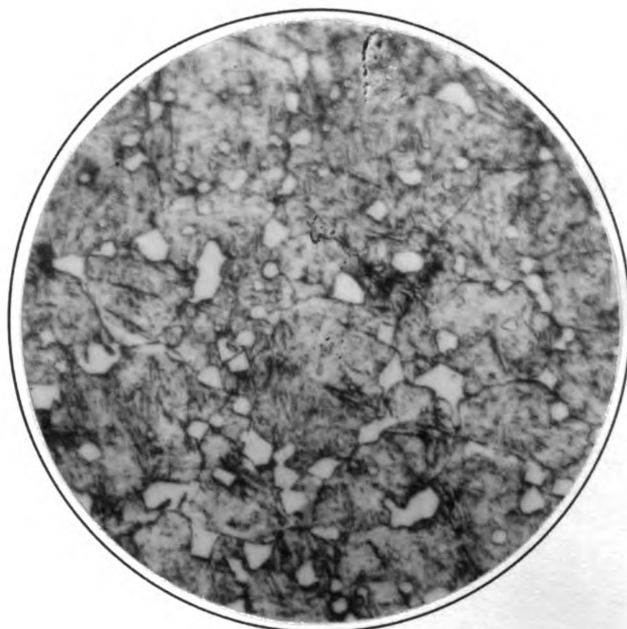
Fig. 9-D

Rockwell hardness ----- 63.1
 Depth of needle like
 structure ----- .002"

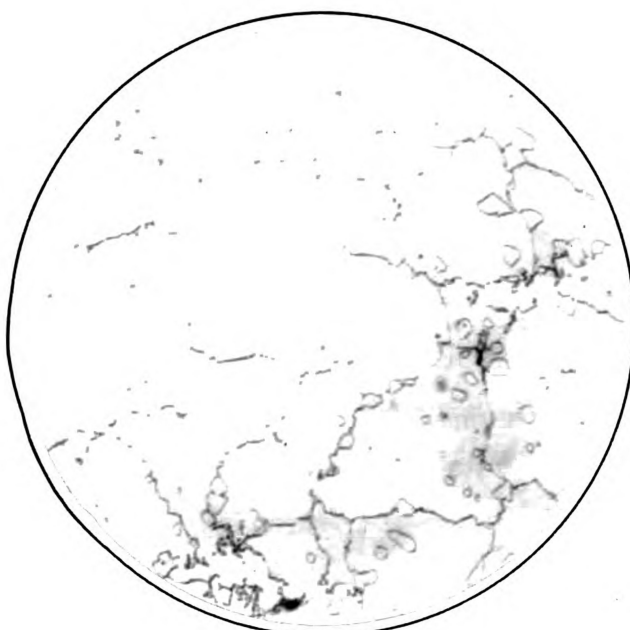
Fig. 10-H

Rockwell hardness ----- 64.6
 Depth of needle like
 structure ----- None

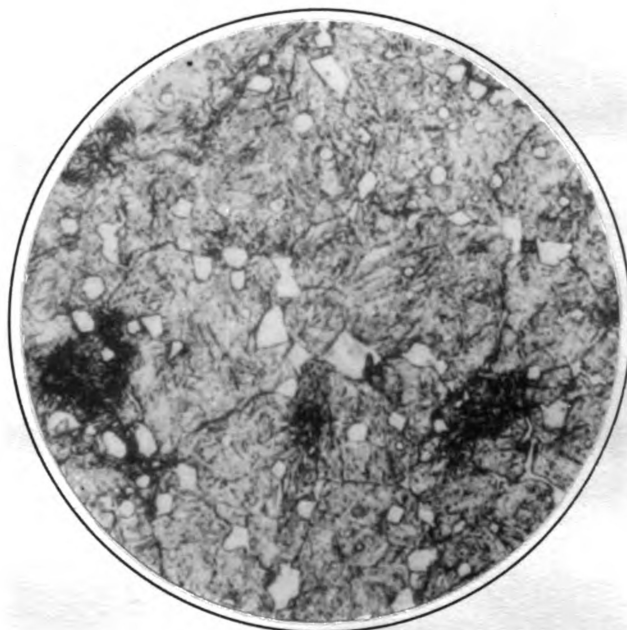
Fig. 10-D

Rockwell hardness ----- 63.5
 Depth of needle like
 structure ----- .002"

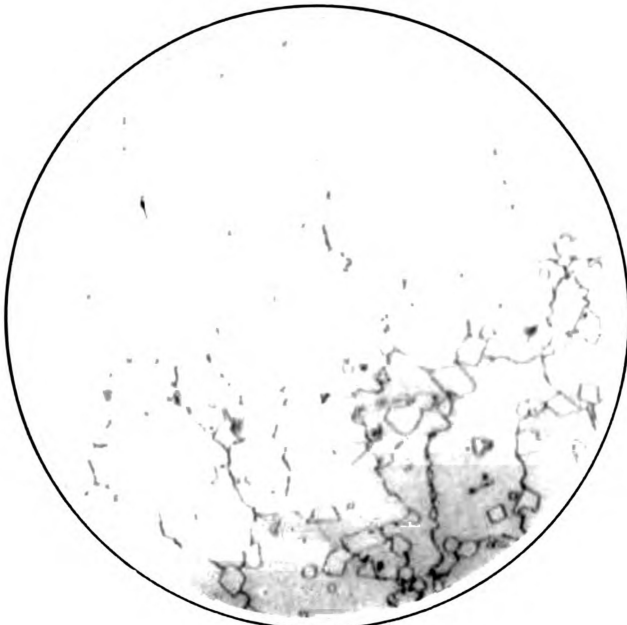
Fig. 11-H

Rockwell hardness ----- 65
 Depth of needle like
 structure ----- None
 Correct hardening temperature

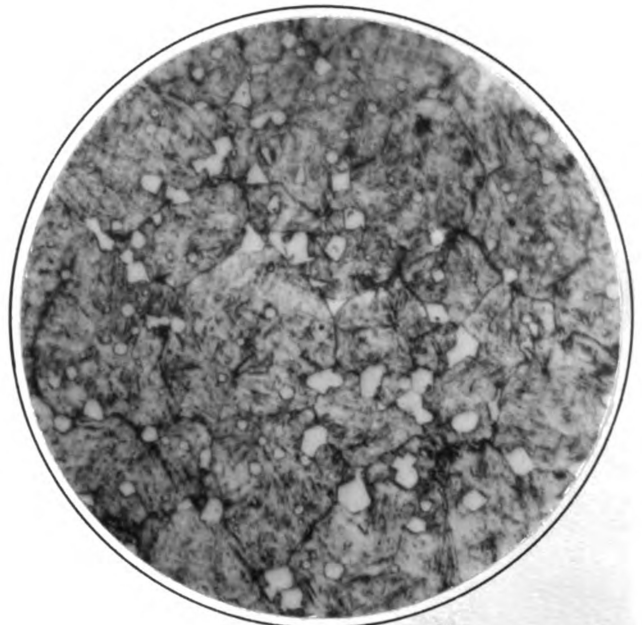
Rockwell hardness ----- 62.3
 Depth of needle like
 structure ----- .004"
 Note the martensitic structure

1. That overheating might not be entirely the answer because this structure was present as far as Fig. 17-D, while Fig. 11-D showed about the correct hardening temperature. In other investigations where the temperature was held as near 2300°F. as possible this structure was sometimes present. However, overheating or some one temperature not necessarily very high considering high speed steel temperatures probably has a decided influence, if it is not the entire cause, because in most cases this structure is on the outside of the samples, which becomes the hottest, also this structure is always very coarse which helps to prove the above statement.
2. That uneven heating is out of the question because it is often present in small samples which have been heated with laboratory accuracy.

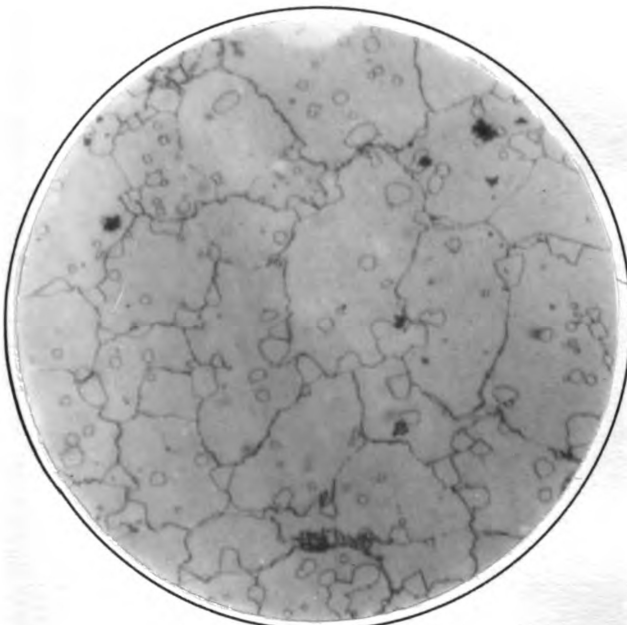
Fig. 12-H

Rockwell hardness ----- 65.1
 Depth of needle like
 structure ----- None

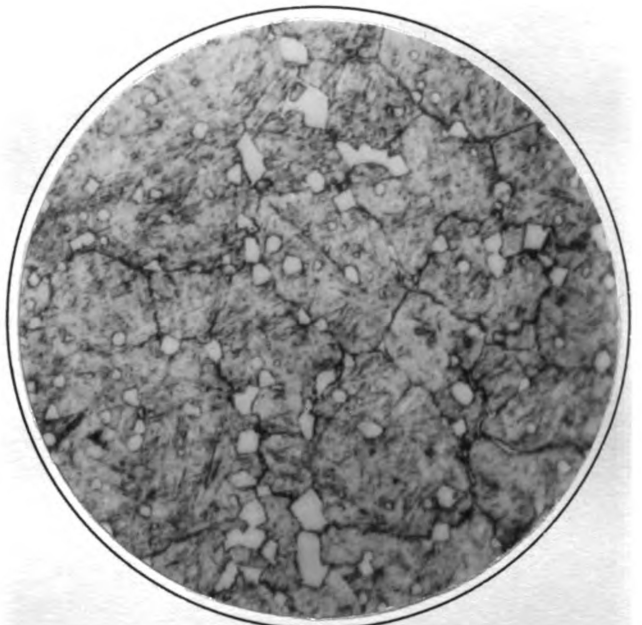
Fig. 12-D

Rockwell hardness ----- 63
 Depth of needle like
 structure ----- .002"

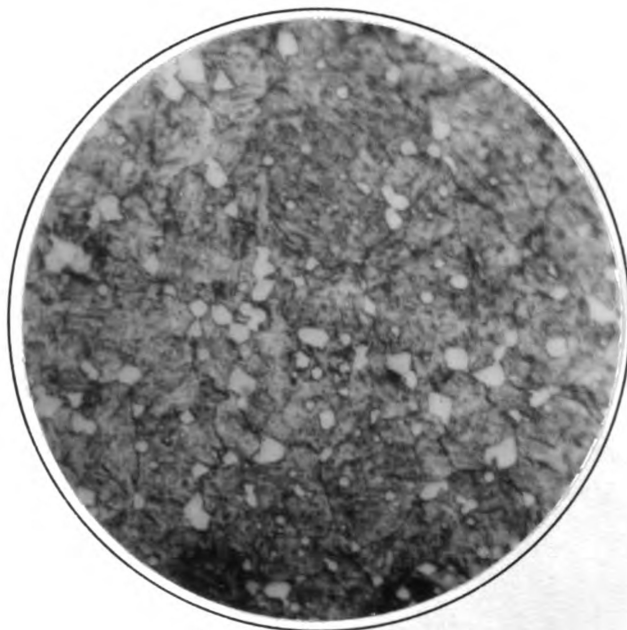
Fig. 13-D

Rockwell hardness ----- 62.5
 Depth of needle like
 structure ----- .002"

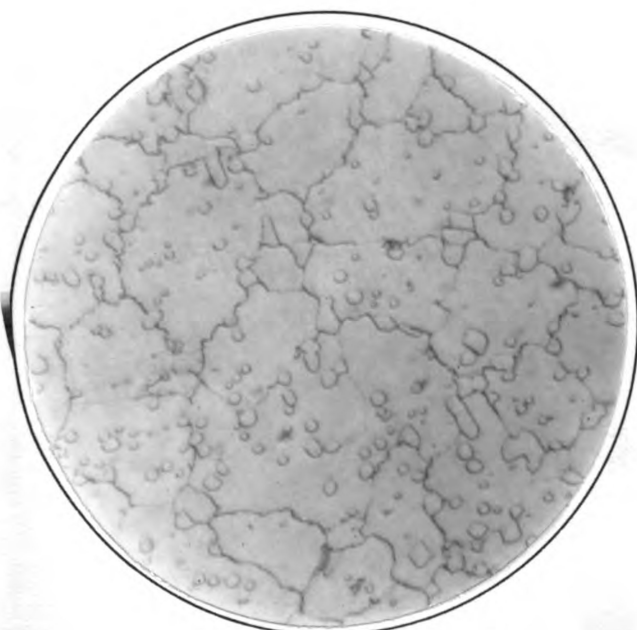
Fig. 14-H

Rockwell hardness ----- 65.1
 Depth of needle like
 structure ----- None

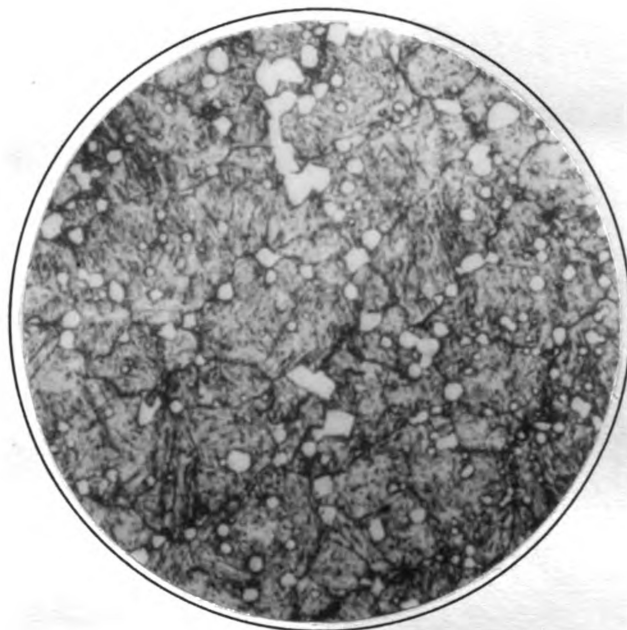
Fig. 14-D

Rockwell hardness ----- 62.1
 Depth of needle like
 structure ----- .0005"

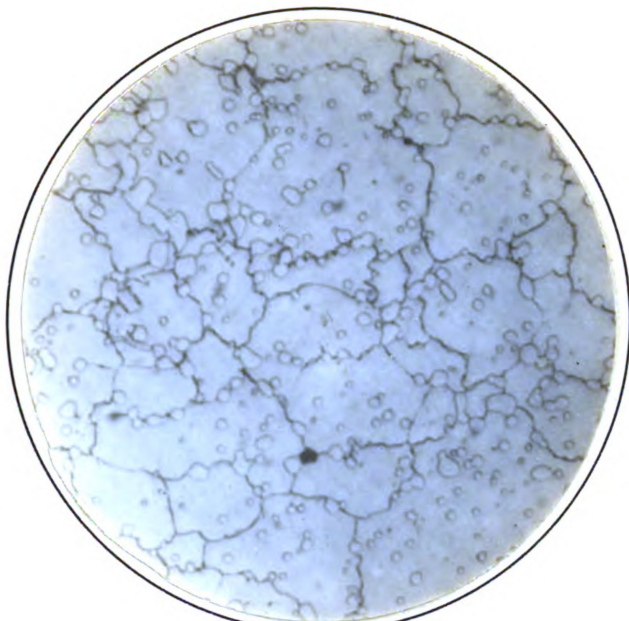
Fig. 15-H

Rockwell hardness ----- 63.8
 Depth of needle like
 structure ----- None
 Note large number of very
 small carbides

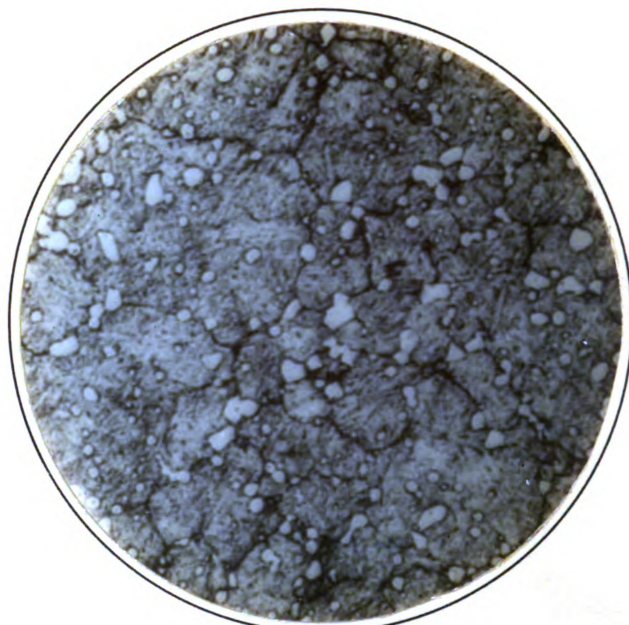
Fig. 15-D

Rockwell hardness ----- 61.3
 Depth of needle like
 structure ----- .0005"

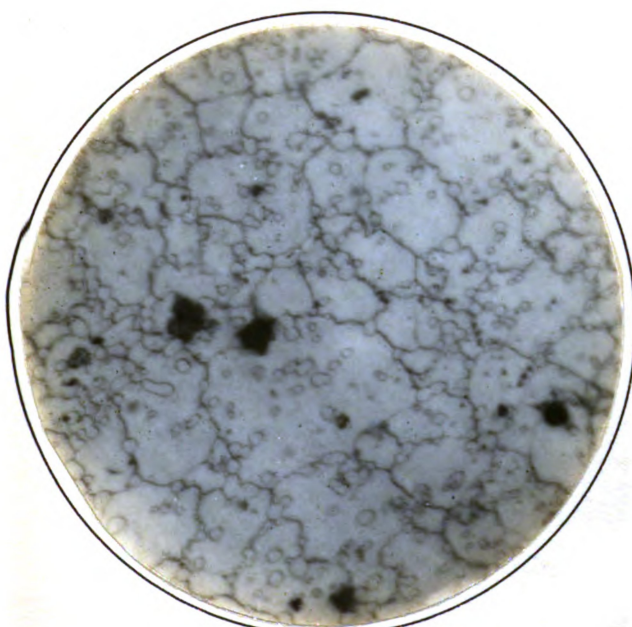
Fig. 16-H

Rockwell hardness ----- 65.1
 Depth of needle like
 structure ----- None

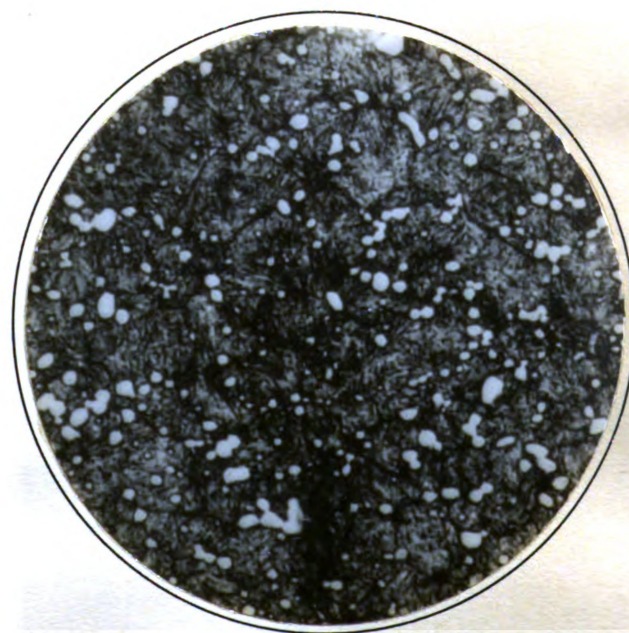
Fig. 16-D

Rockwell hardness ----- 61.5
 Depth of needle like
 structure ----- .0005"

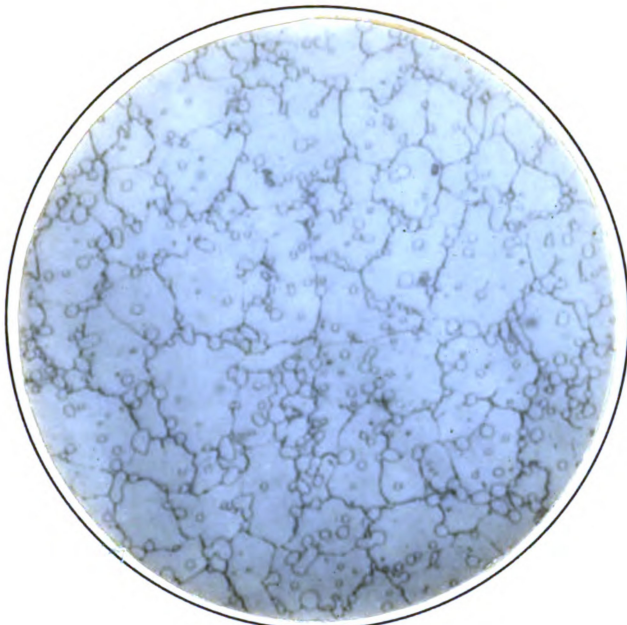
Fig. 17-H

Rockwell hardness ----- 64.3
 Depth of needle like
 structure ----- None
 Nearly all carbides are
 spherical

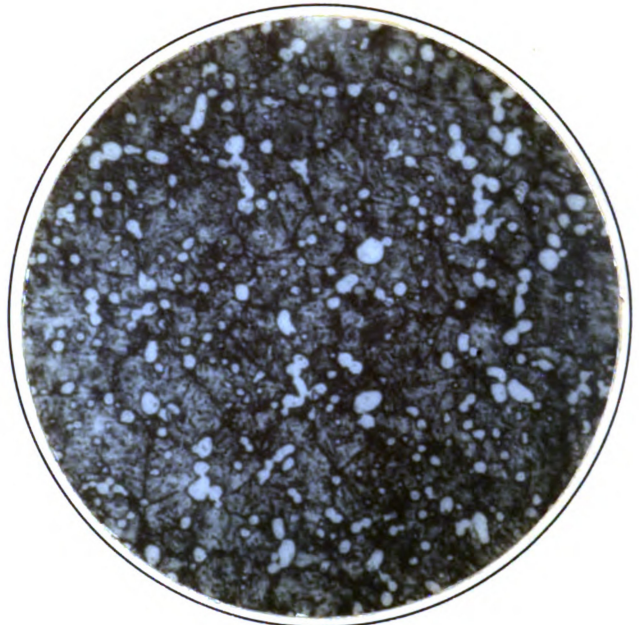
Fig. 17-D

Rockwell hardness ----- 60
 Depth of needle like
 structure ----- .0005"

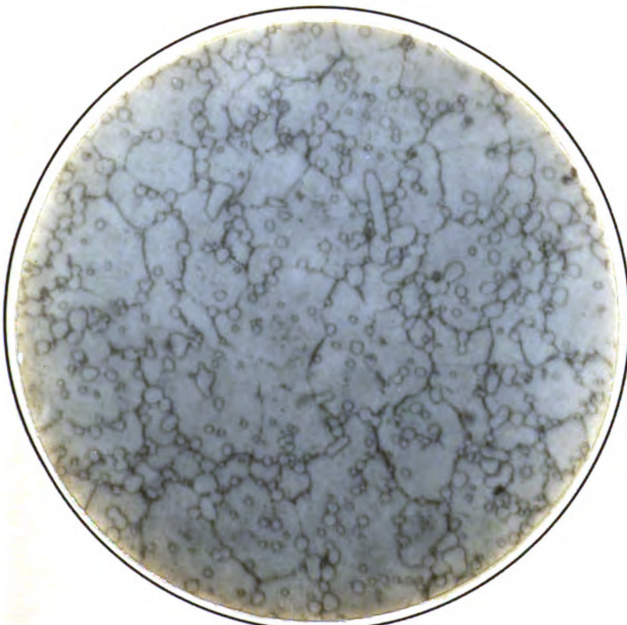
Fig. 18-H

Rockwell hardness ----- 64.1
 Depth of needle like
 structure ----- None

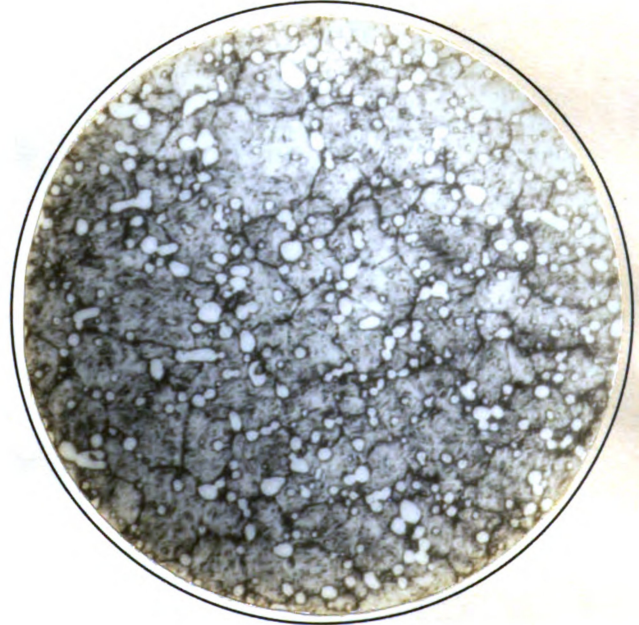
Fig. 18-D

Rockwell hardness ----- 59.6
 Depth of needle like
 structure ----- None

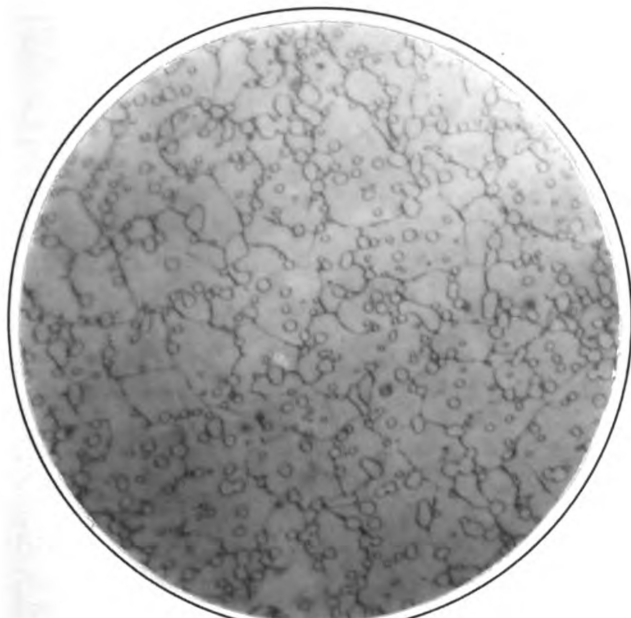
Fig. 19-H

Rockwell hardness ----- 63.3
 Depth of needle like
 structure ----- None
 Incomplete austenite grains

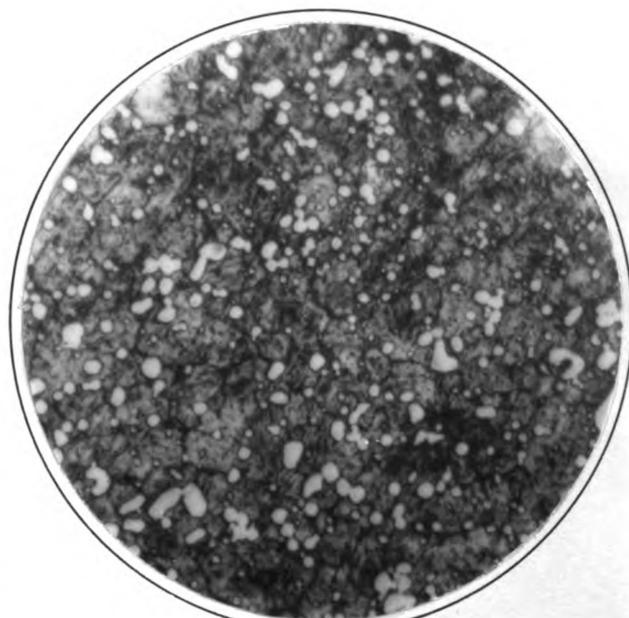
Fig. 19-D

Rockwell hardness ----- 58
 Depth of needle like
 structure ----- None

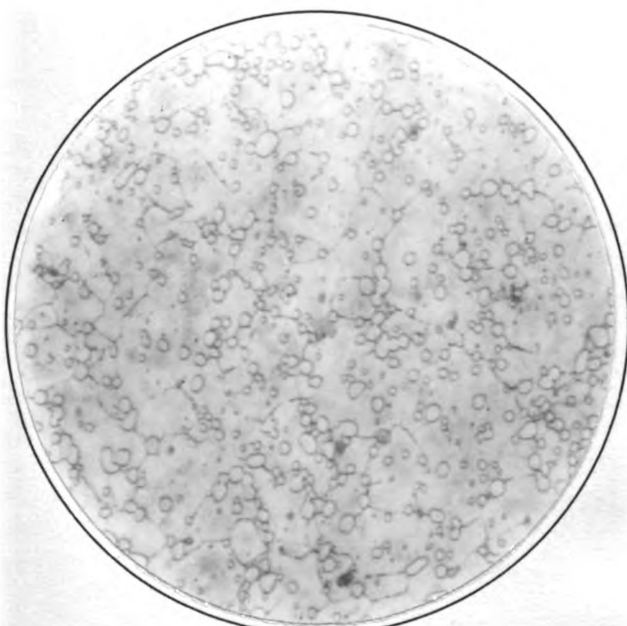
Fig. 20-H

Rockwell hardness ----- 62.8
 Depth of needle like
 structure ----- None

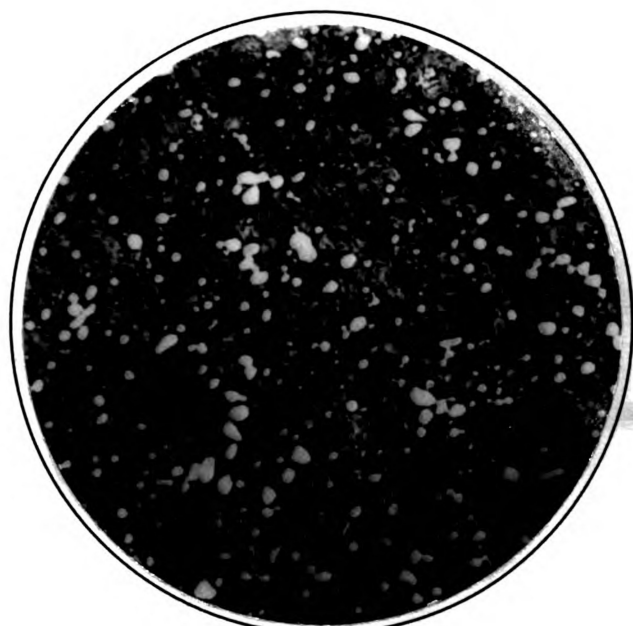
Fig. 20-D

Rockwell hardness ----- 56.3
 Depth of needle like
 structure ----- None

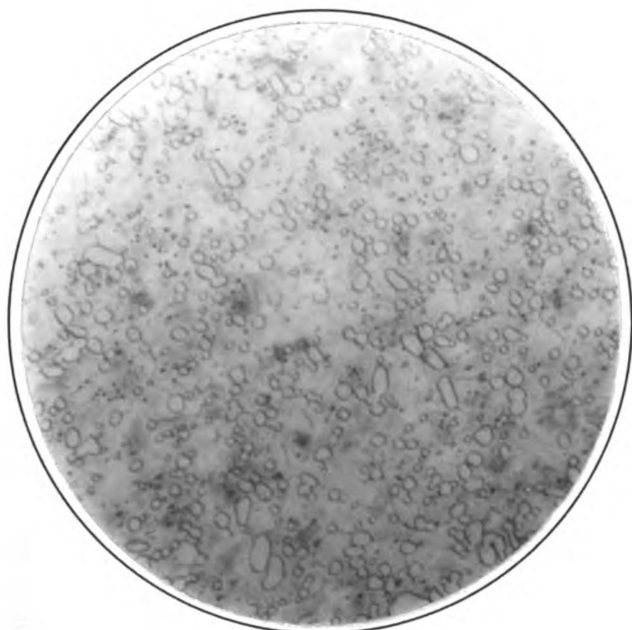
Fig. 21-H

Rockwell hardness ----- 58
 Depth of needle like
 structure ----- None
 No definite austenite grains.
 Temperature too low for the
 formation of austenite grains.

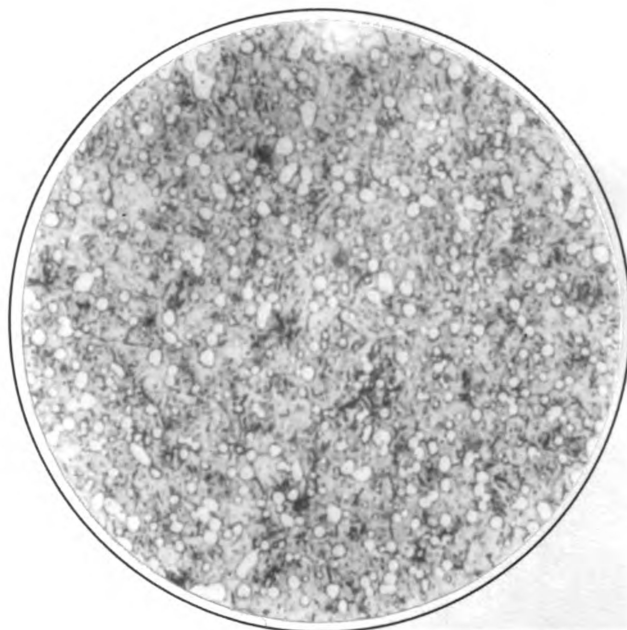
Fig. 21-D

Rockwell hardness ----- 52.5
 Depth of needle like
 structure ----- None
 Structure very similar to
 the hardened structure.
