# TESTING THE EFFECTS OF WINDOW REHABILITATION ON LEAD DUST LEVELS: A CASE STUDY

# A THESIS

MASTER OF URBAN AND REGIONAL PLANNING

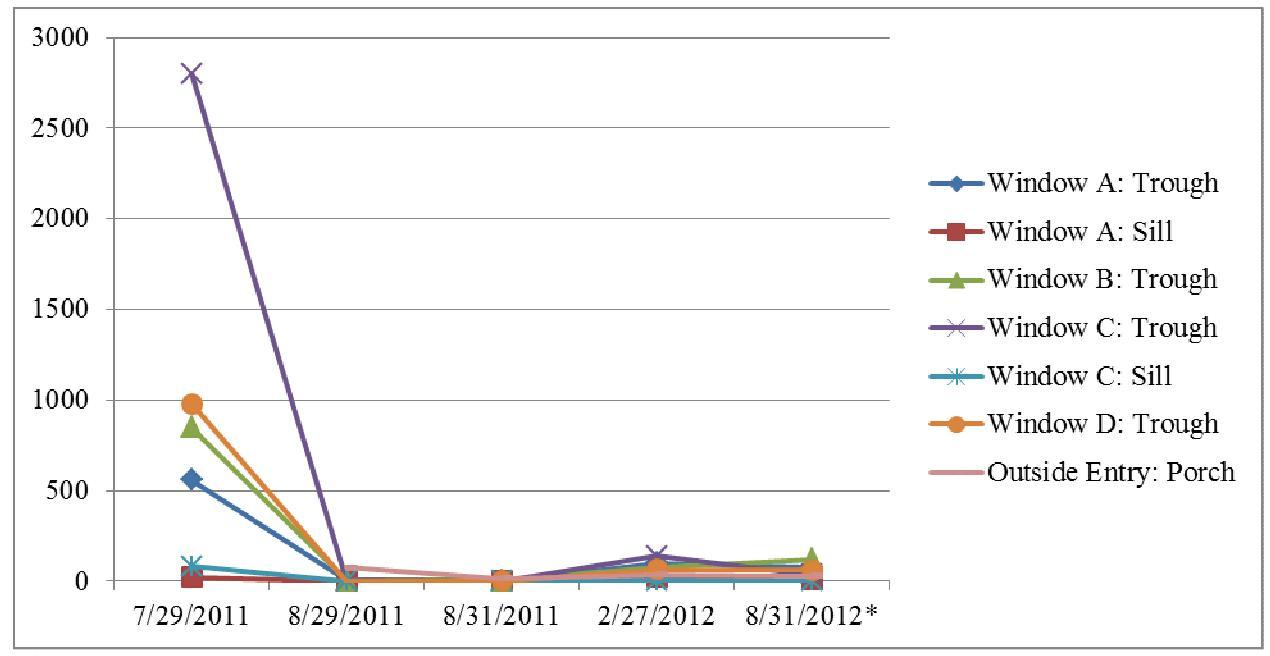
To test the accumulation of lead dust over time, the homeowner was asked not to clean the window troughs or sills during the study period; therefore, the readings for the year following the rehabilitation represent all lead dust that gathered on those surfaces. For the four troughs, the cumulative DLLs after 12 months showed net declines ranging from 68.9% (window A) to 93.7% (window C). The significant net effect of the rehabilitation and cleaning is shown in Figure 1 on the next page.

**Figure 1:** Net decline in DLL over the complete study period. To make the chart more readable, test areas that were below 20  $\mu$ g/ft<sup>2</sup> throughout the study are not shown. Due to the relative similarity in post-rehabilitation, post-cleaning DLLs, data labels are not included. For interpretation of the references to color in this and all other figures, the reader is referred to the electronic version of this thesis.

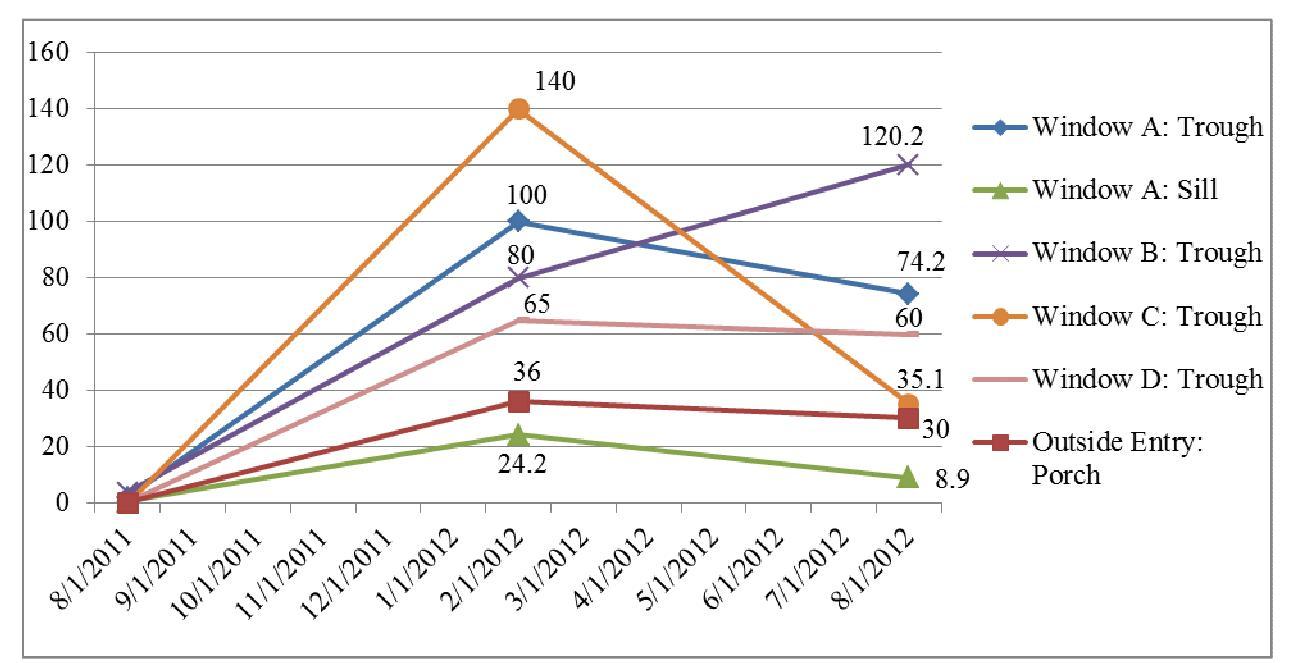
Cumulatively, the DLLs of troughs A, B, and C reached roughly half the HUD clearance standard for troughs, which is 400  $\mu$ g/ft<sup>2</sup> (HUD, 2004). The cumulative trough DLL for

Window D, which received the least intensive rehabilitation, was slightly over one-quarter of the HUD clearance threshold. The sill of Window A was the only sill to show a post-rehabilitation DLL over 20  $\mu$ g/ft<sup>2</sup>. The front porch also exhibited low but readable DLLs. The post-rehabilitation, post-cleaning increase in DLL is shown in Figure 2, below.

**Figure 2:** Increase in DLLs after rehabilitation and cleaning. To make the chart more readable, this chart shows only the test areas that presented DLLs above  $20 \,\mu g/ft^2$  during the post-cleaning period.

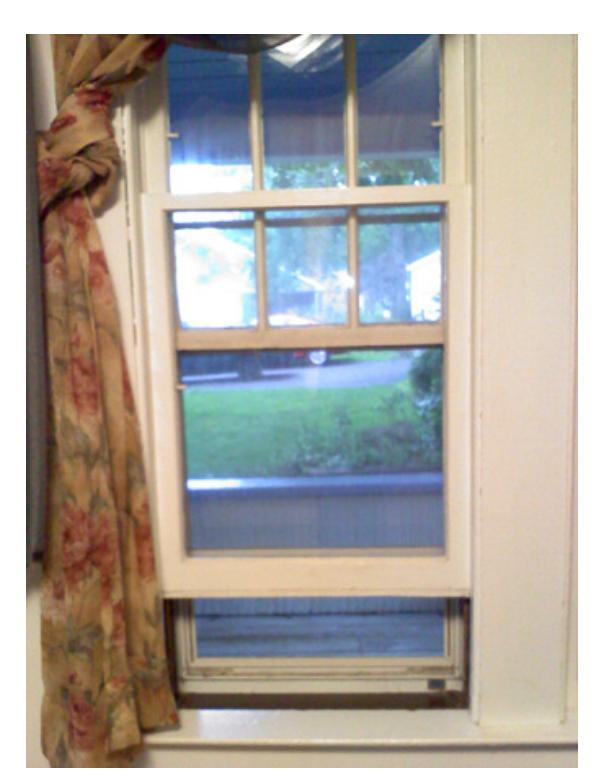
**Figure 3**: Window A before rehabilitation. The front porch, where sash A and B were rehabilitated, is visible through the window. The relatively good condition of the inside trim was typical of all four windows. All photos by the author.

Windows A and B were south-facing windows in the first-floor living room, immediately to the right of the front door, located next to one another and looking onto the front porch. The inside trim and sills were in good condition (Fig. 3). The troughs were very dirty, with paint chips,

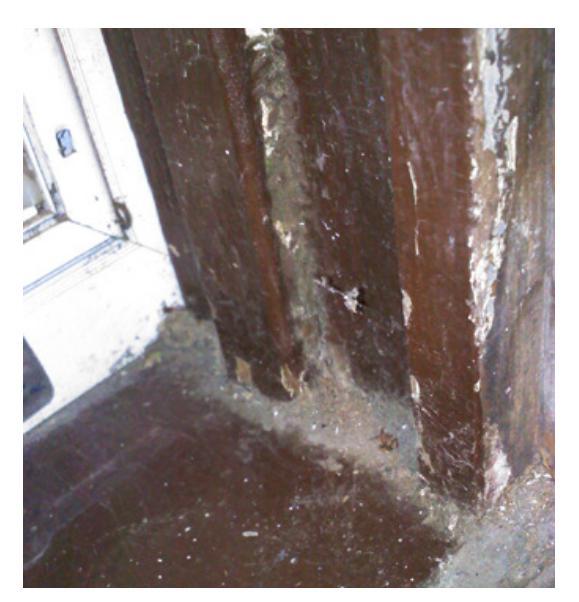
**Figure 4**: Window B before rehabilitation. Close-up photo showing fair to poor condition of trough and jamb typical of all four windows.

peeling paint, and dust (Fig. 4). The jambs presented moderate peeling paint as well as scrape marks from the movement of the sash, which possibly accounted for some of the dust and dirt in the trough. Neither of these windows was painted shut, but both were difficult to open.

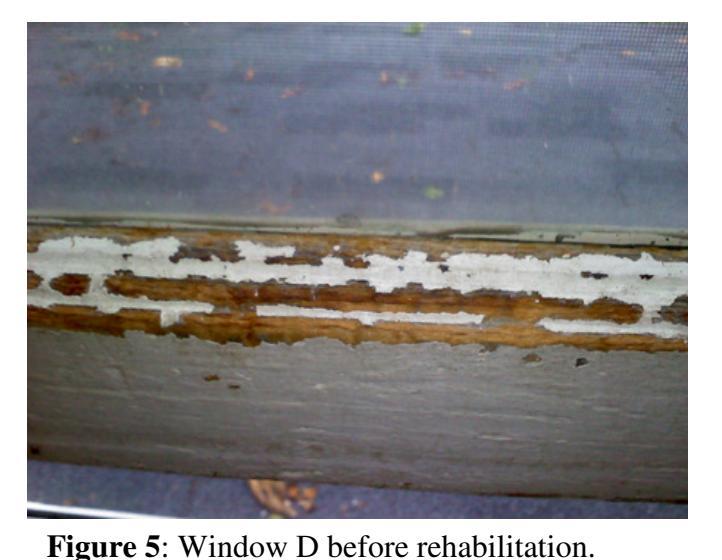
Close-up of lower sash chewed by dog. Roof of

front porch is in background.

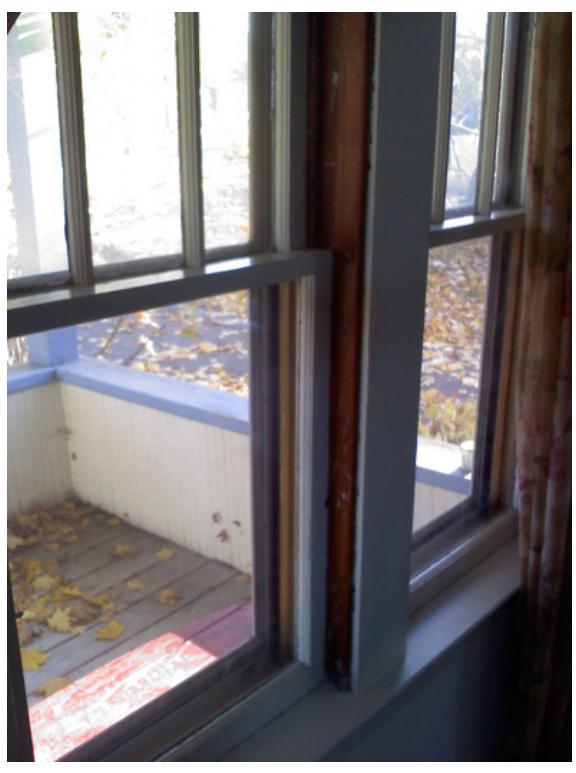
**Figure 6**: Windows A and B after rehabilitation. Note paint removed from stops and jambs.

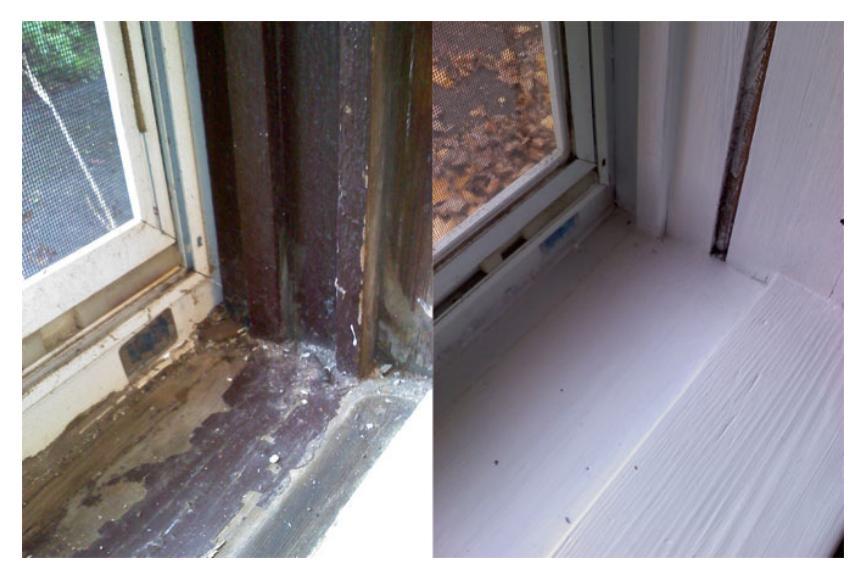
**Figure 7**: Left: Trough of Window C before rehabilitation. Right: Same trough after rehabilitation and before reinstallation of sash and stops.

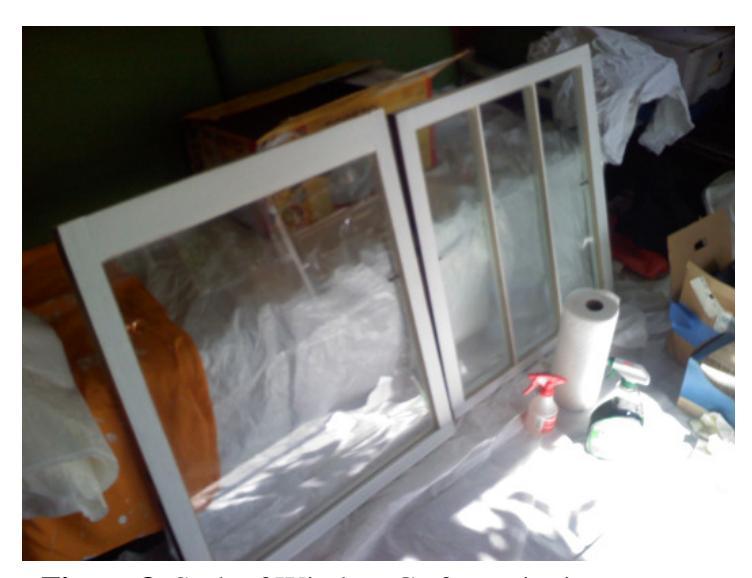
**Figure 8**: Sash of Window C after stripping, reglazing, priming, and painting and before reinstallation.

The goal of this rehabilitation was to remove lead paint from all surfaces, then recoat those surfaces. This was the third window to undergo rehabilitation. Because it was the most deteriorated of the four, this window was chosen for a very

intensive rehabilitation, including removal of the sash and stops offsite for paint removal and reglazing. The researcher performed the bulk of the rehabilitation, including all onsite work and most offsite work. A dropcloth was spread on the worksite and fastened to the wall with removable tape. The sash and stops were removed for offsite rehabilitation. All exposed surfaces of the jambs and trim were completely stripped of paint (with the exception of paint in deep crevices) using a heat gun and carbide scraper. Next, the surfaces were moistened with water from a spray bottle and sanded with sanding blocks. The jambs and trim were then primed and painted. The sash were taken to Wood Window Repair, whose proprietor taught the researcher several useful techniques for paint removal and reglazing. The researcher removed all visible paint (with the exception of traces of paint in deep crevices) using heat guns and a heat plate as well as sanding blocks. The old caulk and glazier's points were removed using scrapers. The glass was cleaned, returned to the sash, and secured with new caulk and glazier's points. Next, the researcher took the sash home to let the caulk cure, then prime and paint the sash; the friction surfaces were treated with linseed oil and mineral spirits and then painted with a very thin coat of primer. At the same location, the researcher stripped, sanded, primed, and painted the stops. Once the primer and paint had cured, the sash and stops were reinstalled at the test site. Due to the intensity of the work and the inexperience of the researcher, this rehabilitation took approximately 45 hours to complete.
