# IMPROVING THE EFFICIENCY OF RESIDENTIAL BUILDINGS IN RURAL ALASKA: AN ANALYSIS OF EXISTING INFRASTRUCTURE AND ITS IMPORTANCE IN CREATING ENERGY-EFFICIENT HOMES

## A THESIS

Submitted to Michigan State University in partial fulfillment of the requirements for the degree of

Environmental Engineering – Master of Science

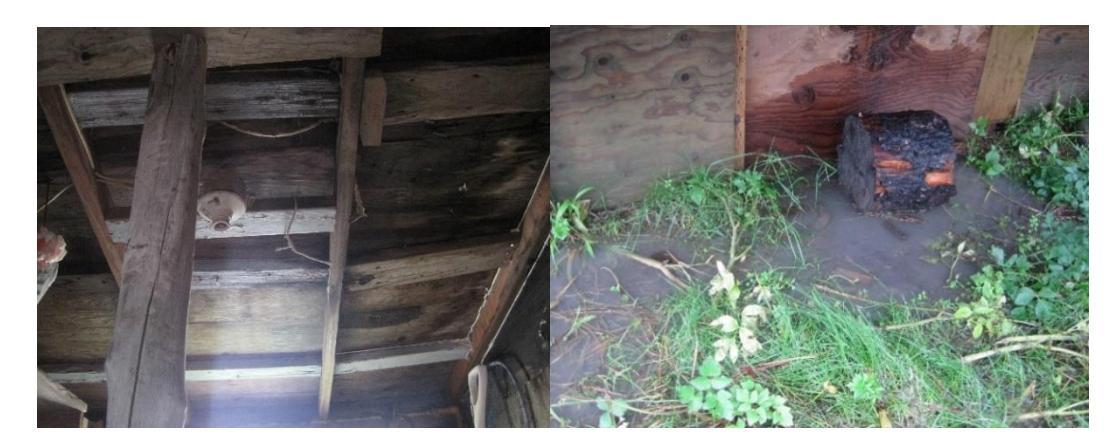
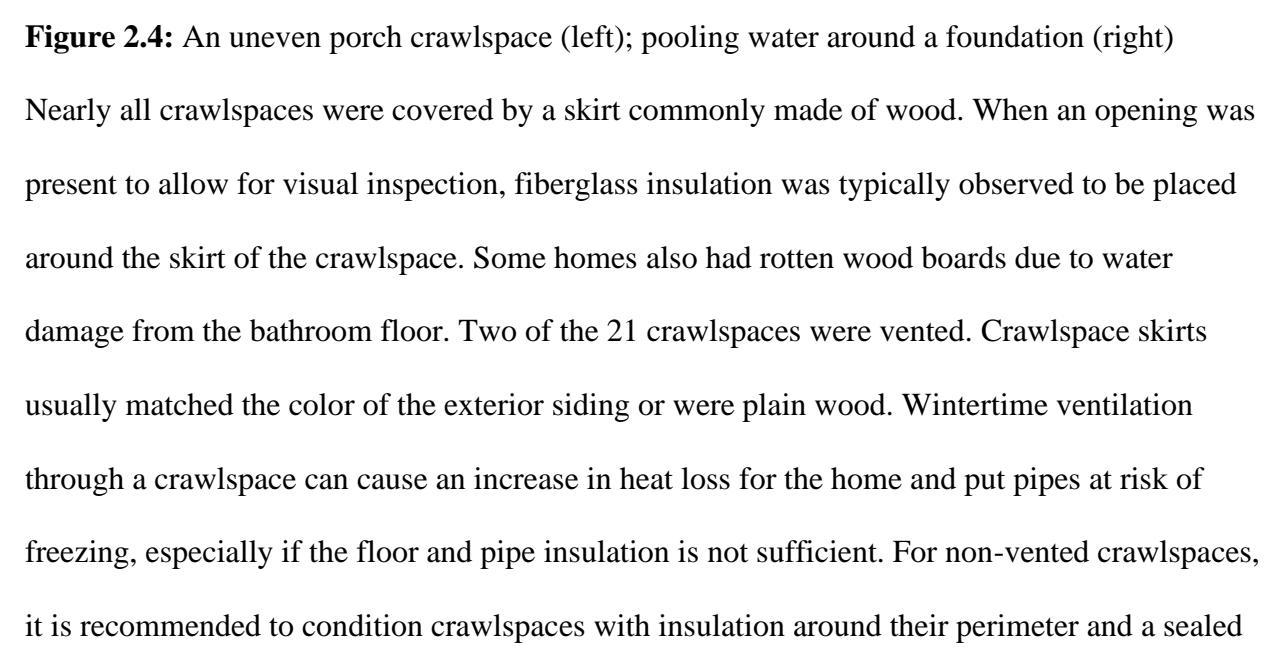
| Figure 1.1: Plan and section of an early dwelling found in Point Barrow [17] |
|---|
| Figure 2.4: An uneven porch crawlspace (left); pooling water around a foundation (right)23 |

Nearly all homes assessed on site (78%) had crawlspaces as their foundation. Six homes (22%) had a slab-on-grade foundation. Many homes were built on level ground; some did have evidence of shifting ground such as cracked foundations, uneven porches (Figure 2.4), and

sloped ground around the foundation, which can affect the building's envelope by causing cracks and air infiltration into the home. Some participants explained that their foundation had to be leveled after the ground shifted. The community and the homes on the hill above it are not built on permafrost; however, the main community is located just off the Bering Sea and built on primarily sandy soil. One participant clarified that shifting of the foundation usually occurred in the spring and winter, and that the house shifts significantly. To avoid pooling, some residents placed rocks as drainage around their crawlspace, however, pooling of water was present around some homes (Figure 2.4).

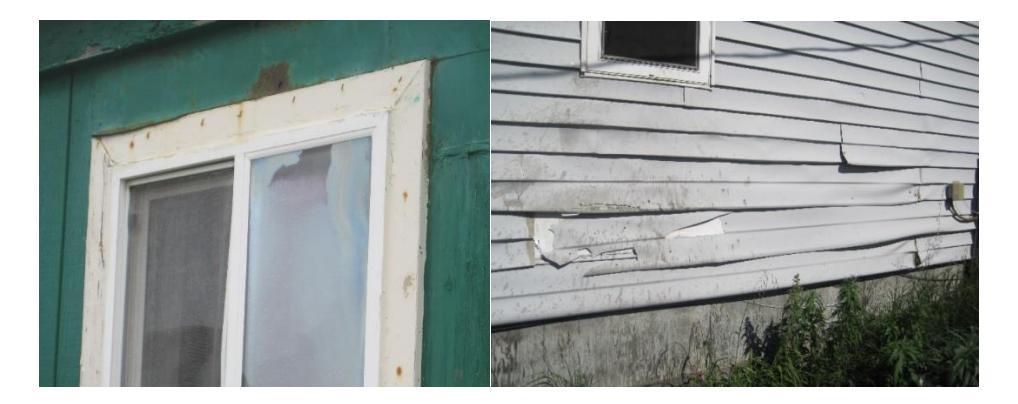
Exterior siding consisted mainly of vinyl (37%) and wood paneling (44%). A few homes had visible water damage to the wood paneling (Figure 2.5). Chipping was present on the vinyl siding, also shown in Figure 2.5. Siding was mostly light colors (59%). Of the homes where onsite assessments were conducted, all exterior walls were insulated per participant comment. Foam board was often used on the exterior, with spray foam or fiberglass on the interior. Two homes had cellulose insulation; one new home contained densely packed cellulose. One participant talked about how the fiberglass insulation dropped within the wall cavity, leaving the bottom of the wall much warmer than the top and impacting the effectiveness of the insulation.

**Figure 2.5:** Rusting and peeling of wooden panels around a window (left); damage to vinyl siding from a snowbank (right)

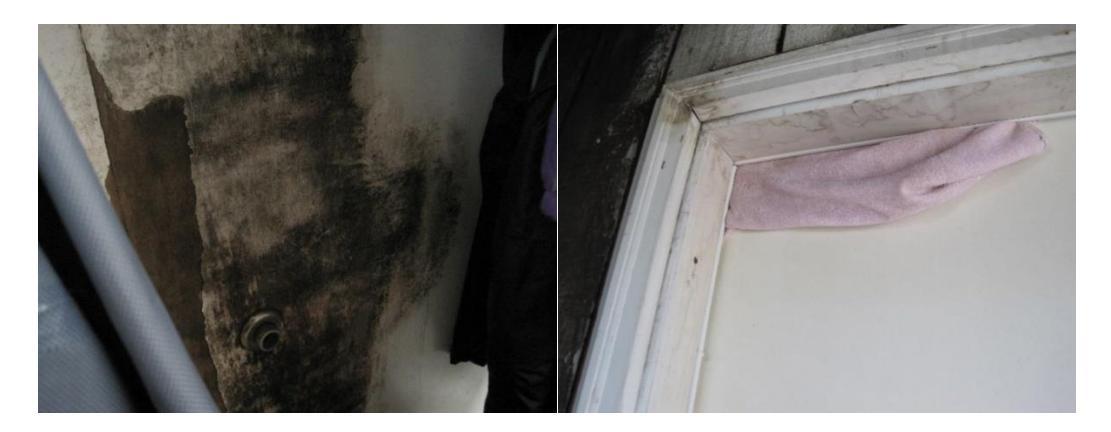
**Figure 2.6:** Apparent black mold growing up a wall near the entrance to a home (left); towel placed to seal exterior door (right)

Frequently, the interior of homes also had damage, such as floors missing tiles, walls with holes, and exterior doors that did not seal well. An example is shown in Figure 2.6 of a home that used a towel to improve air sealing around the door.

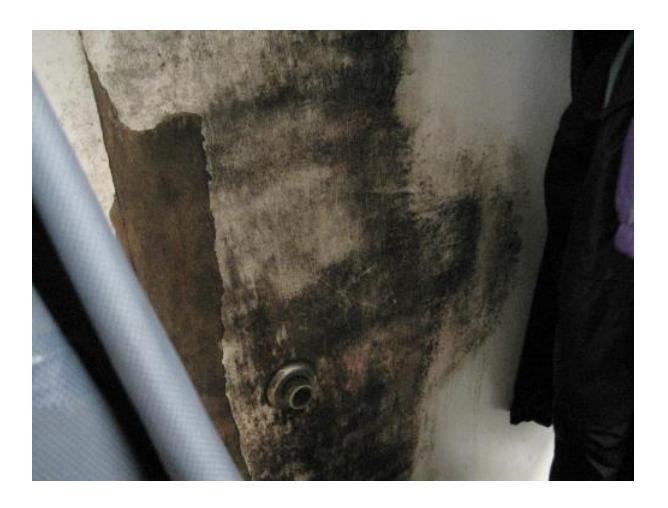
Fourteen of the 27 assessed homes (51.9%) had visible apparent mold present, most commonly black in color. Some homeowners said they managed the mold by cleaning it, but many said it consistently grew back. Mold was observed around windows and in bathrooms; in one home it was present on the walls (Figure 3.3).

Of these 14 homes, half had relative humidity (RH) levels above 65% during the home assessment, which is outside of the 30-60% range recommended for optimal human comfort and minimized biological growth [6]. Three homes had a relative humidity above 70%, including the

home with apparent mold on the walls. The highest recorded relative humidity was 77%. Also noted is that homes with apparent mold present in multiple areas had air exchange rates of 4.5 ACH50 or lower and yet did not have mechanical ventilation installed. Overall, 11 of the 27 total homes assessed (40.7%) had a relative humidity of over 65% (no windows were open); 6 homes had over 70% RH recorded. Figure 3.4 shows a histogram of all relative humidity readings sorted by range. Note that these readings were taken every minute inside the participants' homes, and visits on average lasted two hours. Throughout most of the data collection period, the weather was rainy, with an outdoor humidity of around 60%.

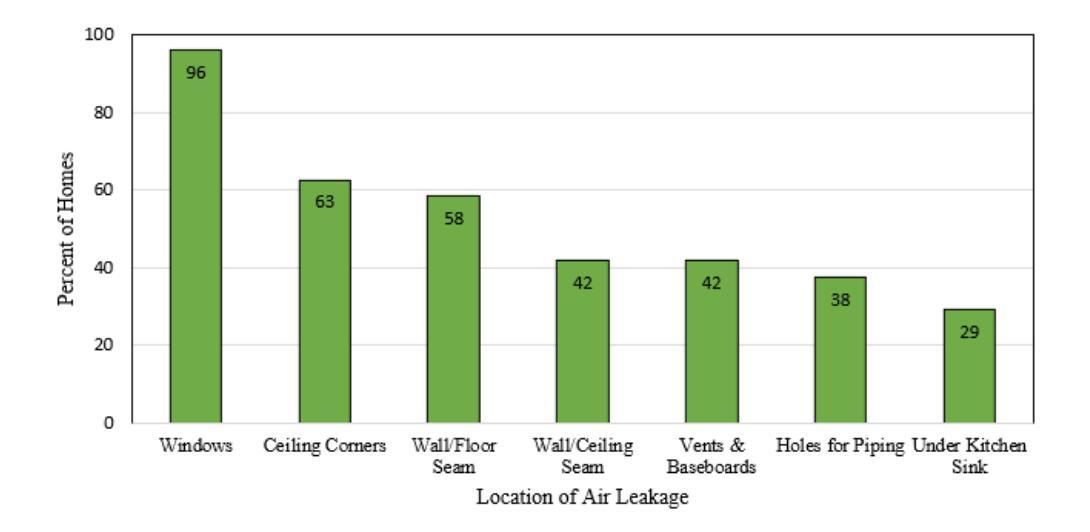
Twenty-four homes were scanned with an infrared camera during the blower door test for locations of air leaks [36]. Leakage was observed as a dark streak through the infrared camera, representing infiltrating cooler air. A smoke generator helped to confirm air leakage, and sometimes leaks could be felt by hand. Common locations of observed leakage are summarized

in Figure 3.6. In this figure, a "seam" refers to the edge of the home where the wall connects with the ceiling or floor.

**Figure 3.6:** Common areas of air leakage observed across 24 homes, by percent All but one home had at least one leaky window. Many times, homes had multiple windows that were leaky enough that incoming air could be felt by hand, even though many homes had their windows recently replaced. Ten interviewees mentioned that they could feel drafts from their windows in the winter. Since leaks and drafts were observed in nearly all homes, the number of homes considered "tight" per Building Airflow Standards was interesting and likely due in part to the higher-than-normal occupant densities [10]. Mold-like growth was also common around windows and in ceiling corners. It was found in some homes in floor corners, where leakage occurred in 5 of the 24 homes (20.8%). Leakage was also noticed from bathroom and kitchen exhaust fans; this is interesting to observe given that several participants mentioned they did not
