DAMAGE OF CONCRETE WITH EPOXY COATED REINFORCEMENT DUE TO  
CORROSION, FREEZE-THAW AND FATIGUE WITH  
APPLICATION TO BRIDGE DECKS

A THESIS

Submitted to  
Michigan State University  
in partial fulfillment of the requirements  
for the degree of

2011

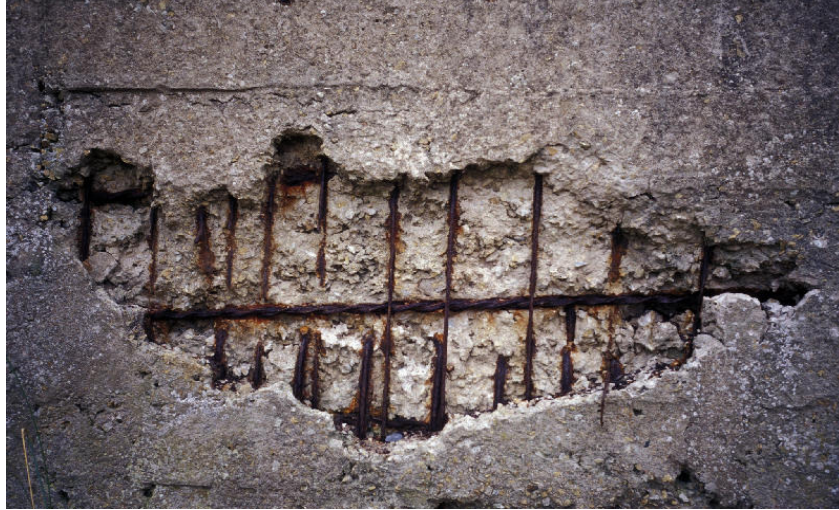
**Figure 1.1:** Steel Corrosion in Concrete. For interpretation of the references to color in this and all other figures, the reader is referred to the electronic version of this thesis.

Figure 1.1 shows corroded reinforcing bars in concrete. The volume of corrosion products for both types of corrosion is approximately 3-6 times the volume of the original steel. Tensile stresses will develop due to the corrosion-induced expansion and results in cracks, delaminations, and spalls in concrete due to its low tensile strength. This further accelerates the corrosion process by providing more pathways for water, oxygen, and chloride ions.

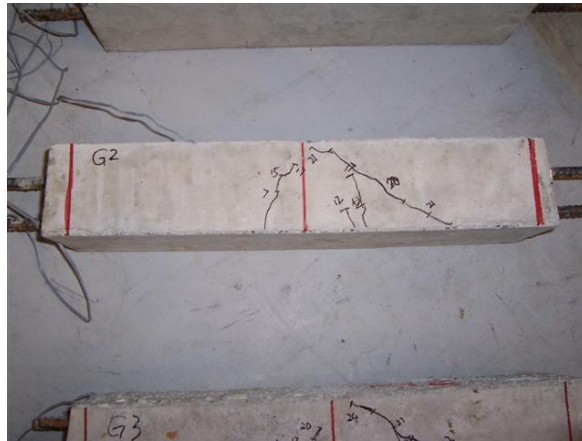
(b) Beam 2

**Figure 2.5:** Failure Patterns of Pilot Test Beams

The load-displacement response for all beams is shown in Figure 2.4 and photographs of their failure pattern are shown in Figure 2.5. Beam 1 (without any anchorage enhancement) failed before yielding of the tension rebar. Beam 2 (with welded washer on bottom bar) failed in shear, but the specimen failed after the yielding of the bottom reinforcement. Beam 3 (with wire mesh shear reinforcement) also failed in shear and the tension bar yielded before failure. From the measured responses, observed failure, and crack patterns, Beam 3 performed the best with a rather smooth response up to failure with the tension bar reaching strains well beyond yield. Beam 2 performed the next best and was satisfactory. Since welding washers was much easier than installing the wire mesh, washers were used for fabrication of the project test units. The molds with the steel rebars before casting is shown in Figure 2.6.

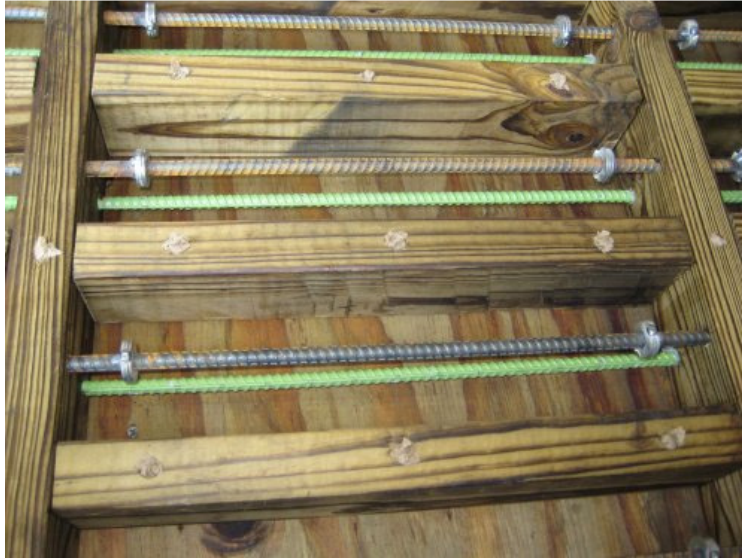
**Figure 2.6:** Molds before Casting

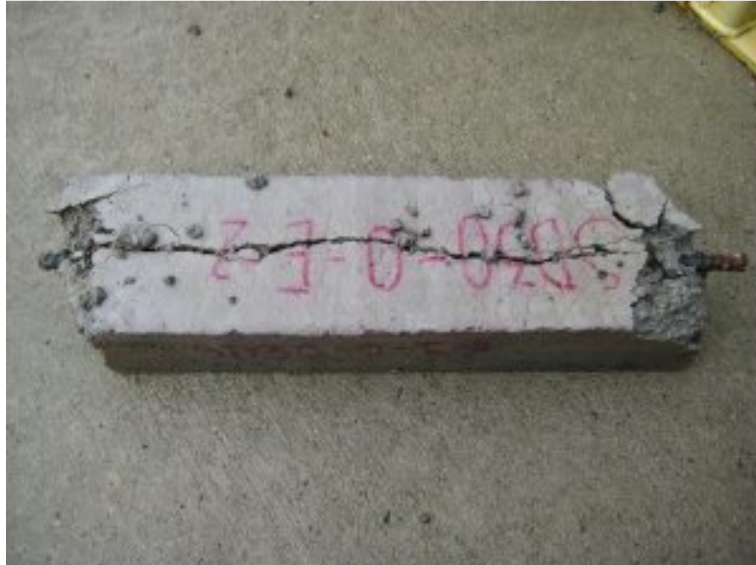
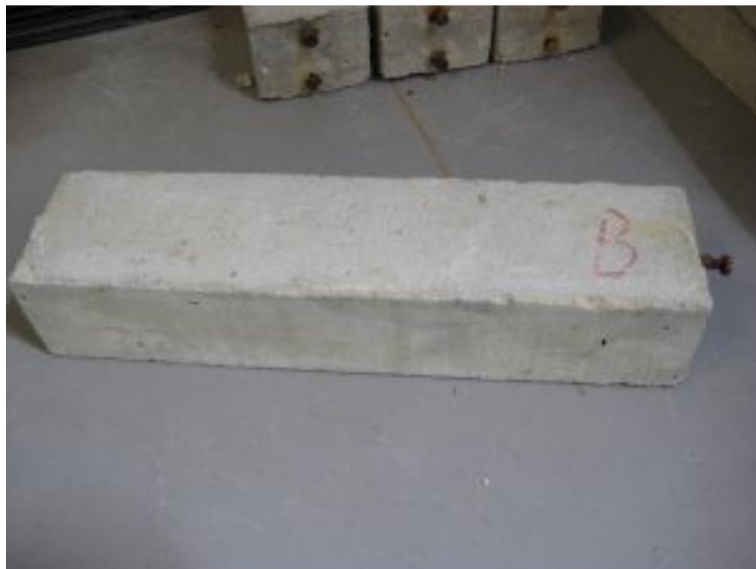
**Figure 2.7:** Specimens after Freeze-Thaw Test

compressive strength of 4.3 ksi was achieved after 28 days of curing. The specimens from the second batch successfully survived the freeze-thaw test as shown in Figure 2.7(b).

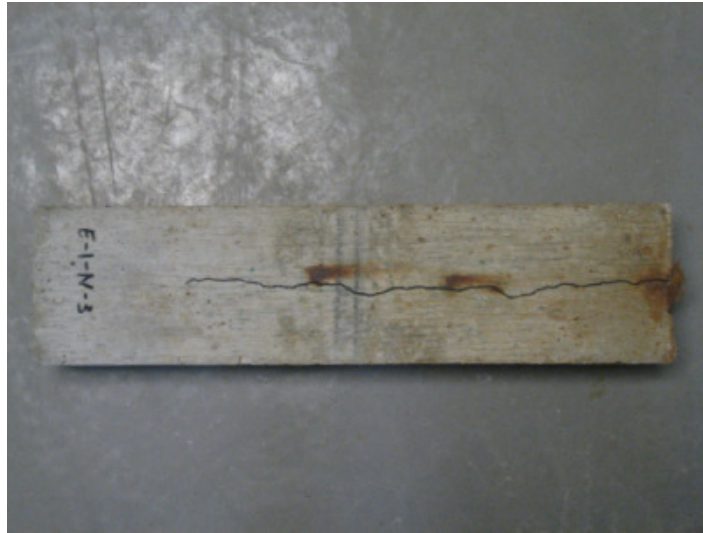
**Figure 2.10:** Specimen after Level 1 Corrosion

Figure 2.10 to Figure 2.13 show typical examples of specimens corroded to different levels. Fine cracks were observed in specimens with Level 1 damage and a marker was used to “highlight” the crack in Figure 2.10. It is obvious that the damage increased as the corrosion level increases, as shown in the following figures.

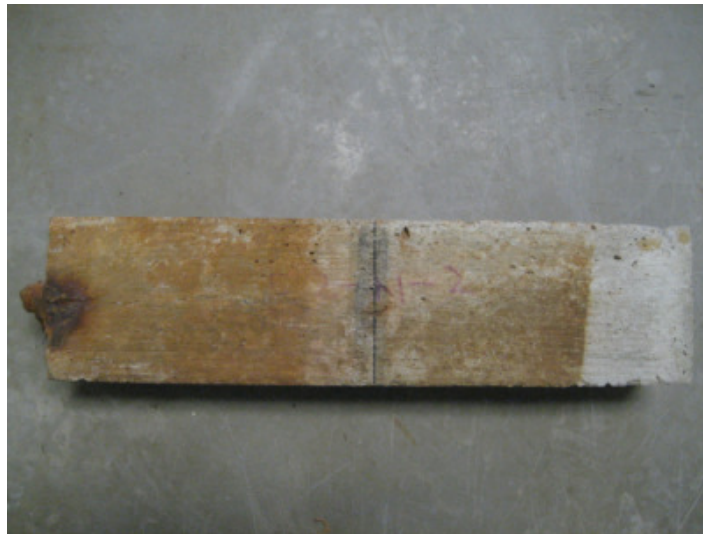
**Figure 2.11:** Specimen after Level 2 Corrosion

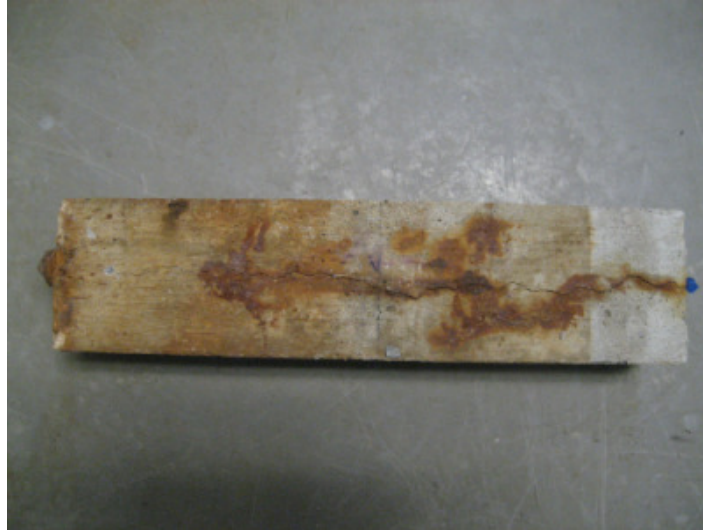
**Figure 2.12:** Specimen after Level 3 Corrosion

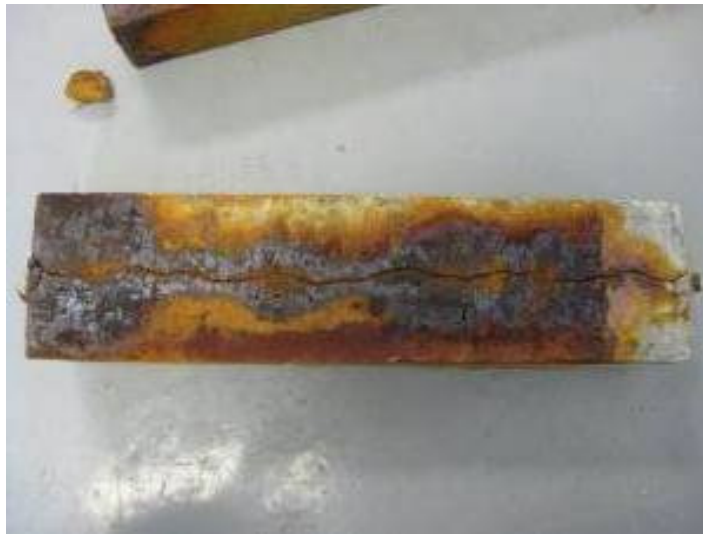
**Figure 2.13:** Specimen after Level 4 Corrosion

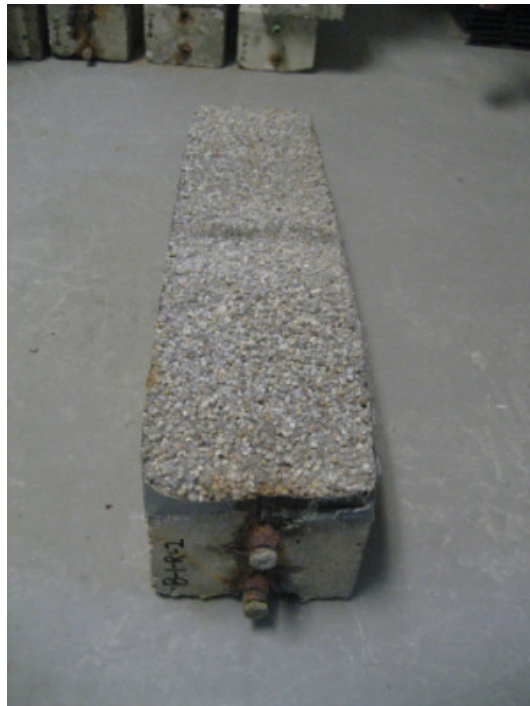
**Figure 2.14:** Specimen Repaired with Epoxy Overlay

[30], epoxy produced by E-bond Epoxies, Inc. was used. The fine aggregate (sand) used in this project was #612 Quartz sand from Best Sand Inc, in Ohio. The surface of the specimen was first roughened by chiseling off the concrete to increase the bond with the applied overlay. According to MDOT's provision, two courses were applied. The epoxy mixture for the first course was  $40 \text{ ft}^2/\text{gal}$  and the second course was  $20 \text{ ft}^2/\text{gal}$ . Sand was applied such that the surface was covered in excess with no bleed or visible wet spots. A specimen repaired with epoxy overlay is shown in Figure 2.14.

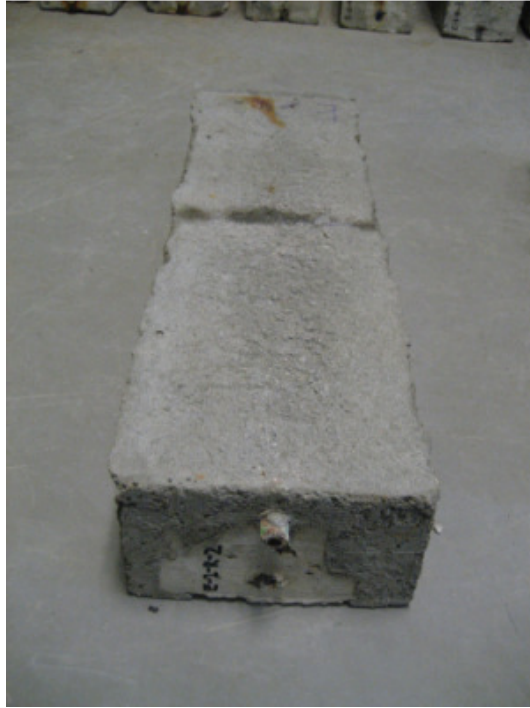
**Figure 2.16:** Specimen with Shallow Concrete Overlay

corrosion cracks developed from the top to the bottom bars. Due to the small size of the specimens, it was easy to break them along the crack and damage them if a chisel was used to roughen the surface (one specimen was damaged due to the impact). To prevent specimen damage, a sander was used to create a rough texture on the surface to provide bonding between the specimen and the overlay. Also due to the penetration of the crack toward the bottom bar (in tension), specimens were prone to be broken in half during the fatigue test. To prevent this, the concrete overlay was applied on both sides and on top of the specimen as shown in Figure 2.15. The confinement provided by concrete on both sides helped prevent the specimen from splitting. Moreover, this over-size repair provided confinement to the damaged specimen and reduced the chance of delamination. The concrete mixture design and material section followed the 2003 Standard Specifications for Construction from MDOT [31]. A typical specimen after repair is shown in Figure 2.16.

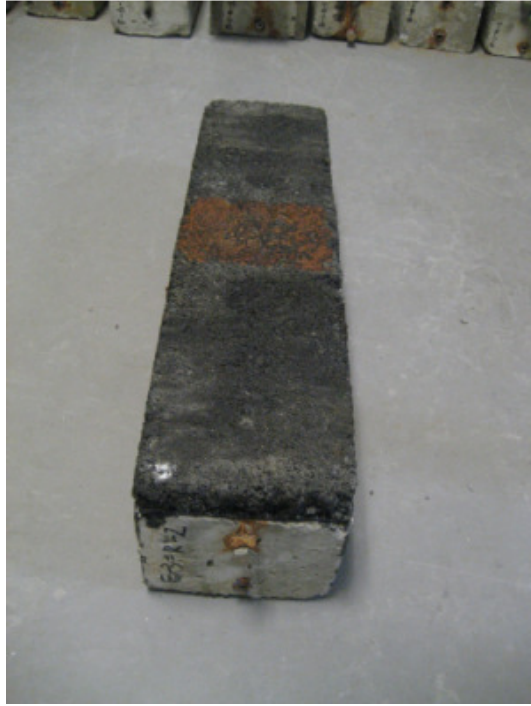
**Figure 2.17:** Specimen with Waterproofing and HMA Overlay

Specimens with Level 3 damage were repaired with a hot mixture asphalt (HMA) overlay and a water-proofing membrane. The HMA mixture and the water proofing were provided by MDOT. The waterproofing was applied according to the 2003 Standard Specifications for Construction [31] provided by MDOT and the asphalt overlay was applied according to the Road Design Manual [32] from MDOT. A typical repaired specimen is shown in Figure 2.17.

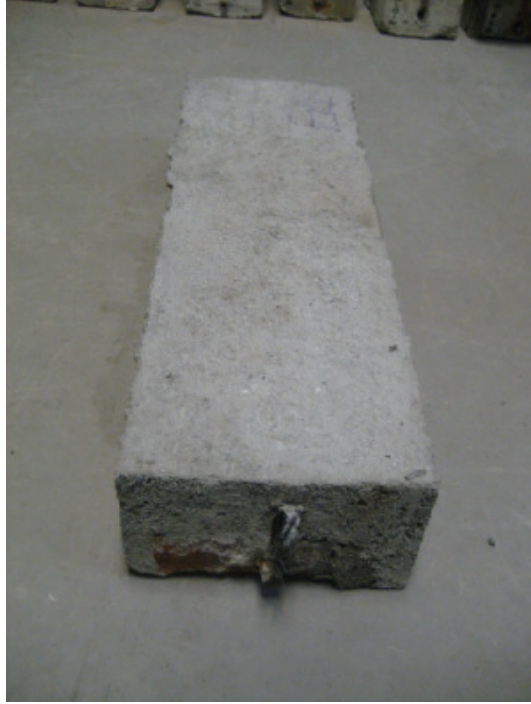
**Figure 2.19:** Specimen with Deep Concrete Overlay

A deep concrete overlay was used to repair specimens with Level 4 damage. Similar to the shallow concrete overlay, an oversize repair method was used due to the small size of the specimens. The mixture design was the same as that used in the shallow concrete overlay. Figure 2.18 shows the size of the deep concrete overlay and Figure 2.19 shows a typical specimen after repair.

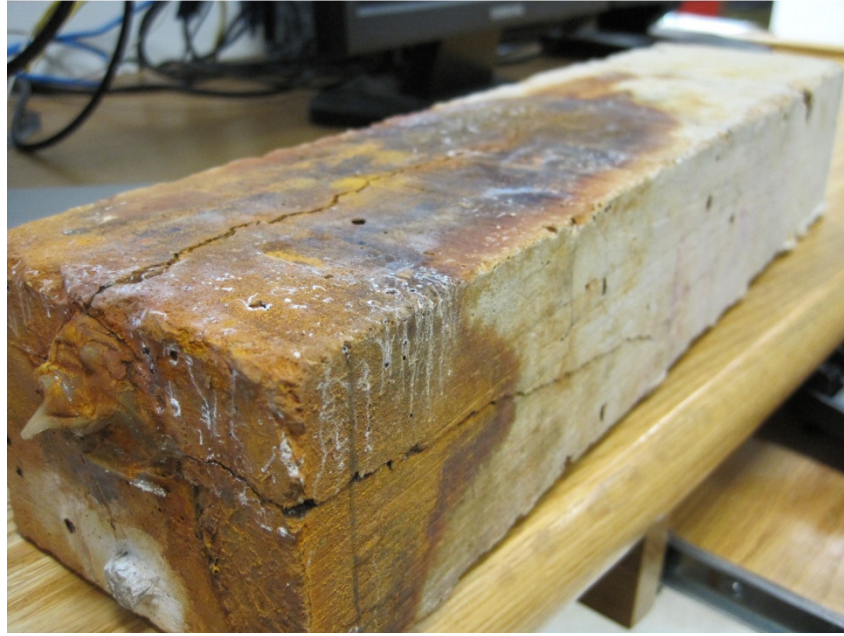
**Figure 5.3:** Photograph of Scanned Specimen

example of an image is shown in Figure 5.2 with a photograph of the specimen shown in Figure 5.3 for comparison.

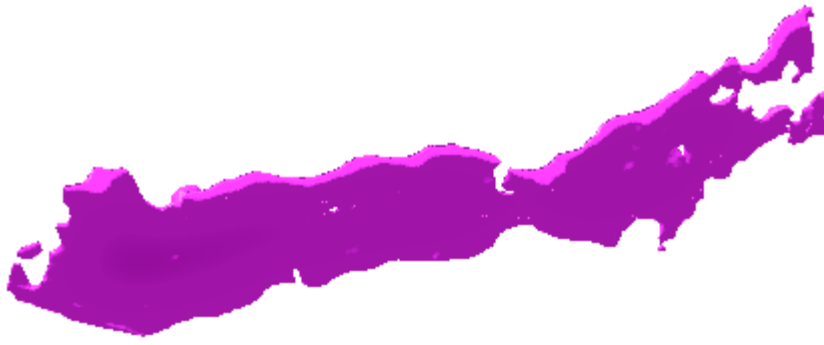
**Figure 5.9:** 3D Rendering of Crack

This process was done for all 89 images at each location. The XCAT software reconstructed the images at each location and created a 3D rendering of the crack, as shown in Figure 5.9. The software then calculated the volume of the crack in voxels (volumetric pixel). The total volume of cracks in a specimen was used as a measure of the damage done to it by corrosion, freeze-thaw, and fatigue testing. The results showing the image-based damage for each specimen scanned are shown in Table 5.1 along with the time that each specimen was exposed to accelerated corrosion (initial corrosion for aging plus corrosion during fatigue loading).
