A STUDY OF THE EFFECT OF SURFACE DEFORMATION
ON THE FATIGUE PROCESS IN COPPER

Thesis for the Degree of M. S.
MICHIGAN STATE UNIVERSITY

William R. Warke

1961

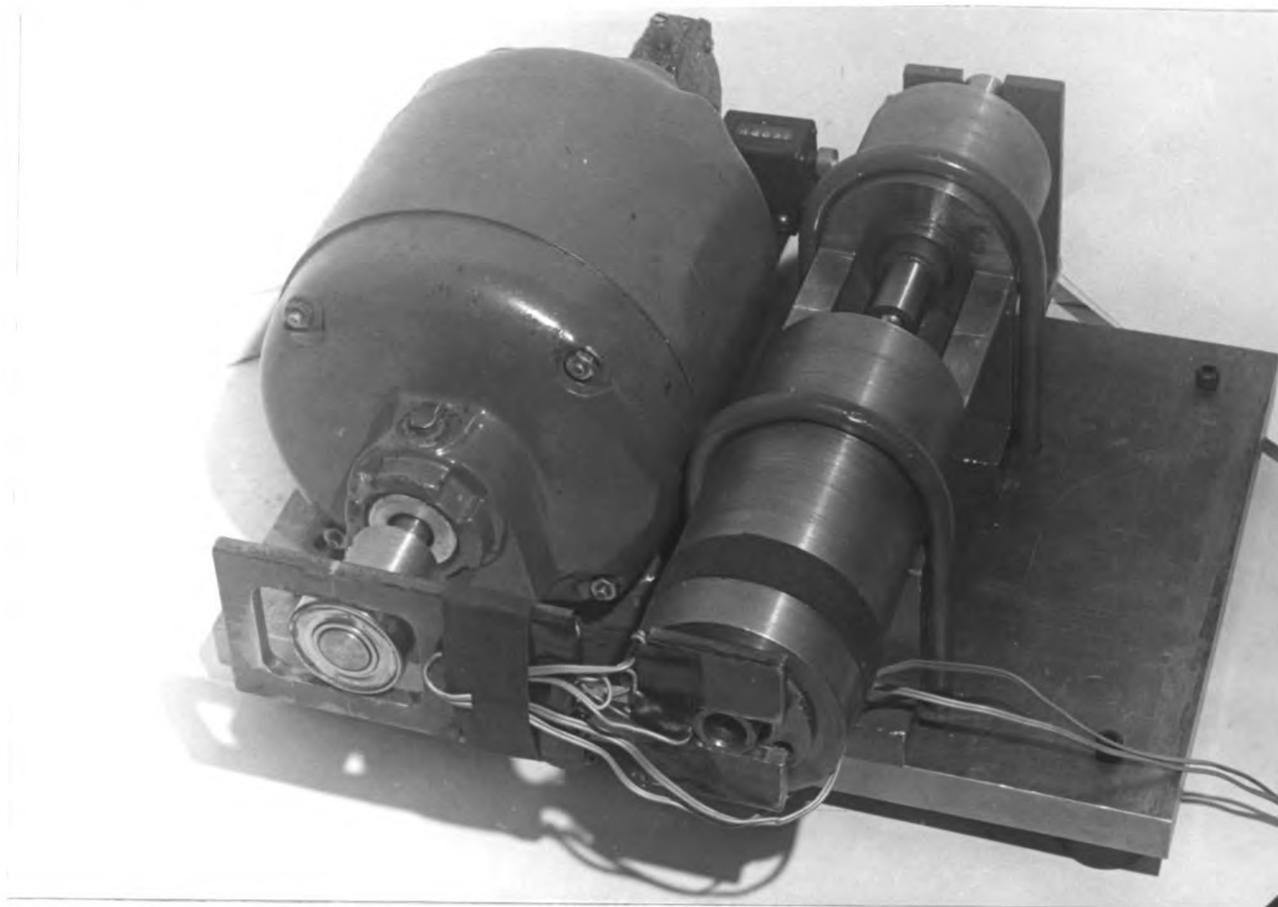
Figure 1. Constant strain amplitude fatigue machine, front view.

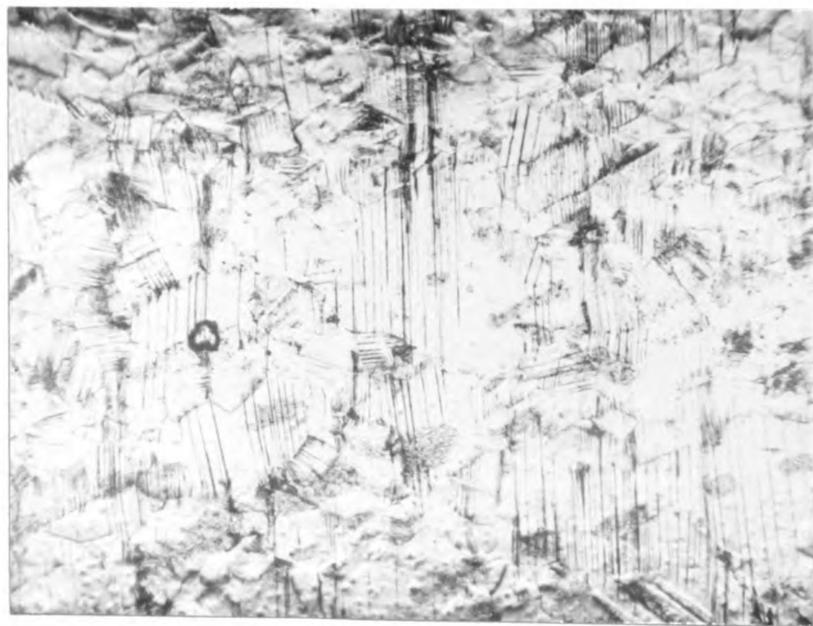
Figure 4. Surface of annealed and polished bar after 640,000 cycles. 100x.

Microscopic examination of the surface of a polished specimen revealed slip band formation as expected. Figures 3 through 7 show an area on the surface at 100 magnification. Slip bands were visible after only 5000 cycles and as can be seen, as cycling continues the slip bands increase in width and darkness and new bands form. At a very early stage, the path of the final fracture is defined by slip bands. The exact point at which the fracture initiates is not evident but it is obvious that its path is almost entirely along slip bands. Figure 8 was taken at 500 magnification using oblique lighting. By this means the three dimensional nature of the

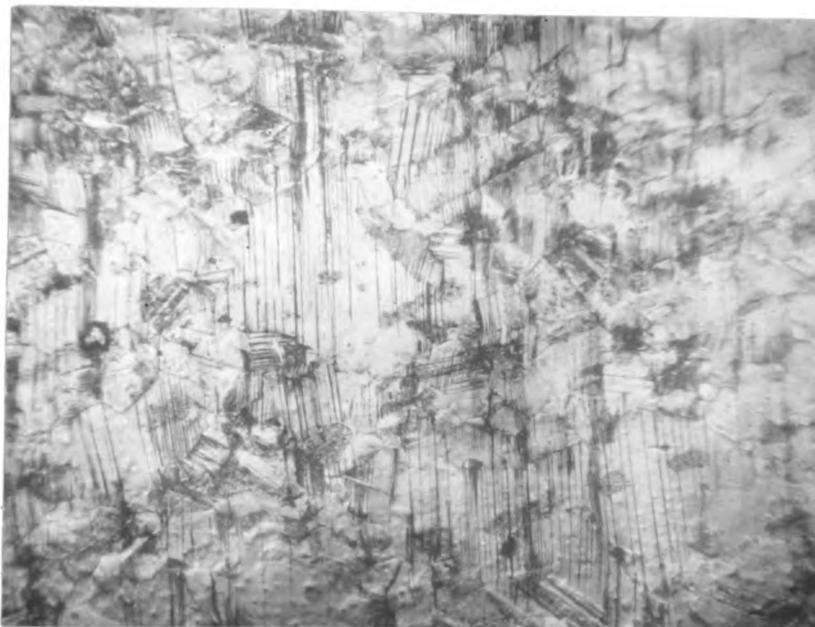
Figure 5. Surface of annealed and polished bar after 2,560,000 cycles. 100x.

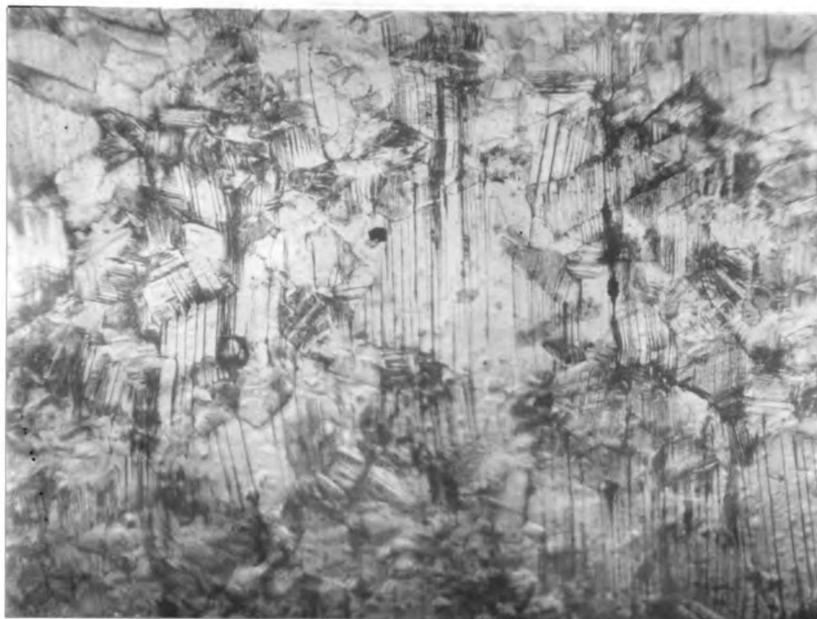
Figure 6. Surface of annealed and polished bar after 5,120,000 cycles. 100x.

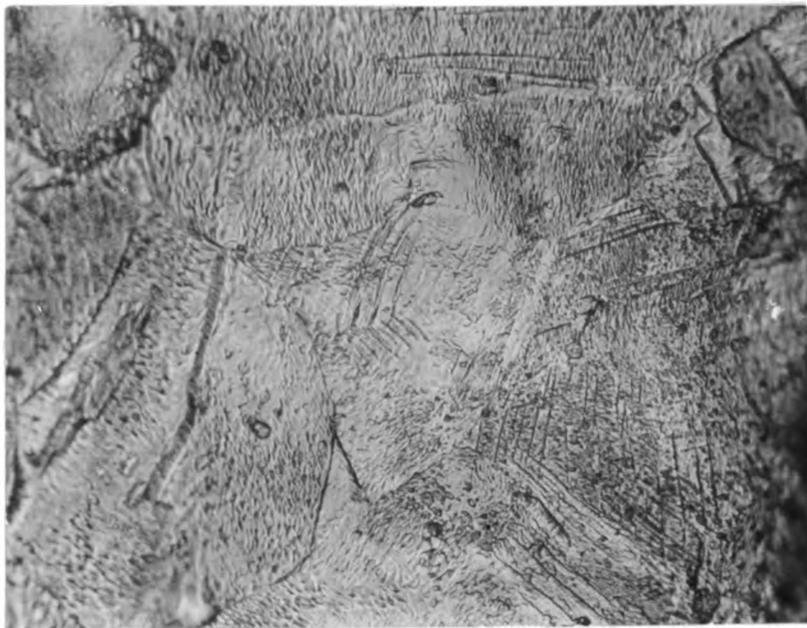
Figure 11. Taper section of peened bar after 640,000 cycles. Etched up markings near surface. 500x.

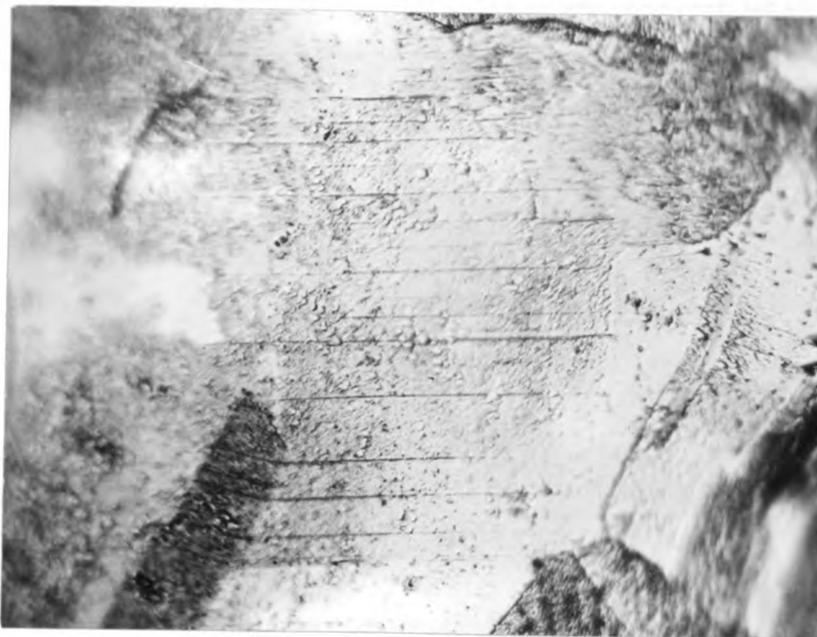
Figure 13. Taper section of polished bar after 640,000 cycles. Etched up slip bands near surface. 500x.

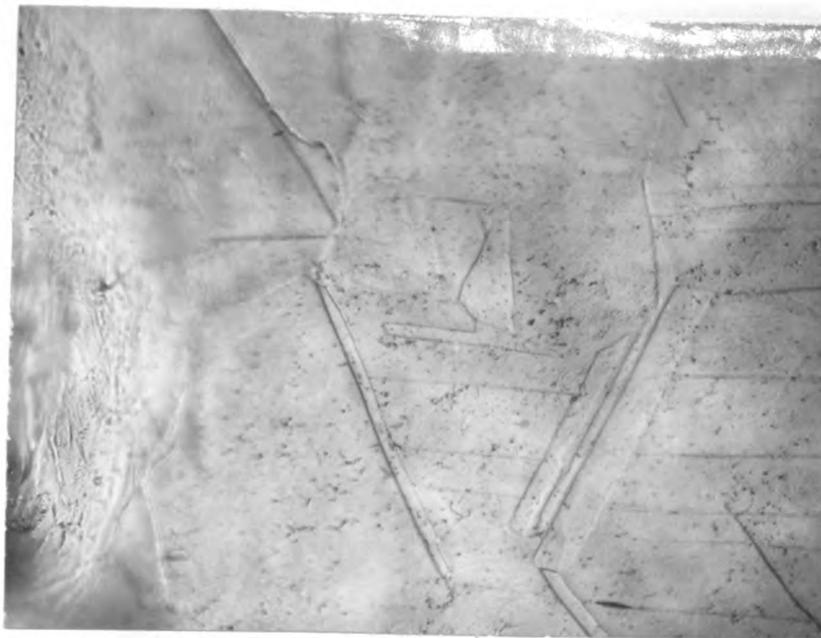
Figure 16. Taper section of peened bar after 2,560,000 cycles. Etched up slip bands near but not at the surface.

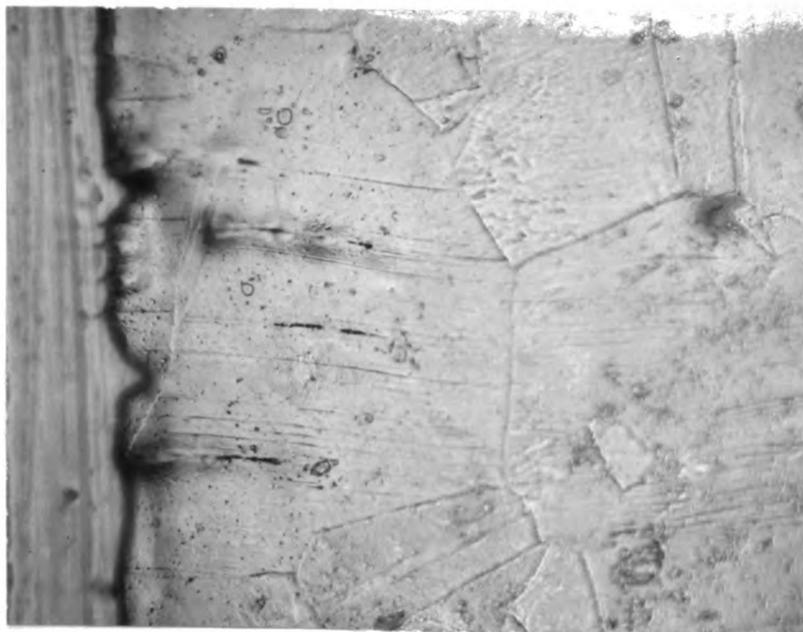
Figure 18. Taper section of polished bar after 2,560,000 cycles. Fissures and etched up slip bands at the surface. 500x.

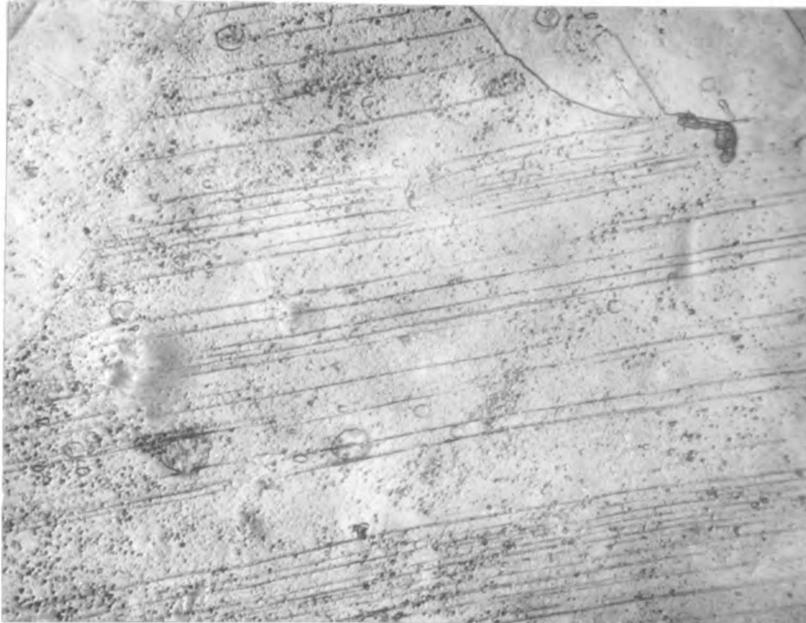
Figure 19. Taper section of polished bar after 2,560,000 cycles. Etched up slip bands near the center of the taper section.

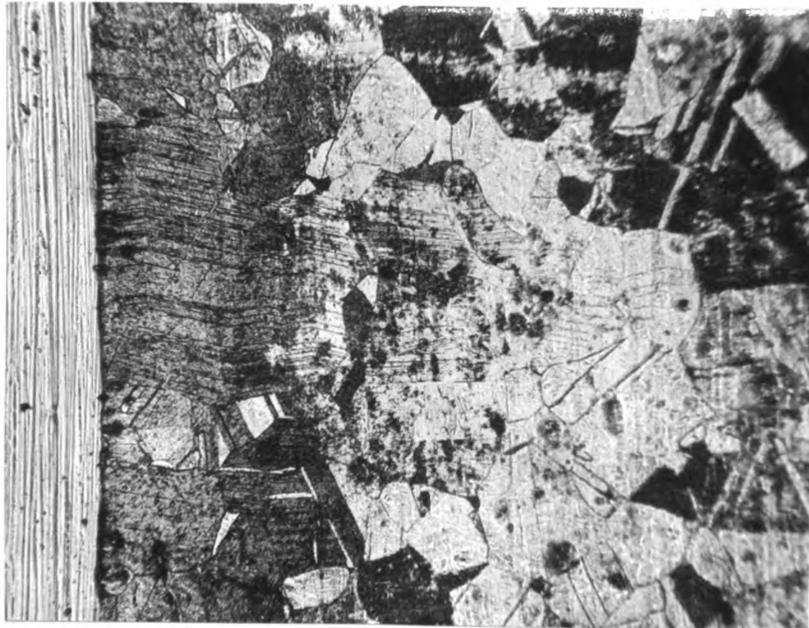
Figure 20. Taper section of polished bar after 2,560,000 cycles. Etched up slip bands at the surface. 100x.

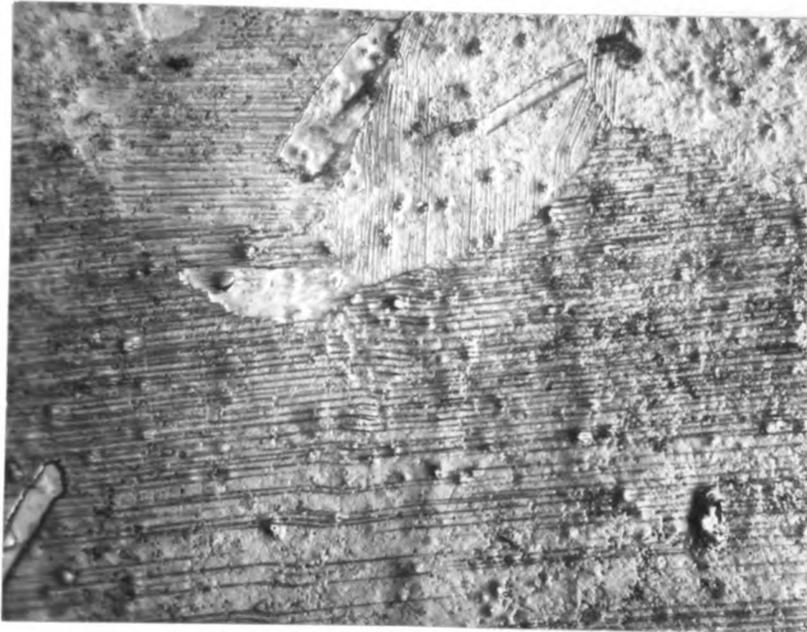
Figure 25. Taper section of polished bar after fracture at 10,920,000 cycles. Etched up slip bands near the fracture. 500x.

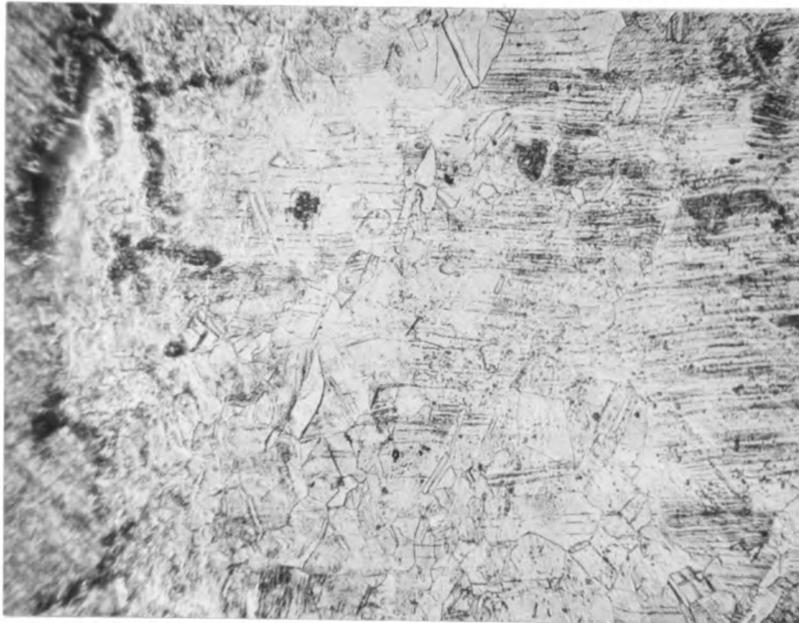
Figure 27. Taper section of peened bar after 20,000,000 cycles showing reduced number of slip bands at the surface. 100x.
