THE CHARACTERIZATION AND INFLUENCE
OF DOMESTIC DRAIN EFFLUENTS
ON THE RED CEDAR RIVER

Thesis for the Degree of M. S.
MICHIGAN STATE UNIVERSITY
ARTHUR RAY TALSMA
1972

A THESIS

Department of Fisheries and Wildlife

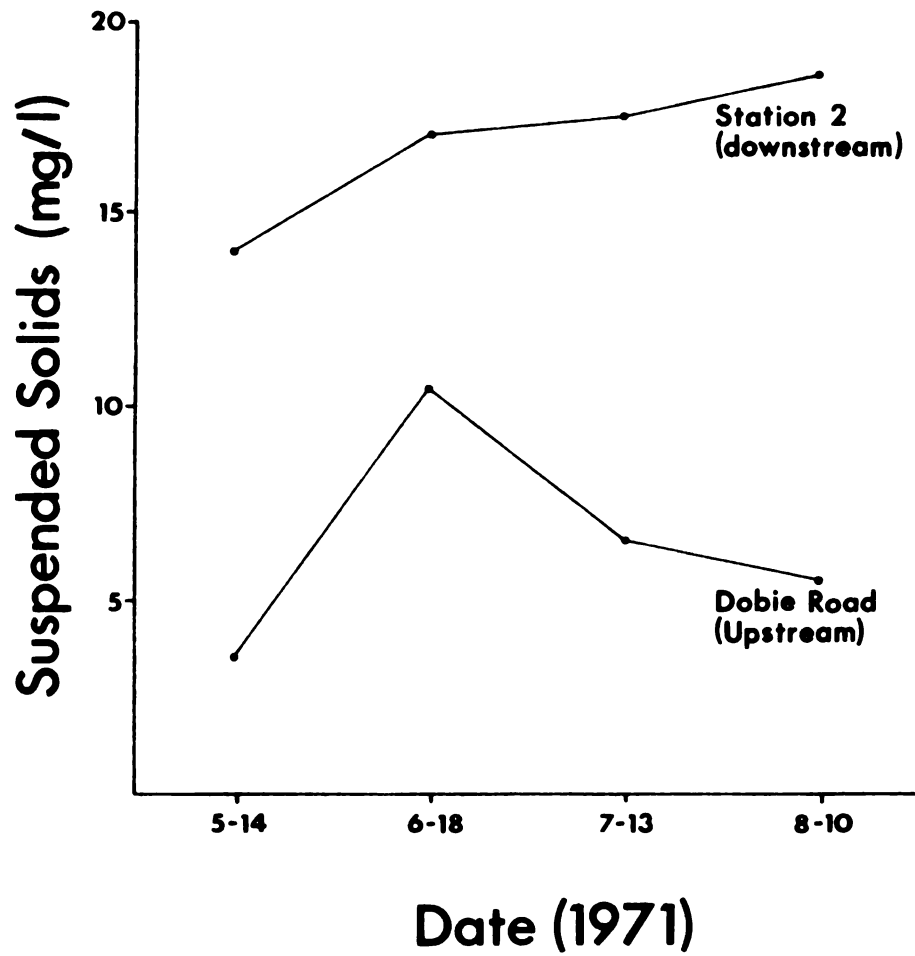
Figure 7. Suspended solids (unpublished data).
[Each value is the average of two determinations.]

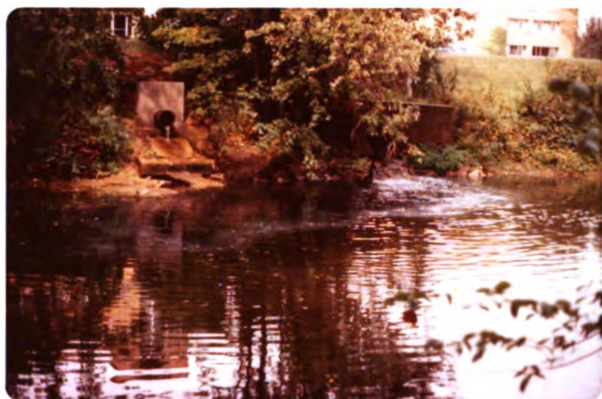
- Figure 15.
- A. Photograph of drain 66 discharging sewage.
 - B. Photograph of drain 82 discharging sewage.
 - C. Major fish kill of August 11, 1971 [shopping cart with dead fish].
 - D. Photograph of effluent from drain 25.

Drain 66: Drain 66 is a combined-storm and sanitary drain which often flowed raw sewage with a high organic nutrient load. A main sewerage interceptor, comprised of three pipes passing under the river at this point, became blocked at times causing the controlling pressure caps of drain 66 to open and discharge raw sewage into the river. There was evidence also that the pressure caps stayed open at times. This drain was designed to flow only during rain and melting conditions, but because of reasons stated above, this was not the case. Fluorescein dye injected into the main sewerage interceptor below Michigan Avenue on May 5, 1971, flowed from drain 66 several minutes later. During a storm the effluent of this drain was diluted with rain water, but when flowing on a "dry" day long after any rain, the drain effluent was entirely raw sewage discharged to the river instead of being treated by the East Lansing Waste Water Treatment Plant. Values from Tables 1 and 2 show the nutrient load (phosphorus, nitrogen and carbon) to be high. Chloride concentrations were well above those found in the river. One likely source is domestic waste, particularly urine, which increases the amount of chloride in sewage about 15 mg/liter above that of carriage water (Sawyer and McCarty, 1967). Anionic detergent analyses of over 1.5 mg/liter accounted for the foaming seen at times and the increased phosphorus load. Synthetic detergents
