THE EFFECTS OF DE-ICING SALT SPRAY  
ON HIGHWAY PLANTINGS

Thesis for the Degree of M. S.  
MICHIGAN STATE UNIVERSITY  
LUTHER MOXLEY  
1973

### THE EFFECTS OF DE-ICING SALT SPRAY ON HIGHWAY PLANTINGS: SURVEY OF INJURY ALONG MICHIGAN HIGHWAYS AND STUDIES ON THE SODIUM AND CHLORINE CONTENT OF AUSTRIAN AND WHITE PINE

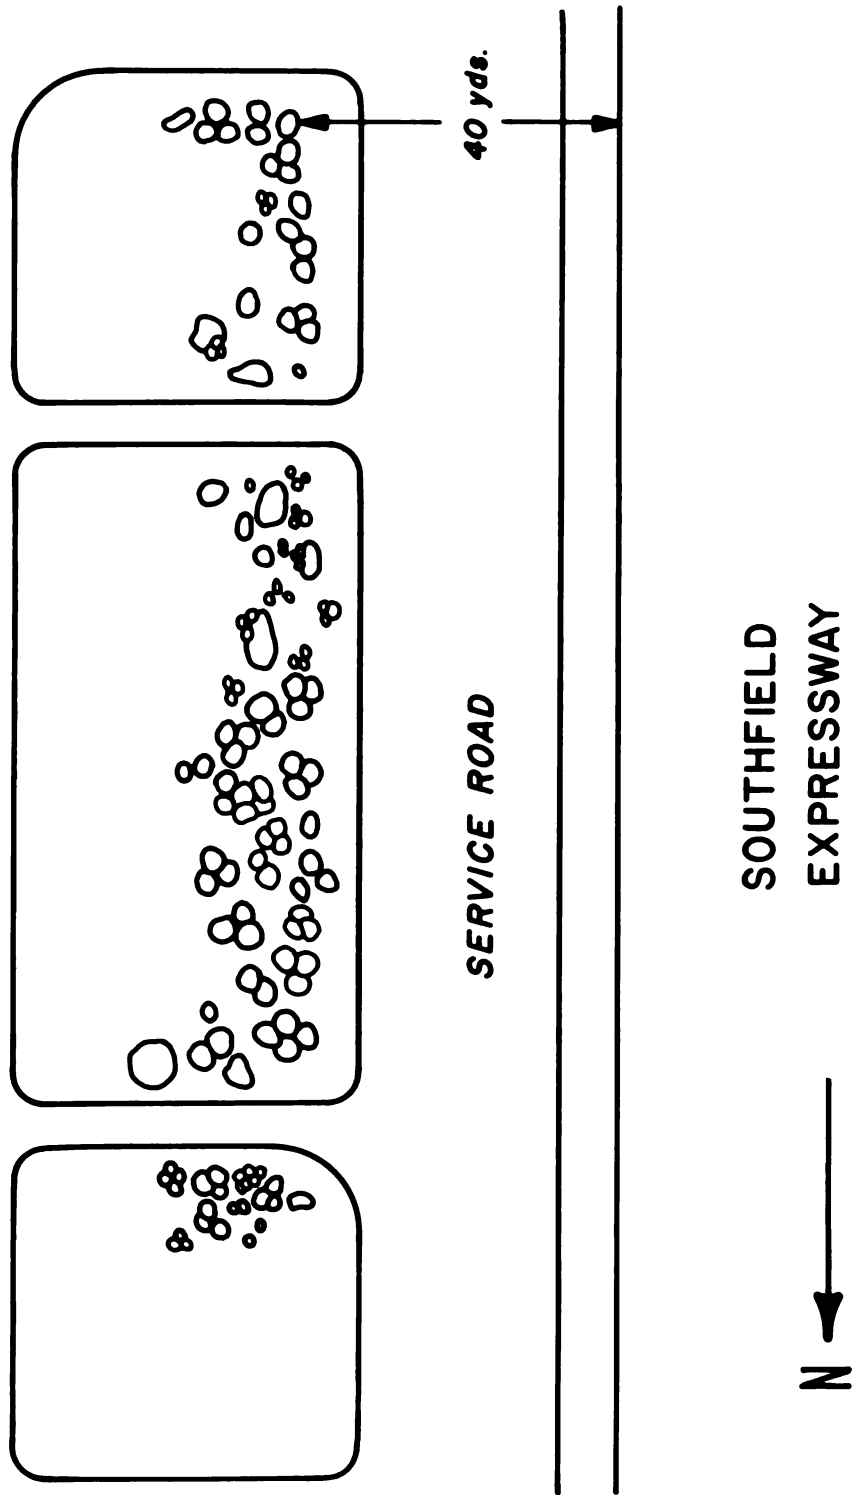
Figure 3. Salt injury survey area--Ford Motor Company's Michigan Arboretum.

In April and May of 1972 and in late April of 1973 surveys of tree and shrub conditions were conducted at the Ford Motor Company's Michigan Arboretum in Dearborn, Michigan. The arboretum is directly adjacent to the Southfield expressway and consists of 95 species of native Michigan shrubs and trees (Figure 3). The plants are from 9 to 13 years old and are located at distances of 40 to 100 yards from the expressway. The arboretum is located on the east side of the expressway and the prevailing winds are from the southwest.

Symptoms of salt spray injury were observed and recorded for the various species. The distances from the highway of each of the plant species were estimated and recorded.

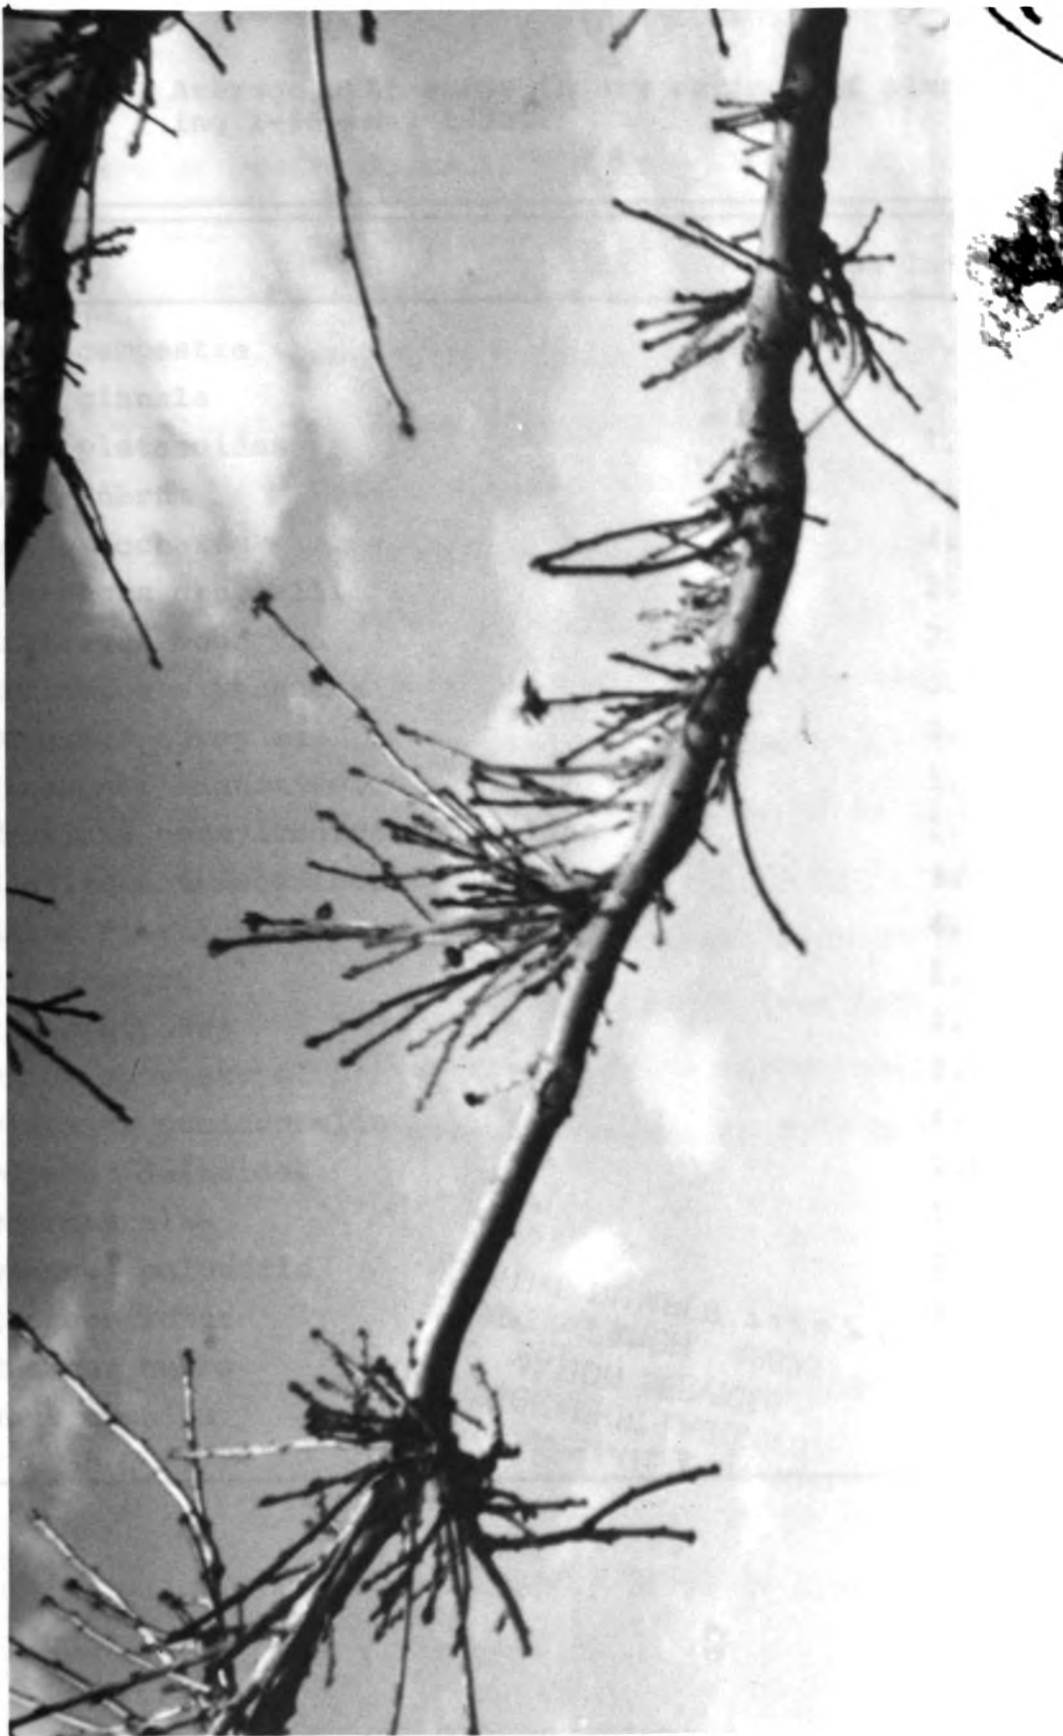
Figure 4. Tufting of the branches of bur oak (Quercus macrocarpa).
