INCLUSIVE DESIGN ASSESSMENT OF STATE PARK BUILDINGS
IN MICHIGAN FOR THE ELDERLY: AN EMPIRICAL STUDY
USING CASE STUDIES AND FOCUS GROUP

Environmental Design – Master of Arts

2018

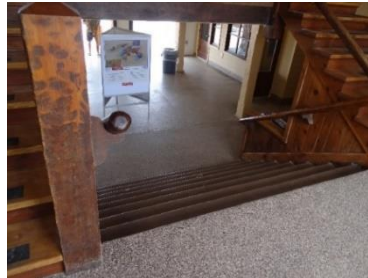
Figure 20. Steps inside the entrance of Lake Michigan Beach House, Ludington State Park
Photo credits: Author)

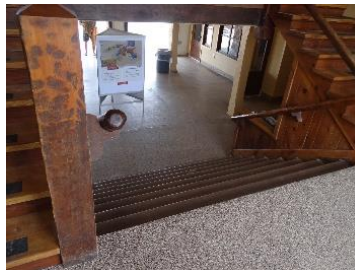
Figure 22. Steps inside Lake Michigan Beach House, Ludington State Park
Photo credits: Author)

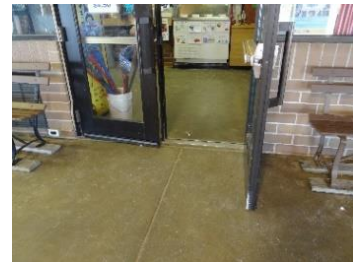
Figure 23. Level difference inside Beach House, Holland State Park
(Photo credits: Author)

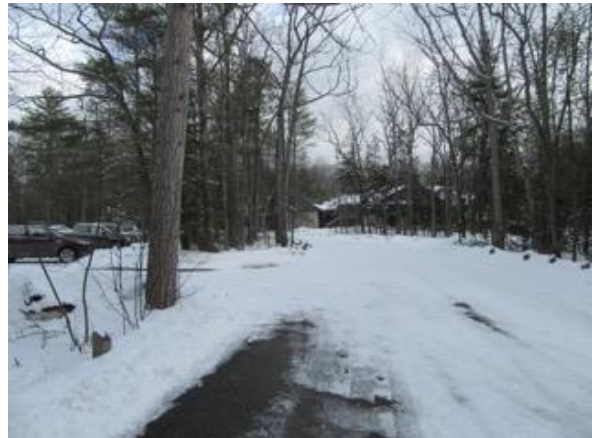
Figure 42. Path from resource center to Lake Ontario lodge
(Photo credit: focus group participant)

During the walk from parking to the entrance of resource center, one participant commented that “walkway was well-maintained and snow removal was good,” while another one pointed out lack of public *seating* on the exterior route, recommending that “some seating would be helpful.” While moving from resource center to towards Lake Ontario lodge, the pathway was covered in snow making one participant point out that “the sidewalks was rather *narrow*, and the *brick path* was difficult for a person with a walker.”

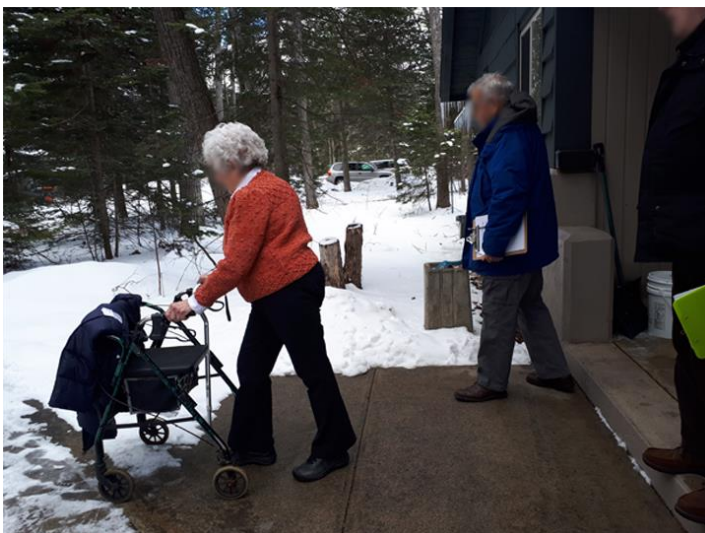
Same issue was reported by another participant, also mentioning the lack of *lighting* on the pathway. One participant recommended that “throughout the site it would be good to find out what the pathways are like after a heavy rain just in case there are large inconvenient puddles or resulting ice patches” affecting people with walkers or wheelchairs. Similar issues were reported while moving from Lake Ontario lodge to Lake Erie lodge. Conservation education building has three entrances, one with stairs and two with ramp. The entrance having stairs was closed and was blocked by snow, making volunteers uncomfortable and unsatisfied.

Figure 43. Snow covered route taken by a walker user
(Photo credits: S. Kim)

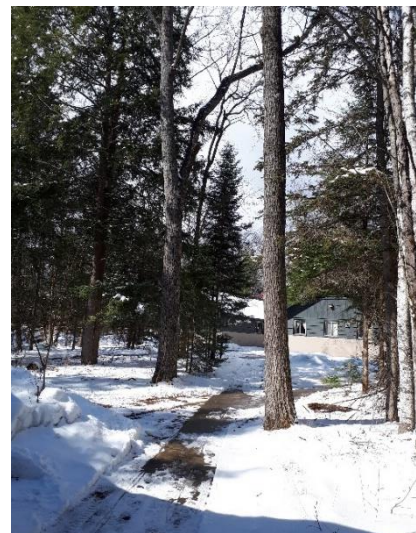
Figure 44. Snow covered route
from resource center to Lake
Ontario Lodge
(Photo credits: S. Kim)

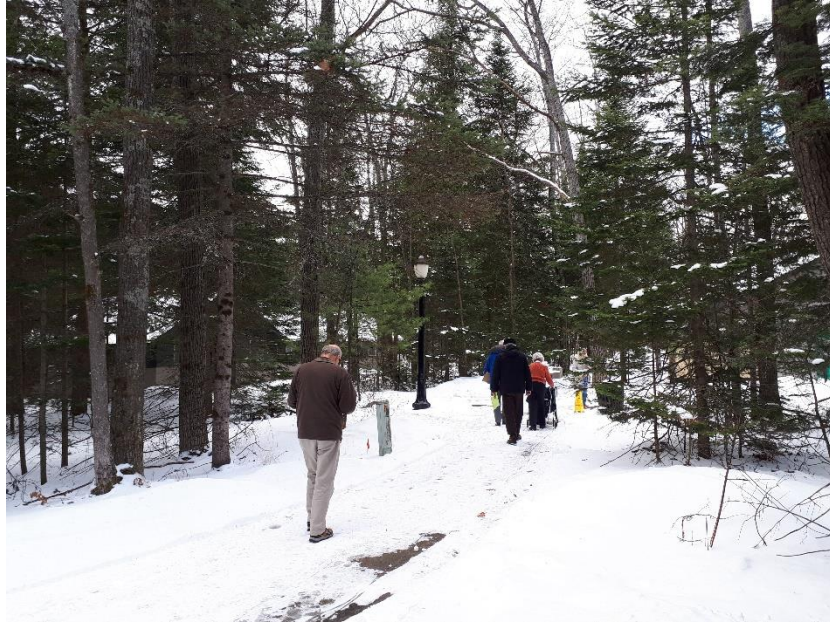
Figure 45. Snow covered route from Lake Ontario Lodge to Lake Erie Lodge
(Photo credits: S. Kim)

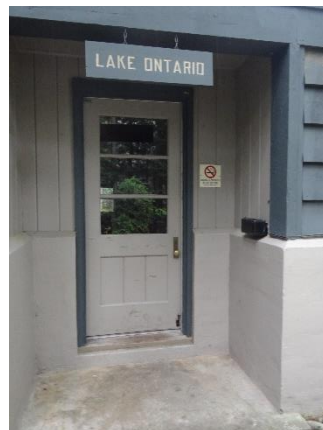
Figure 47. Entrance of Lake Ontario Lodge
(Photo credits: Author)

While entering Lake Ontario lodge, majority of participants found the doors of the lodge very heavy and the level difference uncomfortable. One participant recommended that entrance of the lodge should be *wider*, having a *ramp* for cranes or wheelchair users. Similar issues were pointed out at Lake Erie lodge. The *steps* at all the entrances of both lodges were found problematic by majority of participants.

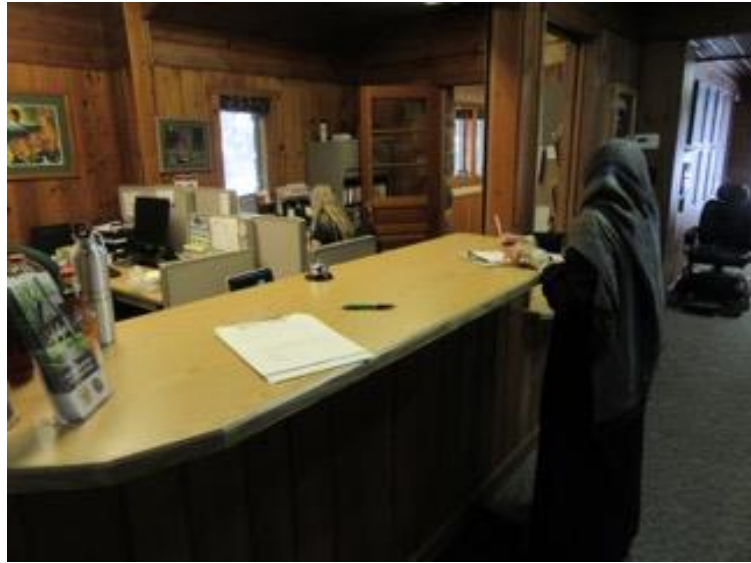
Figure 50. Reception at Resource center
(Photo credit: Focus group participant)

Resource Center, which was found quite high by focus group members to use. Also, they found the reception counter quite high as well and lacking in appropriate amount of *light*.

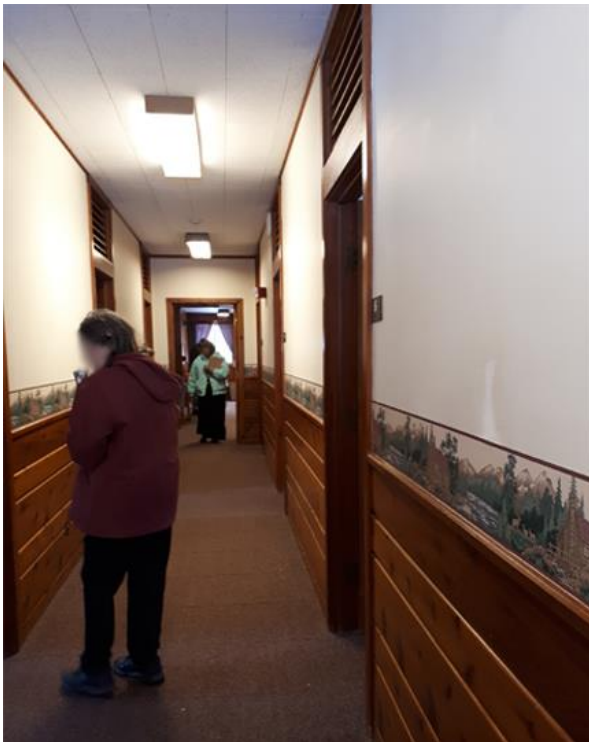
Figure 51. Hallway in Lake Ontario Lodge
(Photo credits: S. Kim)

using sunglasses. In both lodges, *sudden level changes* in the flooring were observed which can cause tripping. One participant commented, “Although carpet tiles are well installed and adequate for wheelchair or walker users, uniformly carpeted floor hides changes in levels or inclines.” The color of the doors in Lake Ontario lodge was appreciated for its brightness, but the hallway was found narrow and *dark* by some participants.

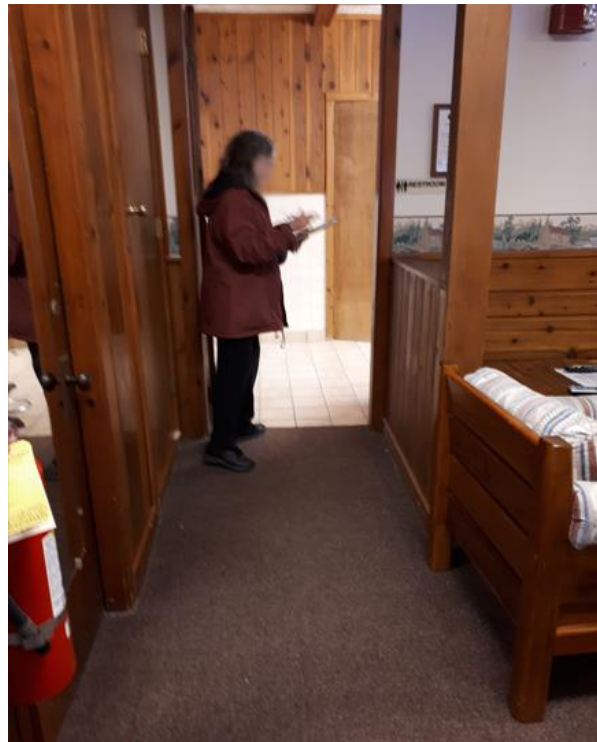
Figure 52. Carpet flooring inside Lake Erie
Lodge hiding level change
(Photo credits: S. Kim)

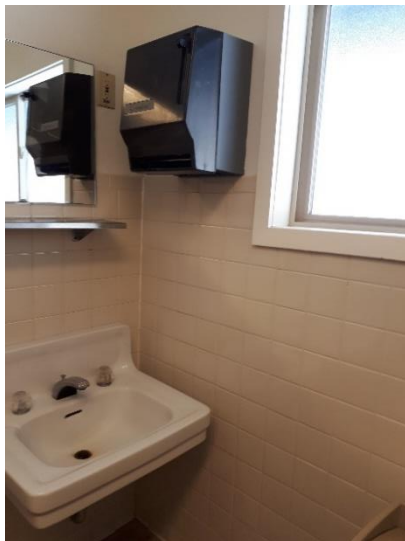
Figure 55. Towel dispenser height in Lake Ontario Lodge
(Photo credits: S. Kim)

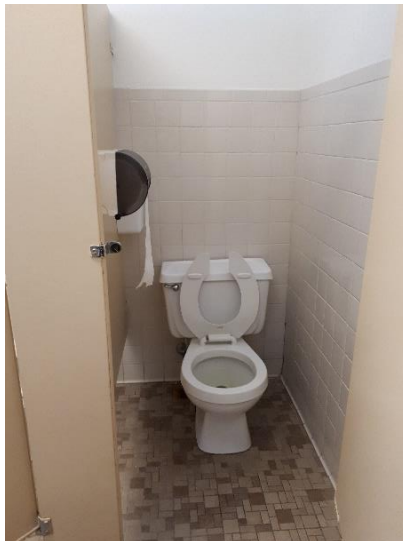
Figure 56. Bathroom in Lake Ontario lodge missing grab bars
(Photo credits: S. Kim)

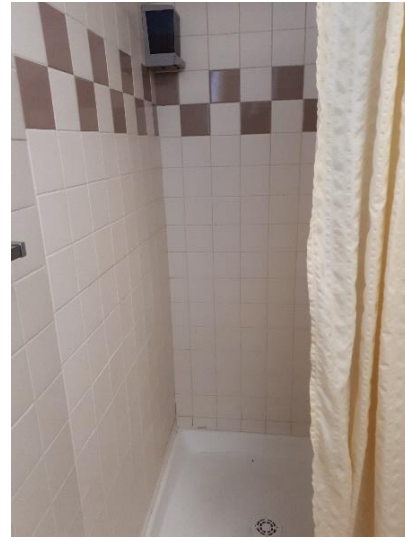
Shower areas of both lodges were also lacking security bars for protection making them inaccessible by handicapped, wheelchair bound or otherwise impeded senior citizens. Also, the *door* of bathroom in Lake Erie lodge was found narrow by one participant, commenting that “one must go through public area to enter bathroom and the door is too narrow.”

Figure 57. Shower area in Lake Ontario lodge missing grab bars
(Photo credits: S. Kim)

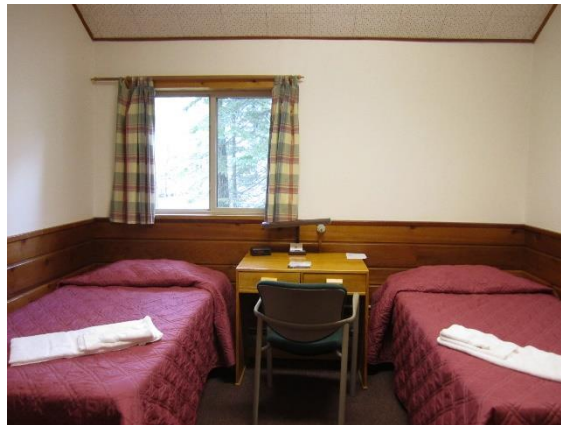
Figure 61. Bedroom in Lake Erie Lodge
(Photo credits: S. Kim)

Both lodges had bedrooms for the visitors of RAM Center. While visiting rooms at Lake Ontario lodge, participants found bedrooms to be of very small in *size* considering that they have two beds. Also, one participant found the rooms to be *dark* at the back, lacking reading lamp, and night table or room for luggage. When asked about the beds, one participant commented that “they are a little *too high*” with another one adding “*too soft*” as well. The room was also criticized for poor *color choice* by a participant. Similar issues were reported for the bedrooms at Lake Erie lodge except they were a little big in size than Lake Ontario lodge. One participant while commenting on the size of bedrooms at Lake Erie lodge and the absence of accessibility arrangements wrote “They are quite adequate for their usual use. Camping is not supposed to be glamorous, but it can be safe”.

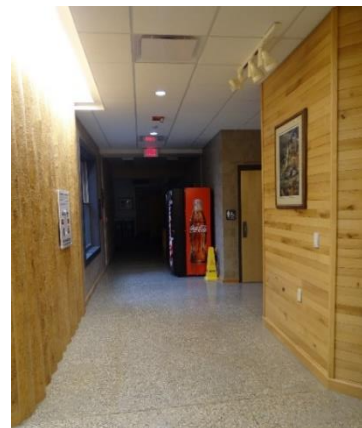
were able to locate *emergency exit signs* in all the buildings, however, in conservation education building, one participant commented that “the emergency exit sign does not look like emergency exit. There should be red shading light on either side of emergency exit sign.”

Figure 66. Exit sign at conservation education building
(Photo credits: Author)
