**ELEVATED-TEMPERATURE FRETTING AND OXIDATION PROCESSES
OF NICKEL-BASE SUPERALLOY TURBINE BLADE ATTACHMENTS**

A THESIS

Department of Metallurgy, Mechanics and Materials Science

1987

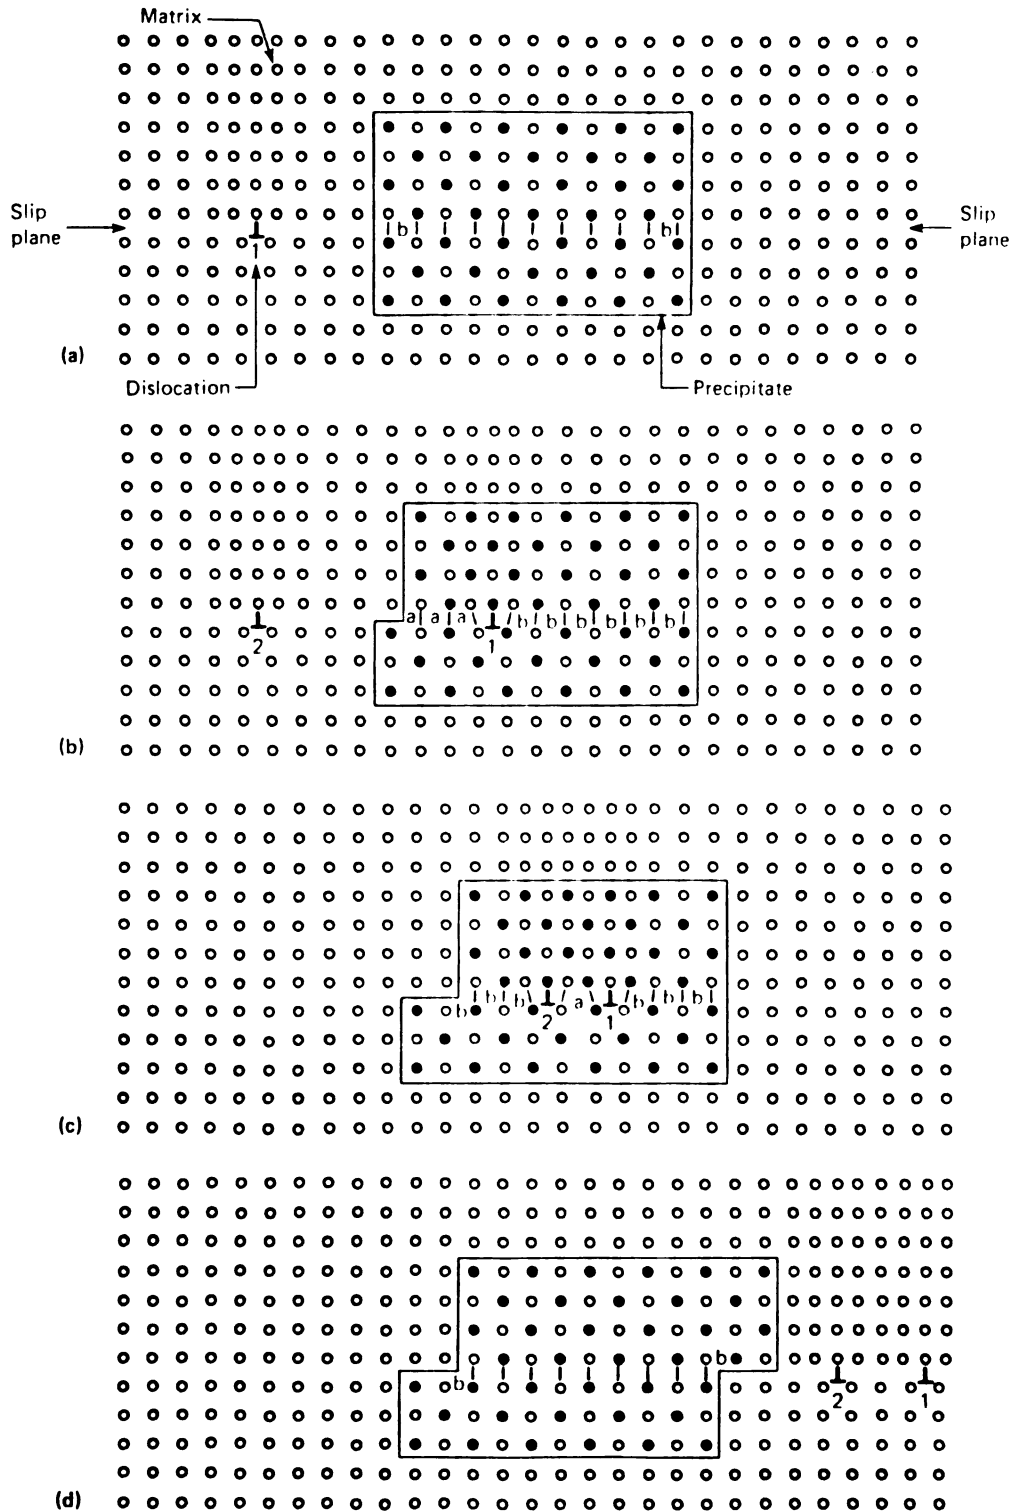
Figure 1. Schematic illustration of the creation of antiphase boundary (APB) bonds (a) formed by a dislocation moving through an ordered precipitate, and APB annihilation by a trailing dislocation (9).

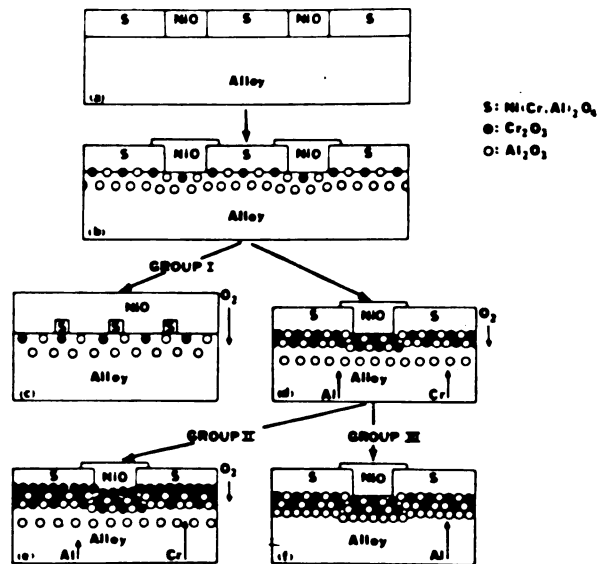
Figure 2. Schematic diagram illustrating the sequence of steps that take place during the development of NiO (Group I), Cr₂O₃ (Group II) and Al₂O₃ (Group III) scales on Ni-Cr-Al alloys. The amount of transient oxides formed prior to the development of a continuous layer of a given oxide depends upon the alloy composition (19).

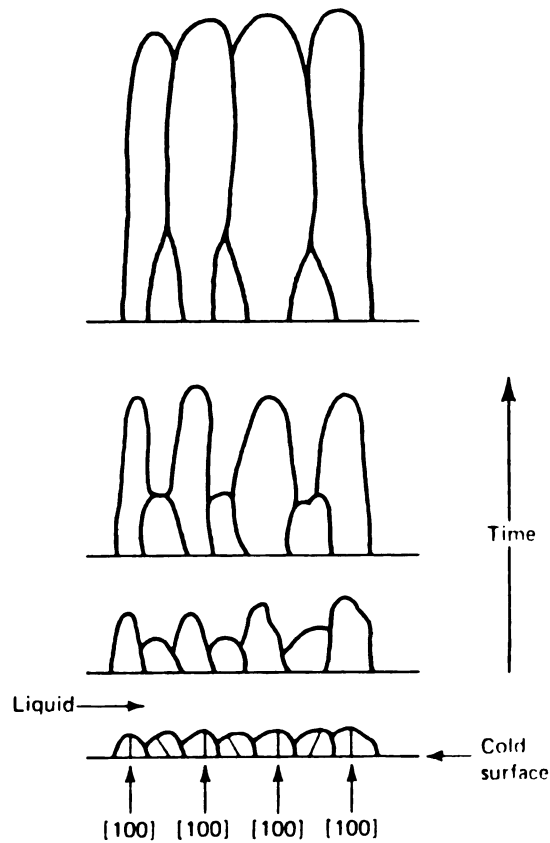
Figure 4. Schematic illustration of the formation of columnar grains having [100] orientation. Each columnar grain is oriented randomly about the vertical axis (9).

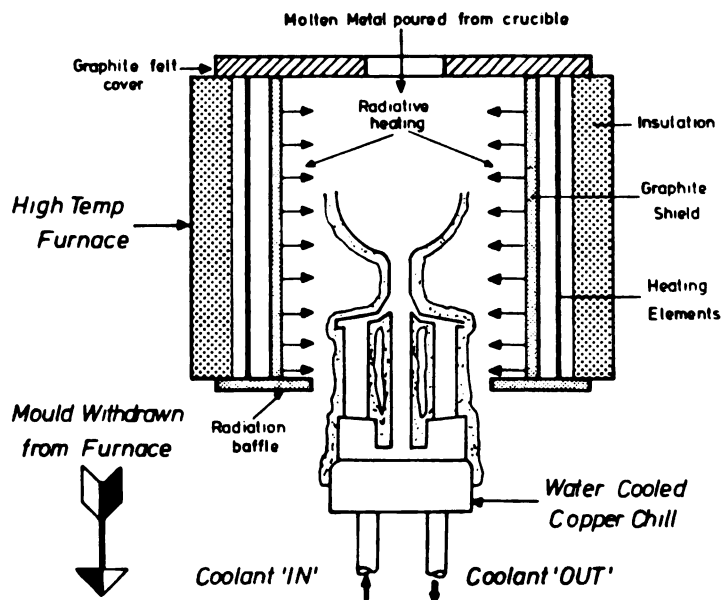
Figure 5. Principle of directional solidification (27).

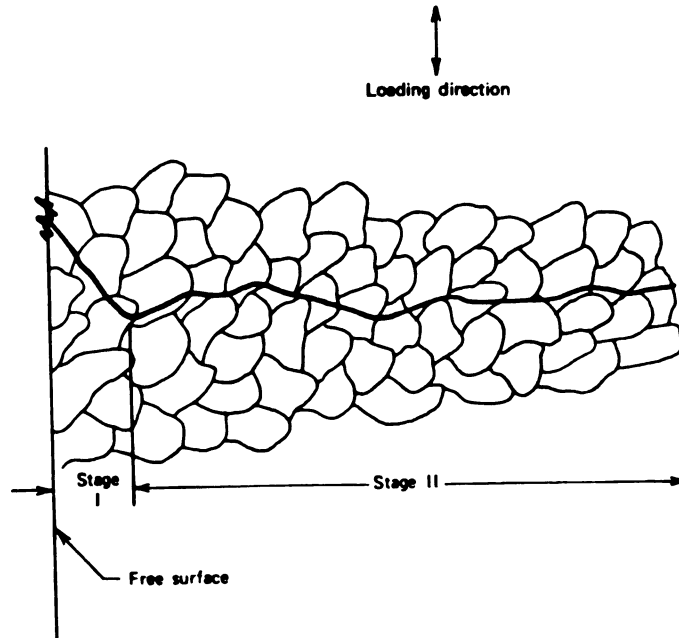
Figure 6. Stage I and Stage II modes of transgranular fatigue crack growth (54).

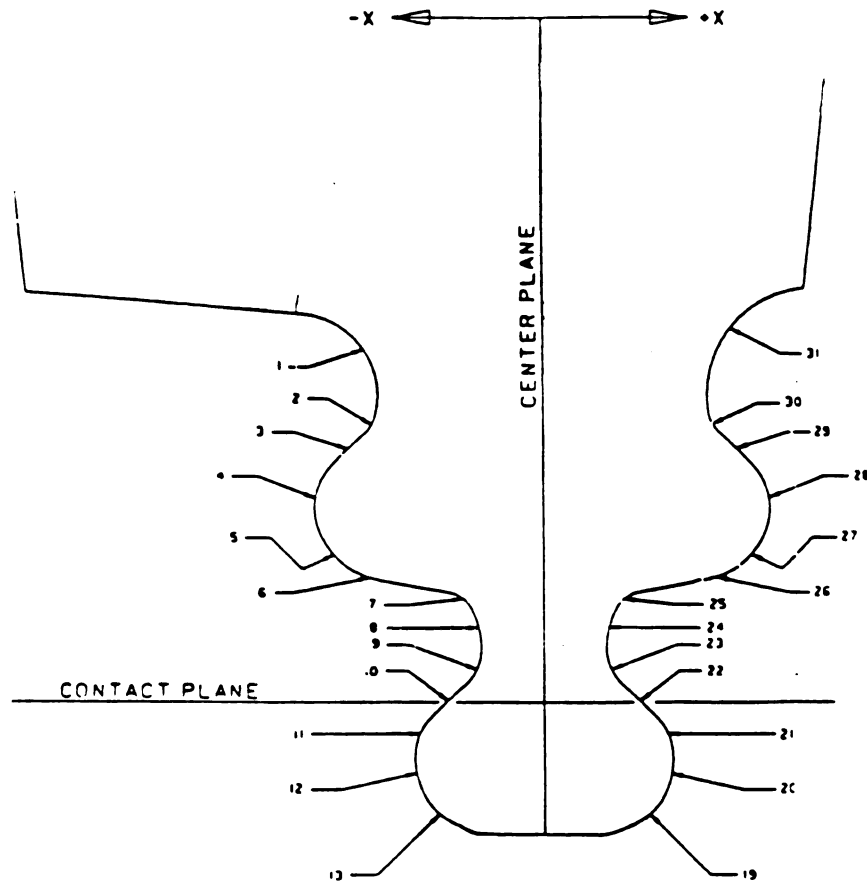
Figure 10. Specimen specifications, crowned geometries (61).

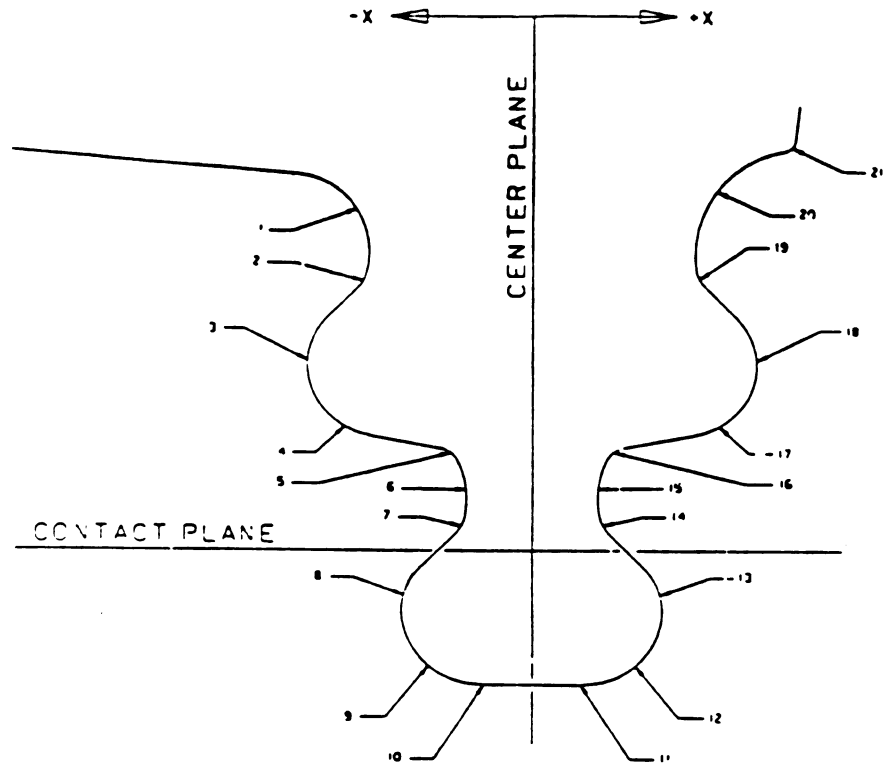
Figure 11. Loading fixture specifications (61).

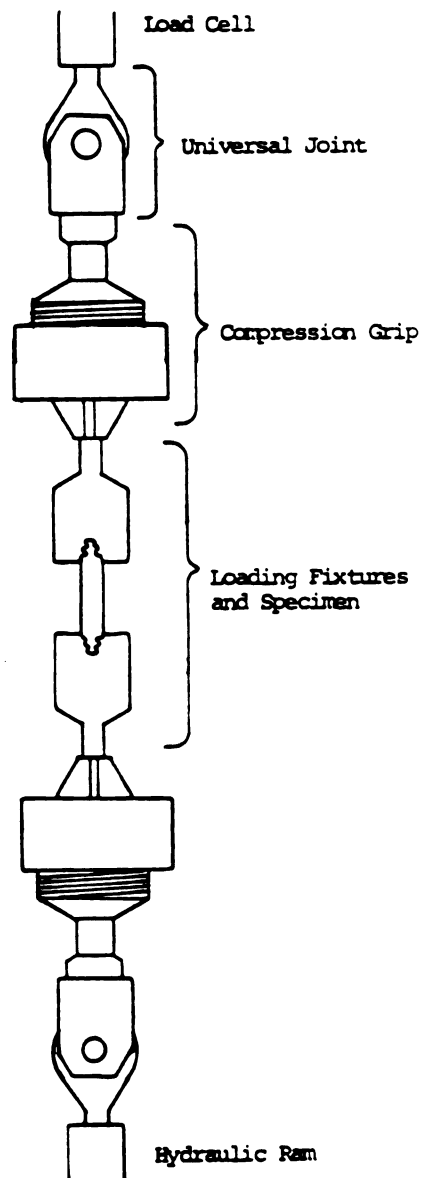
Figure 13. Complete load train (61).

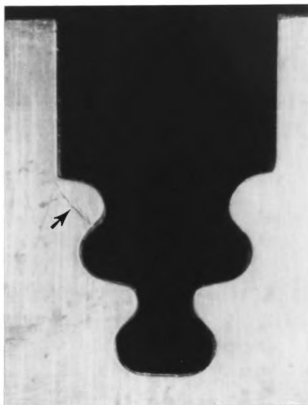
Figure 16. Loading grip #4 containing a crack initiating from a load bearing surface. 5.5X

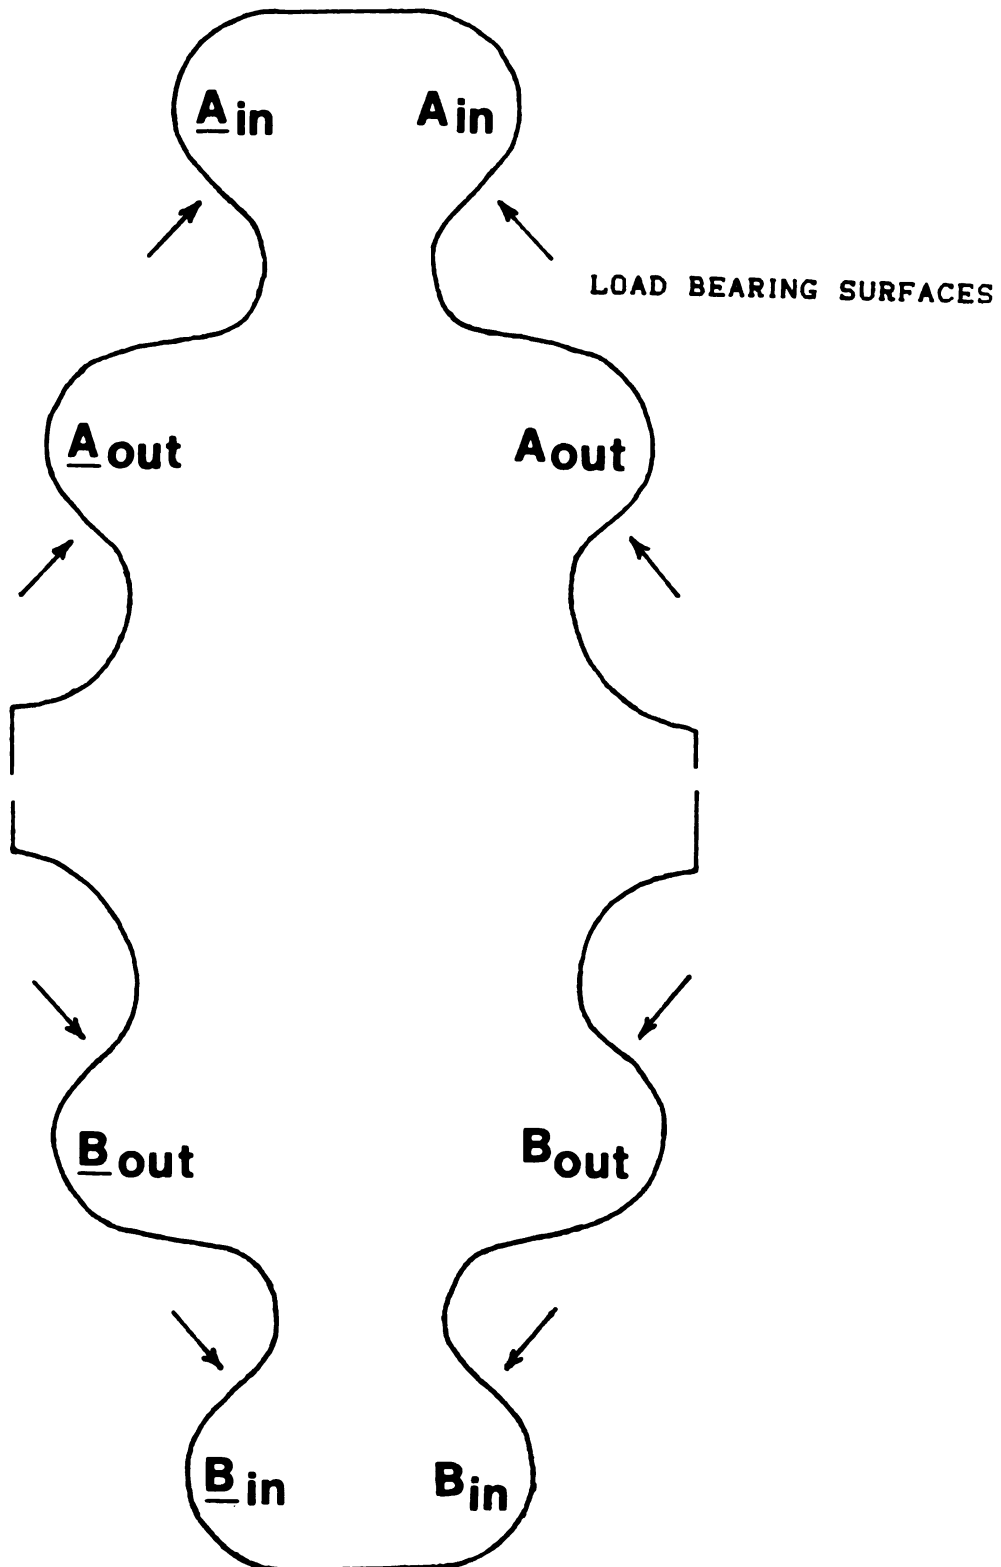
Figure 17. Illustration of nomenclature used for describing specific locations on the fir-tree specimens and for the corresponding loading grip areas.

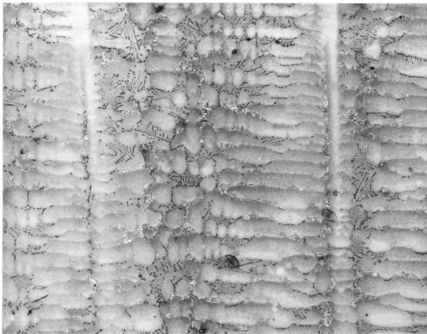
Figure 18. Directionally solidified dendritic structure sectioned longitudinal to columnar grains. OM 50X

The directionally solidified dendritic structures are depicted in sections longitudinal and transverse to the columnar grains, respectively shown in Figures 18 and 19. The microstructure consists of a cored dendritic structure with large script-type carbides and large γ/γ' eutectic nodular regions, primarily in the inner dendritic regions and near dendrite boundaries. The inner dendritic boundaries, or grain

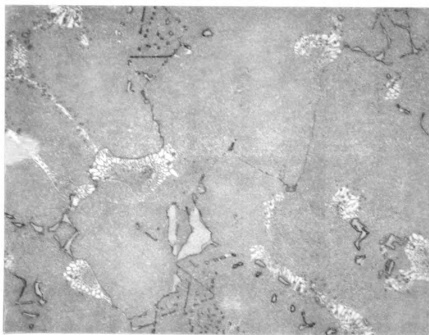
Figure 20. Serrated dendritic, or grain boundaries. OM 200X

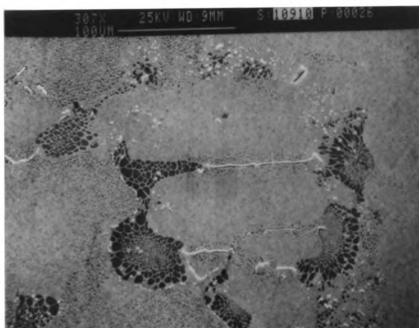
Figure 22. Microstructure showing large eutectic pools (dark), carbide particles (white) and dendritic areas of fine γ/γ' (grey). SEM 307X

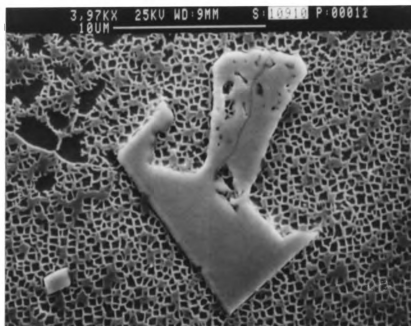
Figure 23. Blocky MC-type carbide. SEM 3,970X

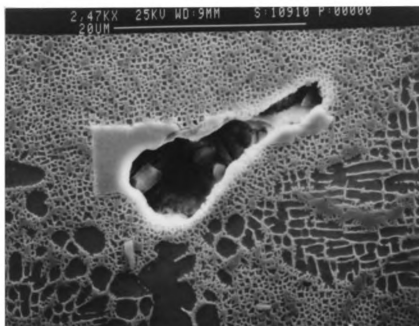
Figure 27. A micropore associated with a carbide. SEM 2,470X

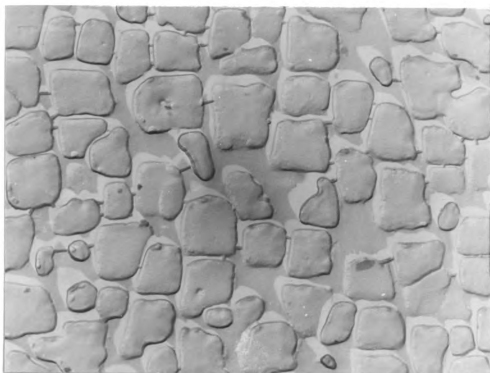
Figure 28. Cubic morphology and aligned directionality of gamma prime precipitates. RTM 19,000X

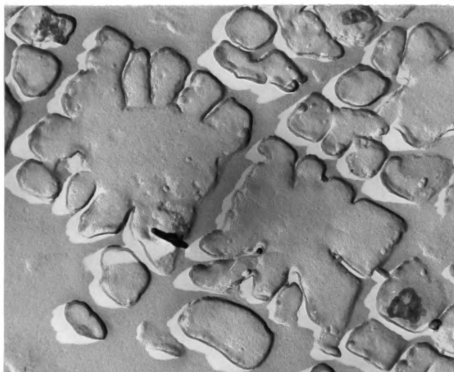
Figure 29. Gamma prime coarsening. RTEM 29,000X

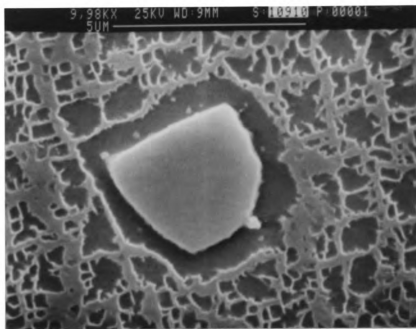
Figure 30. Carbide particle surrounded by a continuous layer of gamma prime (dark), and randomly coarsened gamma prime precipitates. SEM 9,980X

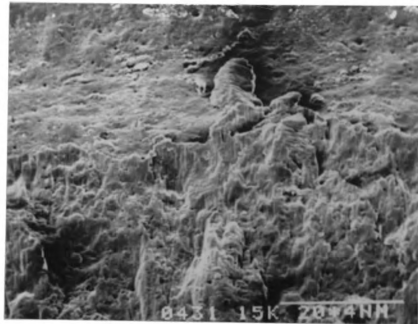
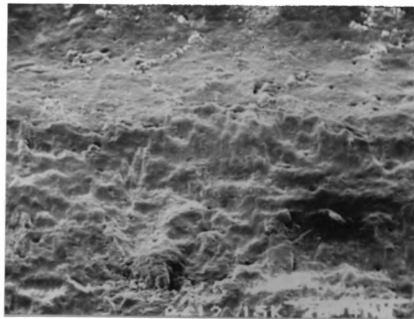
Figure 31. Different stages of fretting wear formed in contact regions. Specimen F109-14 Cr, RSEM 150X; a. initial rough adhesive wear (7,441 cycles), b. smoothing down of the initial damage (15K cycles), c. development of spherical fretting particles (25K cycles), note sphere formation is in region of excessive wear in a., d. retention of spherical particle and continued flattening of rouged area with associated "glaze" formation (30K cycles) and e. parallel abrasive grooves in glazed area and surface damage at fretting sphere location ($N_f=32K$).

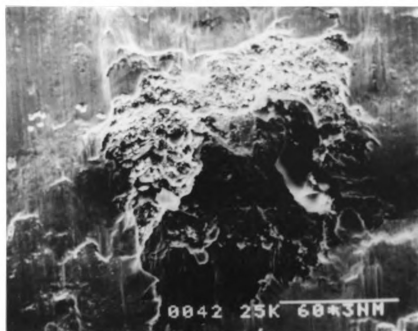
Figure 32. Excessive surface damage caused by a spherical fretting debris particle. SEM 500X

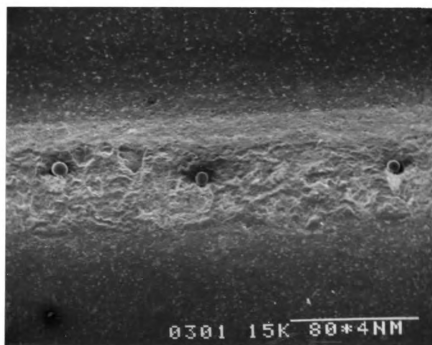
Figure 33. Three fretting spheres located in fretted region. RSEM 38X

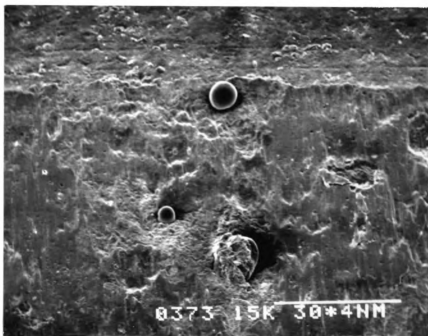
Figure 34. Spherical fretting debris; a. localized roughening at 15K cycles, b. sphere formation at roughened areas. RSEM 100X

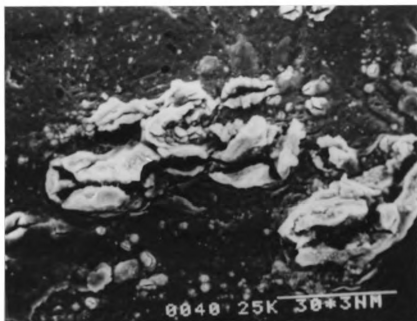
Figure 36. Oxide polyps with inherent cracks. SEM 1000X

others (63), that these structures are some type of oxide polyp. Figure 36, of specimen F109-14 CR, some of these polyps with their inherent cracks are shown.

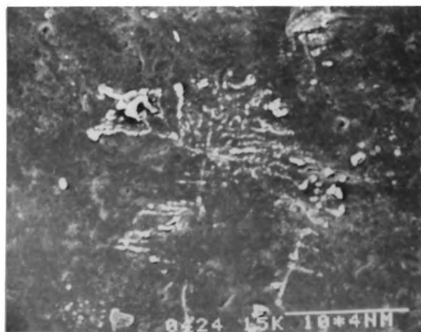
Figure 37. Oxide polyps with a script-morphology. RSEM 300X

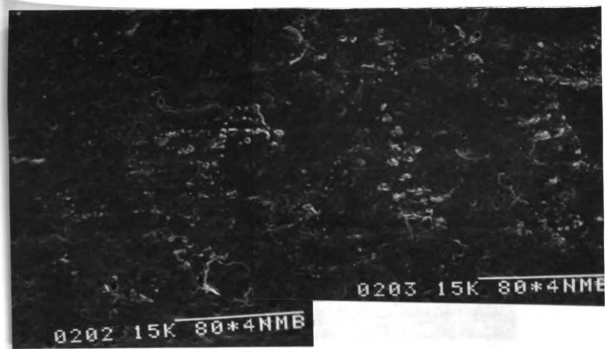
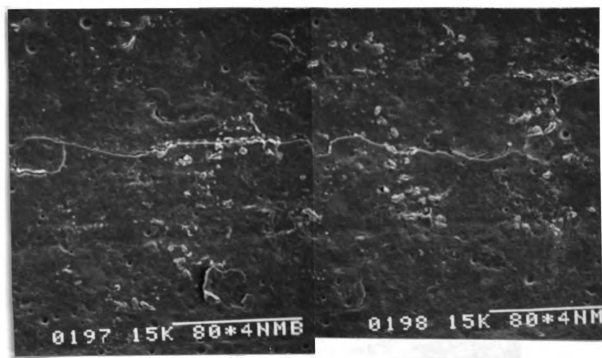
Figure 38. Crack of specimen F109-10 Cr; a. no evident of crack at 8,228 cycles and b. crack following dense path of polyps at 14,444 cycles. RSEM 190X

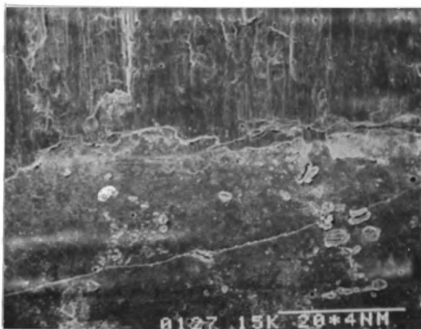
Figure 39. Crack of Specimen F109-1 F developed between cycles 31,587 and 46,587, this crack runs near the fretted slip/no-slip boundary and also extends into the notched region. RSEM 150X, 300X

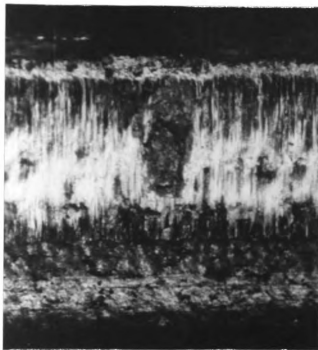
Figure 40. Macrograph of a localized gouged area within a shiny and grooved glazed fretted region.

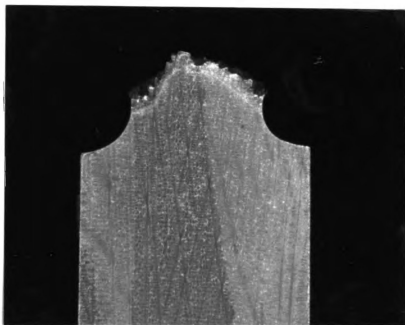
Figure 41. Side view of a "typical" fracture, the directionally solidified dendritic structure is visible. OM 6X

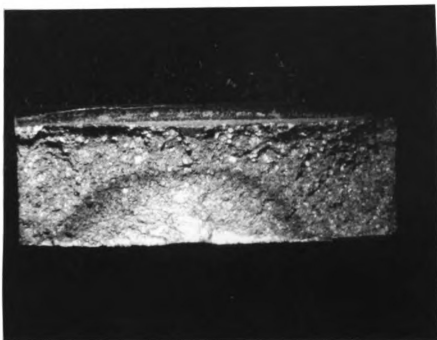
Figure 42. Fracture surface of the longest life specimen, F109-1 F, showing an extensive Stage I region (bright) in a thumbnail crack propagation region. OM 5X

The fracture surfaces of the longest life specimen, F109-1 F (N_r: 51,309), and the shortest life specimen, F109-3 F (N_r: 11,531), are shown in Figures 42 and 43. Both failed under "typical" fracture conditions. The thumbnail fatigue crack propagation regions on these specimens are visible in these macrographs. The very bright region on F109-1 F indicates the region of extensive Stage I mode of crack propagation. The Stage I region on F109-3 F is much smaller. The thumbnail region of F109-1 F is smaller than that of F109-3 F, indicating a smaller stage II propagation region. As previously mentioned in the section on deformation, Stage I crack propagation modes in Ni-base superalloys are associated with planar heterogeneous slip (slip bands) on crystallographic planes, while stage II cracking is non-crystallographic, and due to homogeneous deformation (multiple slip) occurring normal to the stress axis. From fracture surface observations, it is concluded that directionally solidified Ni-base superalloys which exhibit an extensive Stage I fracture mode, with associated planar slip, have greater fatigue resistance than those with a short Stage I and extended Stage II mode of homogeneous crack propagation growth.

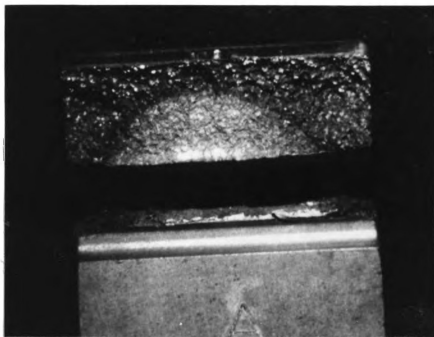
Figure 43. Fracture surface of the shortest life specimen, F109-3, displaying a shorter Stage I region. OM 4X

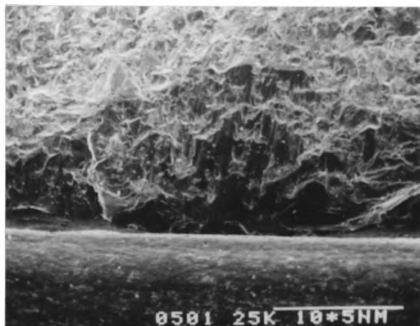
Figure 44. Micrograph of the extensive Stage I region of specimen F109-1 (extending approximately 15mm). SEM 30X

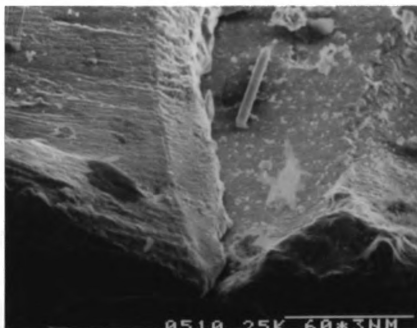
Figure 45. The smoothness or planarity of Stage I crack propagation is seen in this micrograph where two planes of crack growth intersect. SEM 500X

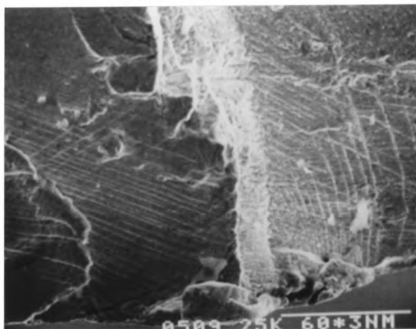
Figure 46. Intersecting slip steps in Stage I crack growth region. SEM 500X

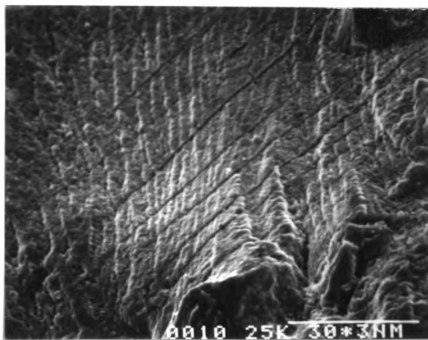
Figure 47. Intersecting slip steps on the order of 10 microns in Stage I crack growth region. SEM 1000X

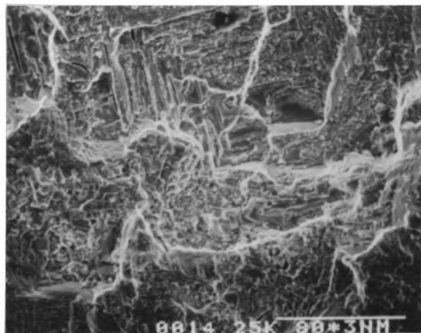
Figure 48. Final fracture region characterized by a rough almost dimple-like surface and secondary cracking. SEM 380X

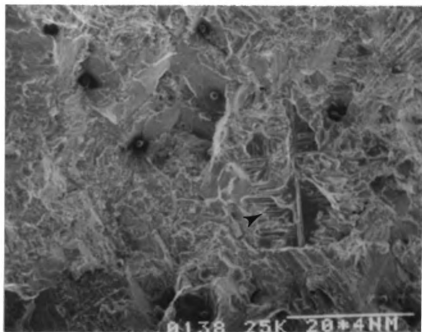
Figure 49. A faceted, planar fracture region (middle right) with perpendicularly intersecting lines in rough overload, non-planar region. SEM 150X

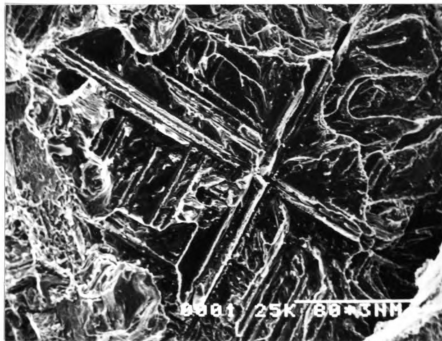
Figure 50. Faceted fracture region with intersecting perpendicular lines in final fracture region. SEM 380X

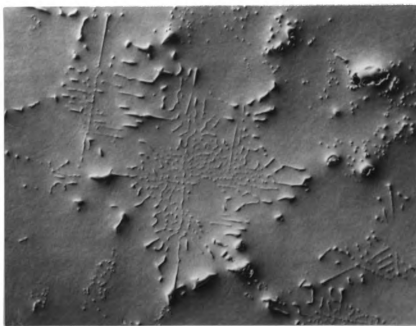
Figure 51. Carbides with script-type morphologies illustrating perpendicularly intersecting lines and other shapes found on faceted fractured surfaces. OM 200X

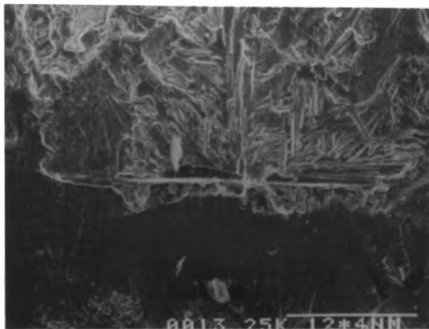
Figure 52. The smooth Stage I mode of crack propagation is abruptly changed at a script carbide. The drawing distinguishes the carbide particles which have been darkened. SEM 250X

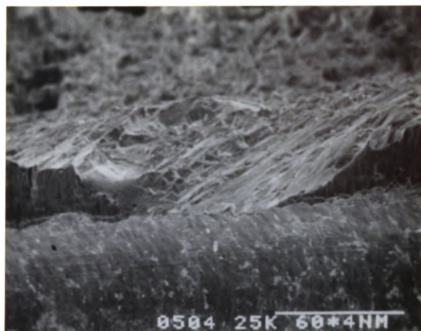
Figure 53. Propagation of the fracture crack from the slip/no-slip fretted boundary. SEM 50X

Scanning electron microscopy studies of surfaces in the fracture vicinity provided information on fatigue crack nucleation sites. Figure 53 is a low magnification electron micrograph which shows the propagation of the fracture crack to be near the slip/no-slip boundary. A closer examination of this

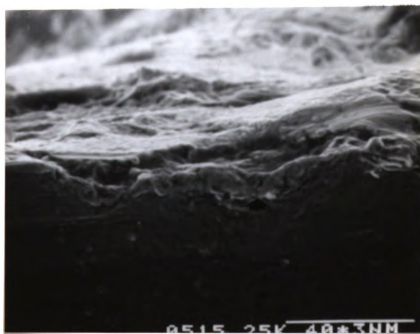
Figure 54. Initiation site of a fatigue crack at an oxide polyp. SEM 750X

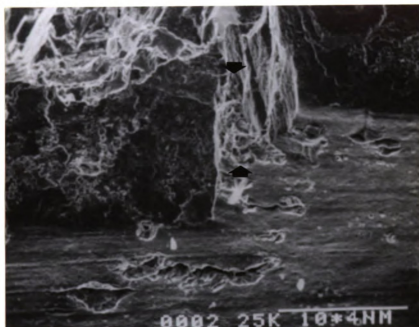
Figure 55. A deep oxide polyp area caused the plane of fracture to separate. SEM 300X

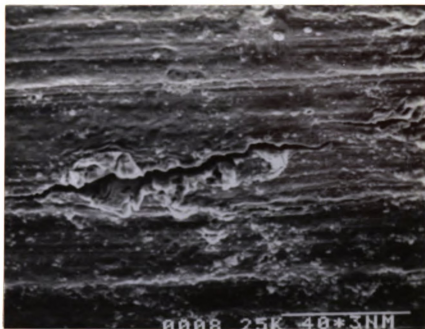
Figure 56. Nucleation of a fatigue crack from an oxide polyp. SEM 750X

The nucleation of a fatigue crack from an oxide polyp is shown in Figure 56. Nucleation of fatigue cracks from polyps usually occurs near the slip/no-slip boundary where the stresses are highest, as shown in Figure 57. Figure 58 shows a group of oxide polyps initiating fatigue cracks near the fretted boundary. An interesting observation about this electron micrograph is the propagation of a crack to the fretted boundary, with the surface wear extending over the crack. This indicates that as the contact region increases in size, polyp cracks may lie underneath the fretted region, resulting in even higher stress concentrations near the fretted boundary. Figure 59 shows the opening up of a fracture region which initiated from an oxide polyp at the fretted boundary. The inherent brittleness of the polyp is illustrated by the secondary cracking associated with this oxide on the fractured surface. These oxidized carbide polyps are found to be detrimental to fatigue resistance. The polyps disrupt the protective oxide layer, while the inherent cracks are believed to mechanically and chemically weaken the material, resulting in the nucleation fatigue cracks.

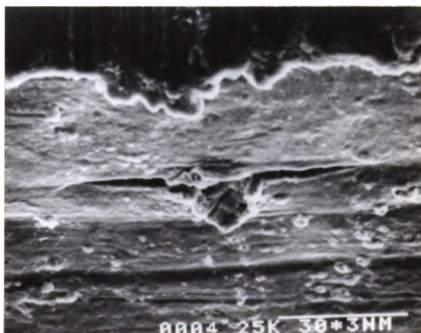
Figure 57. Nucleation of a fatigue crack from an oxide polyp near the slip/no-slip fretted boundary (upper section of picture). SEM 1000X

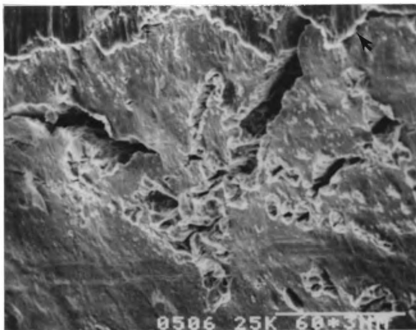
Figure 58. A group of oxide polyps initiating fatigue cracks near the fretted boundary, note the wear region extending over the crack in the upper right corner. SEM 500X

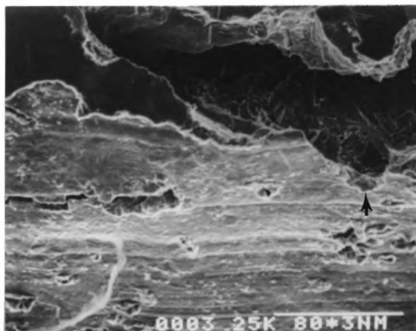
Figure 59. Opening up of a fracture region at an oxide polyp at the fretted slip/no-slip boundary (right side). The brittleness of the polyp is illustrated by the secondary cracking. SEM 380X

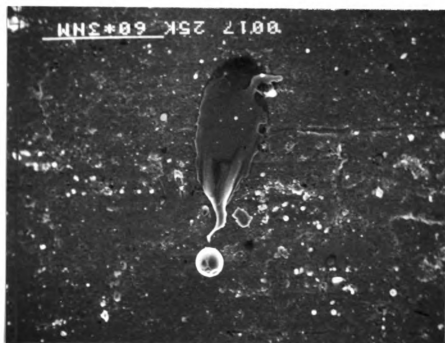
Figure 62. Dripping sphere: incipient melting area characterized by glassy, very smooth appearance. SEM 500X

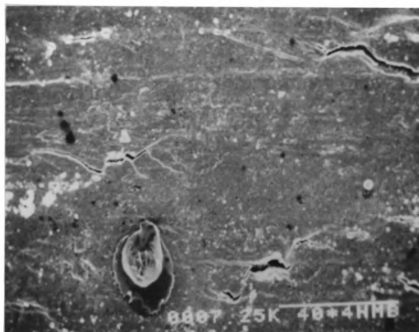
Figure 63. Evidence of incipient melting (feature in lower left area). Cracking at oxide polyps. SEM 375X

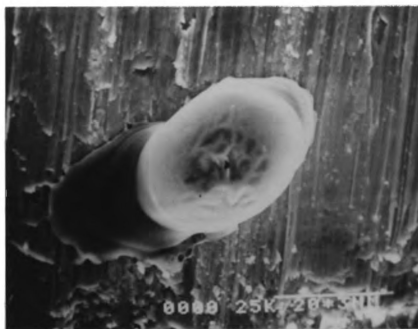
Figure 64. A spherical particle located just inside the boundary of the wear region where localized melting has occurred and recorded the cyclic movement in the smooth melted region. SEM 1500X

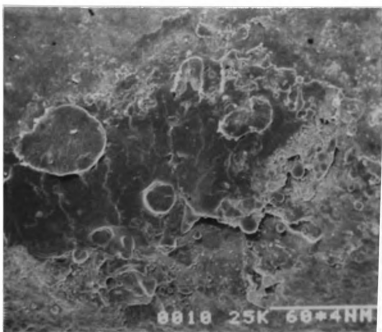
Figure 65. Replica of large surface discontinuity on specimen F109-14 Cr having characteristics of melting and rapidly solidifying; melt droplets, melt craters and solidification shrinkage cracks. RSEM 50X

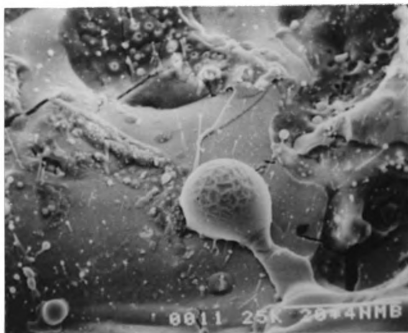
Figure 66. Higher magnification of Figure 65 showing quenched droplets from splashing of molten metal and rapid solidification cracks. RSEM 750X

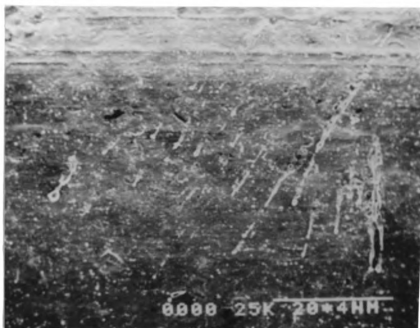
Figure 67. Splashed quenched droplets radiating away from the large surface discontinuity in Figure 65. SEM 150X

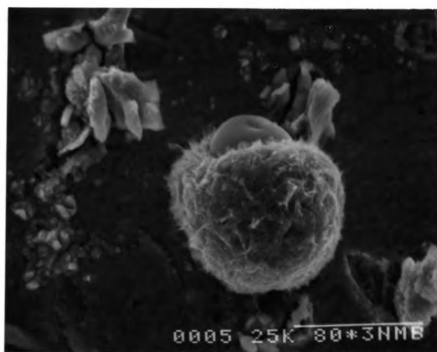
Figure 74. Replication of spherical and protruding features:
a. replica at 46,587 cycles, 1000X, b. specimen
with $N_s=51,309$. 1900X

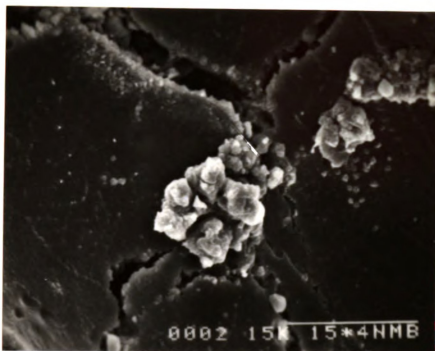
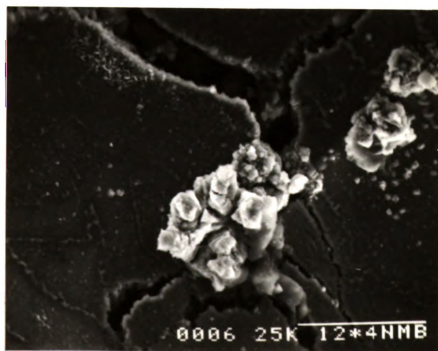
Figure 76. Replica quality comparison: a. replica 1000X (15KV) and b. specimen 1250X (25KV).

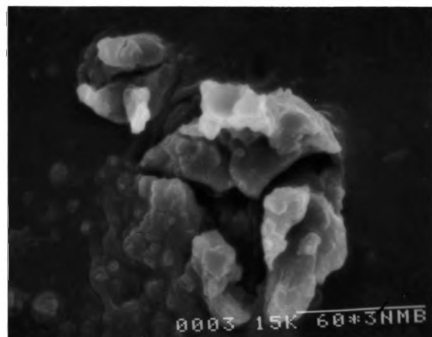
Figure 77. Replica loses some detail at higher magnification: a. specimen 2500X (25KV) and b. replica 2500X (15KV). It should be noted that a relatively thick coat of gold was applied to these replicas and they are examined at lower accelerating voltages.
