Package Design For A Gas Range Product Line

PACKAGE DESIGN FOR A GAS RANGE PRODUCT LINE

A THESIS

School of Packaging

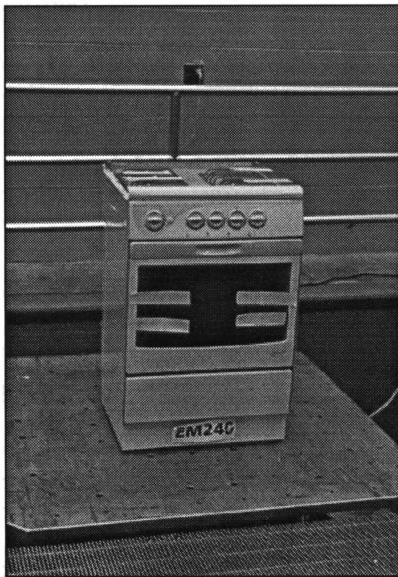
Figure 31 - Sample EM240 on the vibration table

Resonant frequencies (Hz)	Remarks
23-27 44	Resonant vibration of cover and glass lid Noise from top, probably from the cover
Note: the oven floor lid does not fit well to the oven floor because it is bent. Also, the lid is twisted. See Figure 30 Conditions: without the oven floor lid and rack. The glass lid is taped to the cabinet. With burners and supports. See Figure 31 Damage: no damage

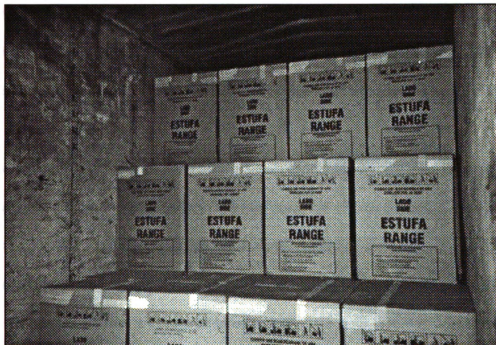
Figure 67 - Corrugated fibre box package

1. Corrugated fiberboard box with packaging protectors. This is the current system for the current ranges (see Table 44 and Figure 67). Domestic products use honeycomb protectors and export products use polystyrene protectors. The advantages are low cost and ease of assembly in the production line. The domestic package has the smallest size. The disadvantages are that quality materials are not always good and, damage level is some times high. If there is a damage during distribution, it is almost impossible to detect. The honeycomb package does not have any cushion at the bottom.
