This is to certify that the
thesis entitled
**Spatial Patterning of Artifacts from a Civil War Era
Machine Shop, Camp Nelson, Kentucky**

**SPATIAL PATTERNING OF ARTIFACTS FROM A CIVIL WAR ERA MACHINE
SHOP, CAMP NELSON, KENTUCKY**

AN ABSTRACT OF A THESIS

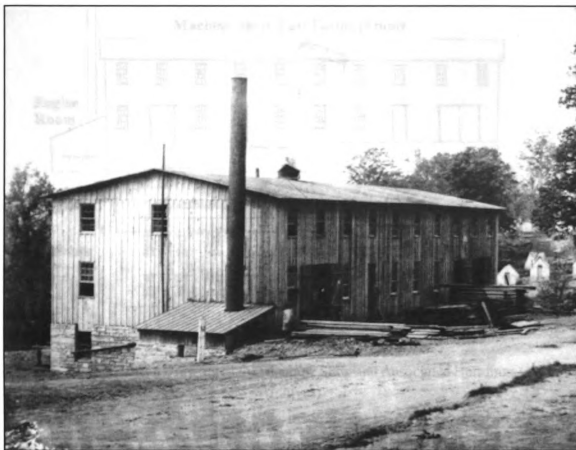
Figure 5. 1866 Photo of the Machine Shop (National Archives).

When the machine shop was constructed in the summer of 1863, the site was likely a pasture or lightly wooded area. US Army quartermaster department records indicate that the machine shop was 100 foot long by 40 foot wide, two stories high on its east side (front) and three stories high on its west (rear). Historic documents, including a photograph, indicate that the structure had a solid limestone foundation, was of board-and-batten construction and had

numerous windows. Interestingly, three lists of machinery from this building dating from March and May 1865 and January 1866 are extant. These lists indicate that the shop contained one 50-hp steam engine with a six-flue boiler, one planing machine, one tenon machine, one shingle machine, one morticing machine, one jockey stick machine, one saw table, one cut-off saw, one rip saw, one iron turning lathe, one machinist turning lathe, one large grind stone with side rest, one machinist vise, 225 feet of leather belting, two grist mills, one shelling machine, and two hay cutters. These machines support Capt. Theron Hall's statement that the "machine shop is a building in which all the carpenter work of the camp is done including the making of doors, windows sashes, desks, and

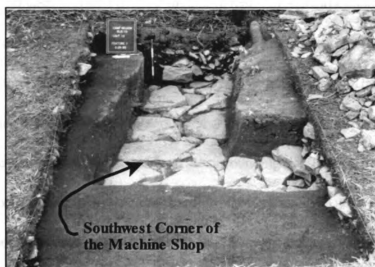
Figure 11. The Southwest Corner of the Machine Shop Foundation.

Feature 1 was first encountered in Unit 4 as a 70 to 90 cm wide and 40 cm deep builder's trench filled with dark brown to brown silty loam and limestone rubble (Figure 11). It also had no

remaining intact foundation stones. The foundation at this point had been robbed. Further excavation in Units 8 and 18 indicated that much of the shop's western wall foundation had been robbed. The bottom coarse of stones in the northwest and southwest corners were extant, however, as was demonstrated in the excavation of Units 9, 13, and 15. Here large horizontal limestone slabs were extant within the builder's trench. The distance from Units 15 to Unit 13

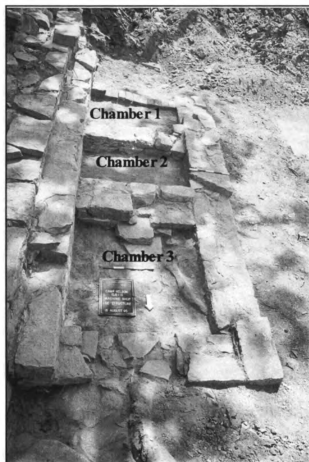
Figure 12. The Three Chambered Limestone Extension.

At the southeastern corner of the foundation, feature 1 A, a three chambered extension store pad was uncovered (Figure 12). This pad extended out 2.2 meters from the main foundation and consisted of three east-west limestone walls, one connecting north-south limestone wall, and an east-west brick wall. It was 4.3 meters long.

The limestone and brick of this pad and the surrounding soil showed evidence of extreme heat in the form of reddening of the stone and spalling of the brick. Given the location of the steam engine off the southeast corner of this building in the 1860s photograph (Figure 5) and elevation drawing, it is possible that this pad held machinery related to the steam engine. No architectural evidence of the small steam room was discovered during excavation. It is also possible that this pad served another function. The large quantity of iron slag and bar stock recovered from this area indicates extensive iron forging activities occurred in or near this site.

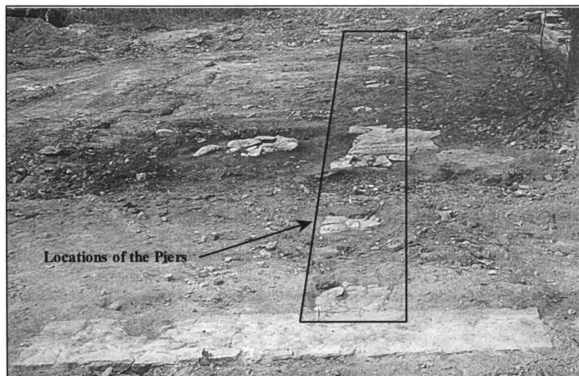
Figure 13. The Piers at the Machine Shop.

Other architectural evidence of the shop included nine limestone piers found extending down the middle of the shop (Figure 13). These were typically 70 x 80 cm in size and placed 2.8 meters (9 ft) apart. The piers were the bases of large pillars (probably wooden) which helped hold

up the roof and load-bearing beams of the second and third floors. They give evidence of the size of this building and the weight that the second and third floors had to support.

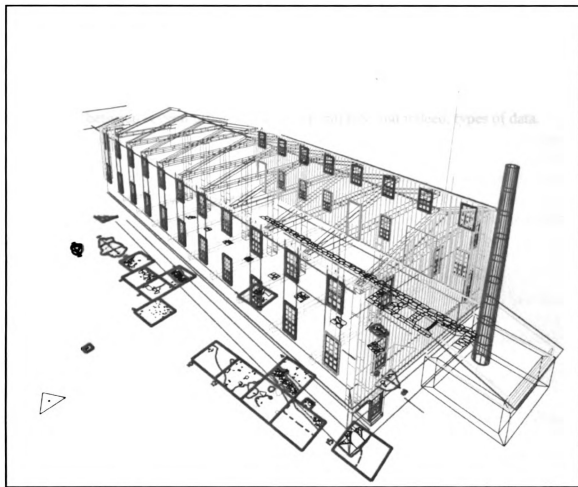
Figure 19. Computer Reconstruction of the Machine Shop in Relation to Features.

An initial analysis conducted by myself with the aid of Chris Rankin showed some promise (Beverly and Rankin 1999) (Figure 19). We looked at a computer reconstruction of the architectural features of the machine shop, especially the windows. We then placed this architectural model over the machine shop's foundation and examined its relationship with the spatial distribution for

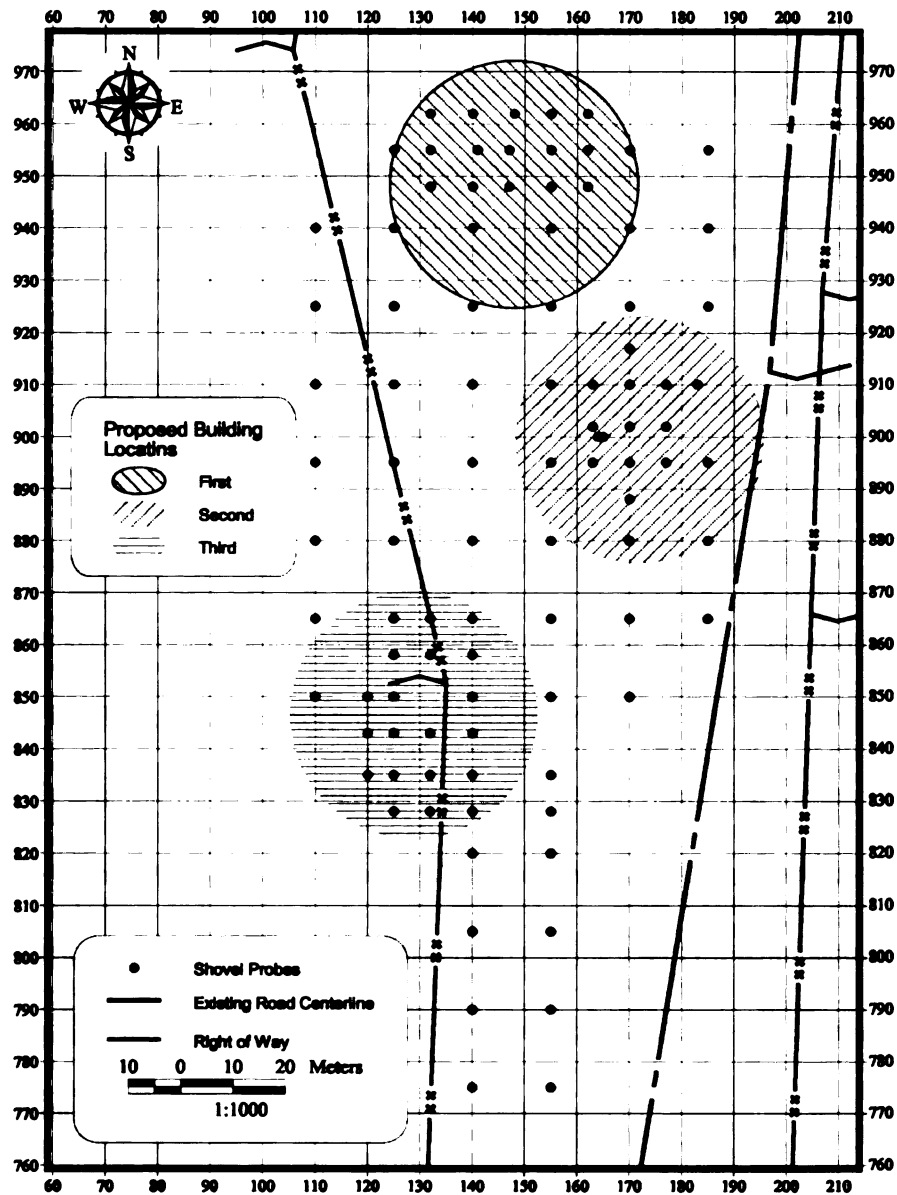
Figure 23. Location of Proposed Building Areas.

An examination of the spatial data for brick, flat window glass, and late cut nails show that they cluster in three distinct areas (Figure 23). For the purpose of this discussion, I will refer to these three areas as the first, second, and third building areas. As seen in Figure 23, the first

building area is located near the east-central part of the Machine Shop site. The second building site is located on the north-central proportion of the site, and the third building site is located in Machine Shop's south-western area.

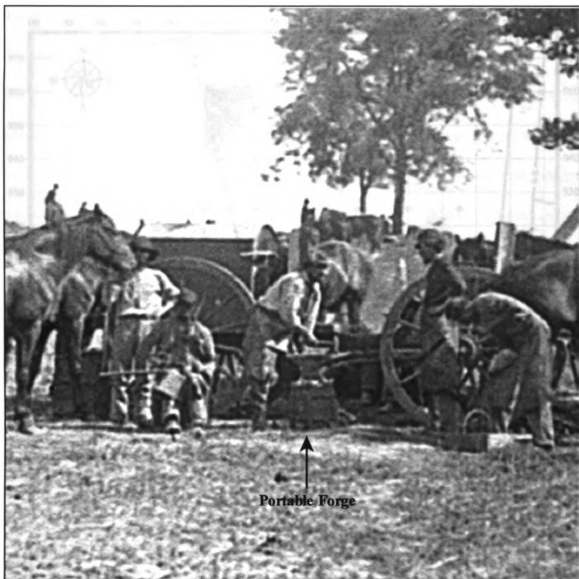
Figure 25. Distribution of Job/Activity Artifacts from Shovel Probed.

The distributional analysis for job/activity reveals an interesting pattern. It shows two clusters, one in the vicinity the second building area (Northern Gully) and a second cluster just south of the first building cluster (Machine Shop) (Figure 25). This second cluster is represented by a single triangular file and may have been used activities involving metal working (Table 12). The other cluster, south of the first building area, is comprised of four blacksmithing bar stock fragments. The presence of these pieces of bar stock may indicate that blacksmithing activity was occurring in the general vicinity. The bar stock may be related to repair work on the shop's engines or machinery. Perhaps a portable forge was set up here (Figure 26).

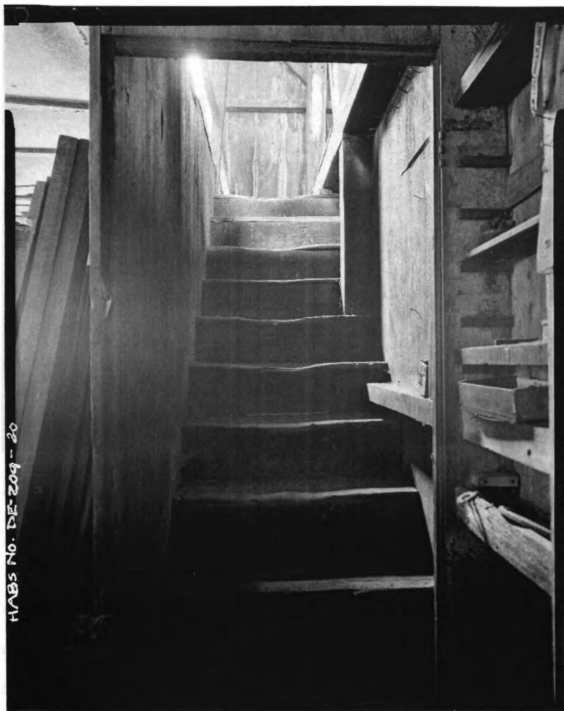
Figure 34. Wilson Alexander Agricultural Works Complex. First Floor Storage Cupboard.
(DE-209-19).

The interior of the first floor is shown in Figures 32 and 33 and 34. The organization of space for the two floors is shown in Figure 32. Figure 33 shows the forge hearth remains in the southwest corner of the east bay. Figure 34 shows a storage cupboard in the west room. The interior of the Machine shop may resemble these photographs. The evidence for blacksmithing

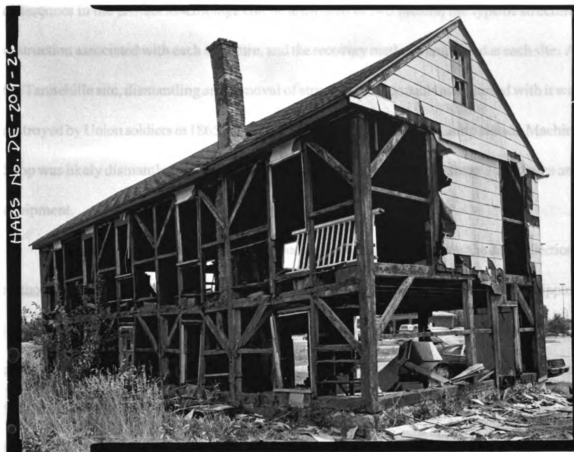
Figure 39. Wilson Alexander Agricultural Works Complex. Structural Frame Revealed During Demolition. (DE-209-26).

Probably the most interesting photograph of the Wilson Alexander Agricultural Works Complex is Figure 39. This photograph shows the framework of the building. Note the timber frame resting on top of the stone foundation. This photograph is a likely indicator of the building practices used to construct the Camp Nelson Machine Shop.

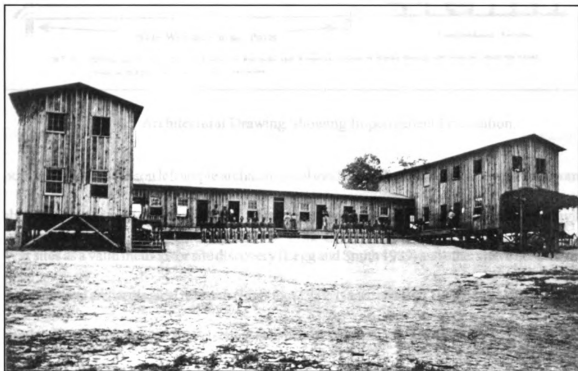
Figure 40. An Example of Impermanent Barracks Foundation.

the remnants of the ornamental fountain in front of the Headquarters building, and a stone floor for a blacksmith shop that is not on Miller's map. Apparently the impermanent nature of Camp Nelson's structures affected how they would be visible in the archaeological record. A review of a typical Civil War era barracks photograph (Figure 40) and an architectural drawing (Figure 41) for structures similar to those built at Camp Nelson shows that the Union Army built these structures on top of the ground (Nelson 1982). This may be the reason for the paucity of building related features.
