HISTORIC CHANNEL CHANGES IN THE MUSKEGON RIVER, NORTH-CENTRAL MICHIGAN,  
USA

A THESIS

Geography - Master of Science

2015

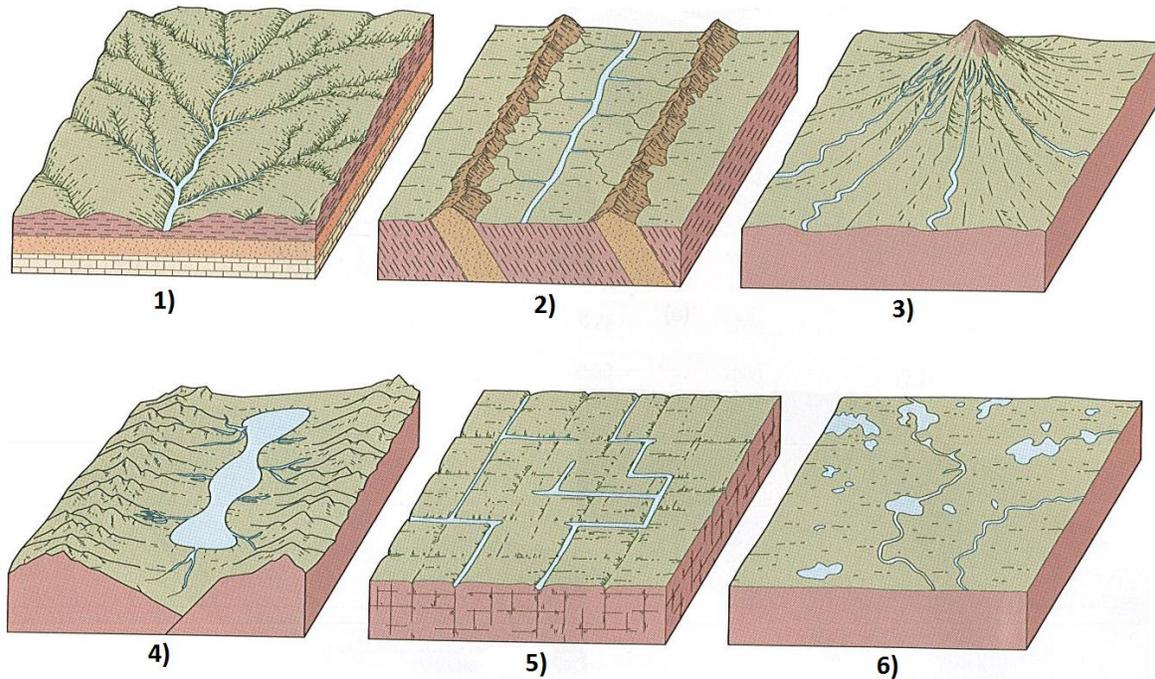
**Figure 2.1.** Common drainage patterns: 1) Dendritic Pattern, 2) Trellis Pattern, 3) Radial Pattern, 4) Centripetal Pattern, 5) Rectangular Pattern, and 6) Deranged Pattern. (modified from Gabler et al., 2007)

Like the trellised pattern, some drainage patterns are only found in areas with certain bedrock structures. This is the case for radial patterns, which develop outward from rounded uplands, such as a volcano or dome (Figure 2.1; Arbogast, 2011). The opposite pattern is centripetal, where drainage flows inward into a lake or basin (Figure 2.1). This pattern is common in the arid Basin and Range province of the American Southwest, frequently forming playas (Strahler and Strahler, 1992). Another bedrock controlled drainage pattern is rectangular. This pattern is typical in areas with jointing and faulting of shallow bedrock and exhibits straight streams flowing in fractures and commonly intersecting at right angles (Figure 2.1; Gabler et al., 2007).

The final drainage pattern is deranged, which is characterized as having an irregular direction of flow (Figure 2.1; Arbogast, 2011). Deranged drainage patterns typically have a low number of tributaries with many interconnected wetlands and lakes (Arbogast, 2011). This pattern commonly develops in areas that have been recently deglaciated (e.g., northern Canada; Gabler et al., 2007), with relatively low slopes that promote these stream systems to wander between marshes and small lakes (Gabler et al., 2007).

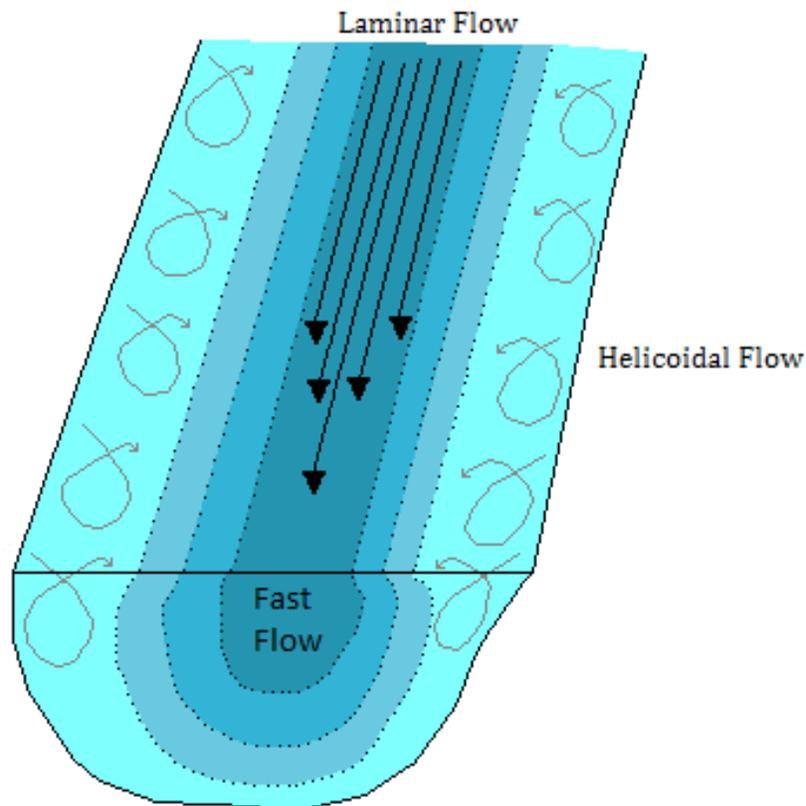
**Figure 2.2.** Diagram showing both helicoidal and laminar flow, as well as flow speed in a three-dimensional channel cross-section.

In addition to helicoidal flow, a stream's centrifugal force also plays a role in the movement of the channel (Wormleaton et al., 2005). The force of a channel's flow pushes water against the outer bend of a meander, causing the water surface to be slightly elevated. This leads to alterations to the channel bed and lateral flow within the stream, eventually causing the channel to slowly form a new morphology (Wormleaton et al., 2005). Together with helicoidal flow these forces aid in the migration of meander bends (e.g., translation, extension, and/or rotation) in a downstream trend (Chen and Duan, 2006).

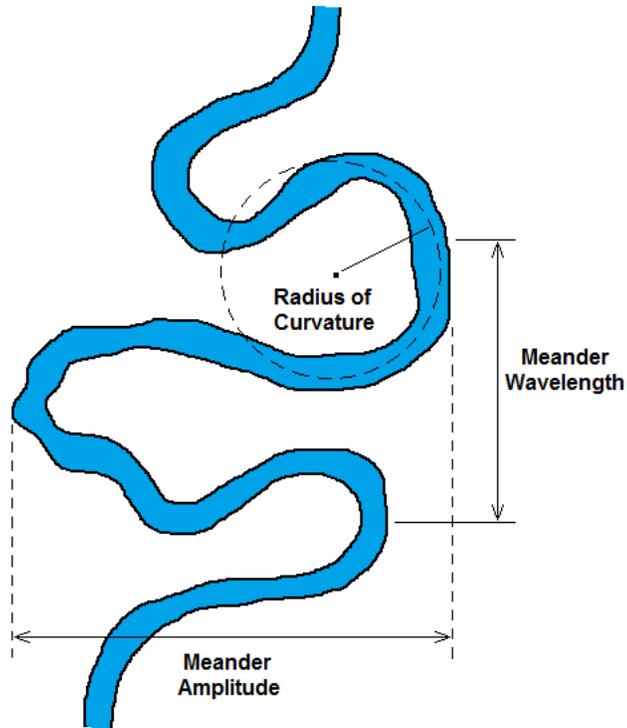
**Figure 2.3.** The meander geometry of a stream, including meander wavelength, amplitude, and radius of curvature. (adopted from Charlton, 2008)

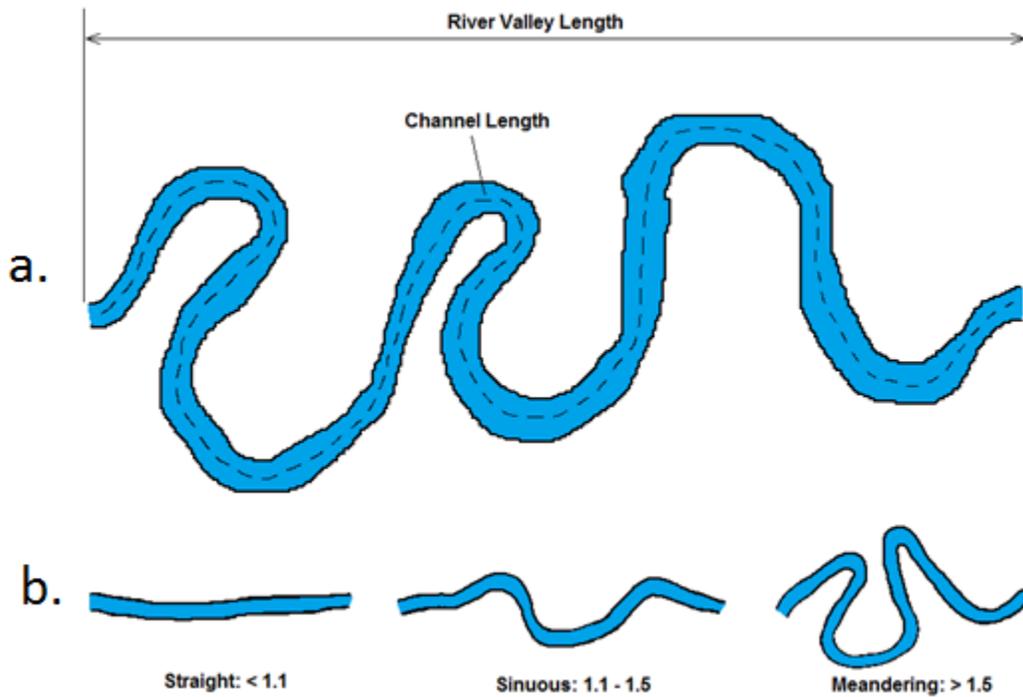
**Figure 2.4.** a.) Diagram showing how sinuosity is calculated. b.) The appearance of straight, sinuous, and meandering streams in regards to sinuosity. (modified from Charlton, 2008)

A second approach to characterizing a meandering stream involves analyzing sinuosity. Sinuosity is calculated by dividing the length of a given channel reach by its river valley length (Figure 2.4, a; Charlton, 2008). Generally, streams with a sinuosity of  $\sim 1$  are considered straight, while streams with sinuosity values between  $\sim 1$  and 1.5 are categorized as sinuous (Figure 2.4, b). Streams with a sinuosity  $> 1.5$  are labeled as

meandering (Figure 2.4, b; Leopold et al., 1964; Petts and Foster, 1985; Charlton, 2008). Schumm (1968) noted that sinuosity can vary among different rivers and stream segments and suggested that factors such as valley slope, channel gradient, and the percentage of silt-clay in channel banks can influence channel migration.

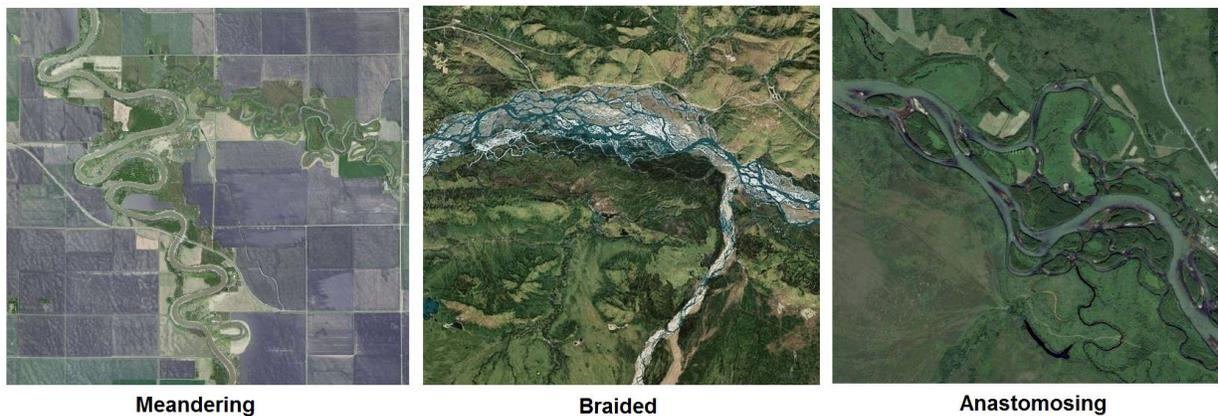
**Figure 2.5.** Aerial images of meandering, braided, and anastomosing channel patterns.

of channels that divide and recombine with hills between the individual branches (Figure 2.5). Schumm (1989) distinguished the differences between a braided channel and an anastomosing stream by noting an anastomosing channel's low gradient with multiple deep narrow channels. Bradshaw et al. (1978) attributed the formation of an anastomosing channel to a shift from an arid climate to humid climate, which increases stream discharge. Anastomosing channels can also be regarded as a subcategory of an anabranching river, which is associated with banks resistant to erosion in flood-dominated fluvial systems (Nanson and Knight, 1996).

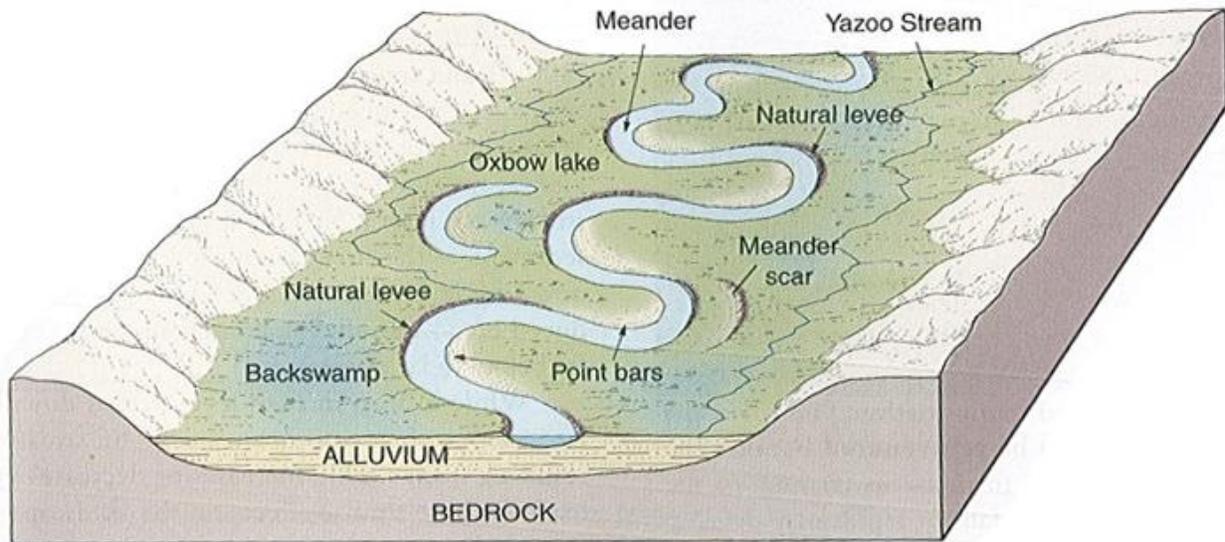
**Figure 2.6.** Features of a well-developed floodplain. (modified from Gabler et al., 2007)

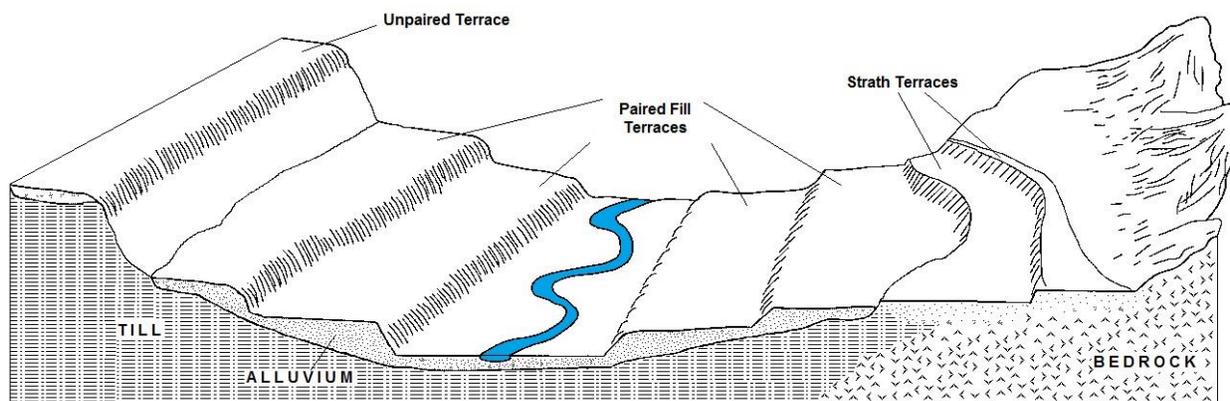
**Figure 2.7.** Examples of different types of terraces (e.g., paired vs. unpaired, fill vs. strath; modified from Charlton, 2008).

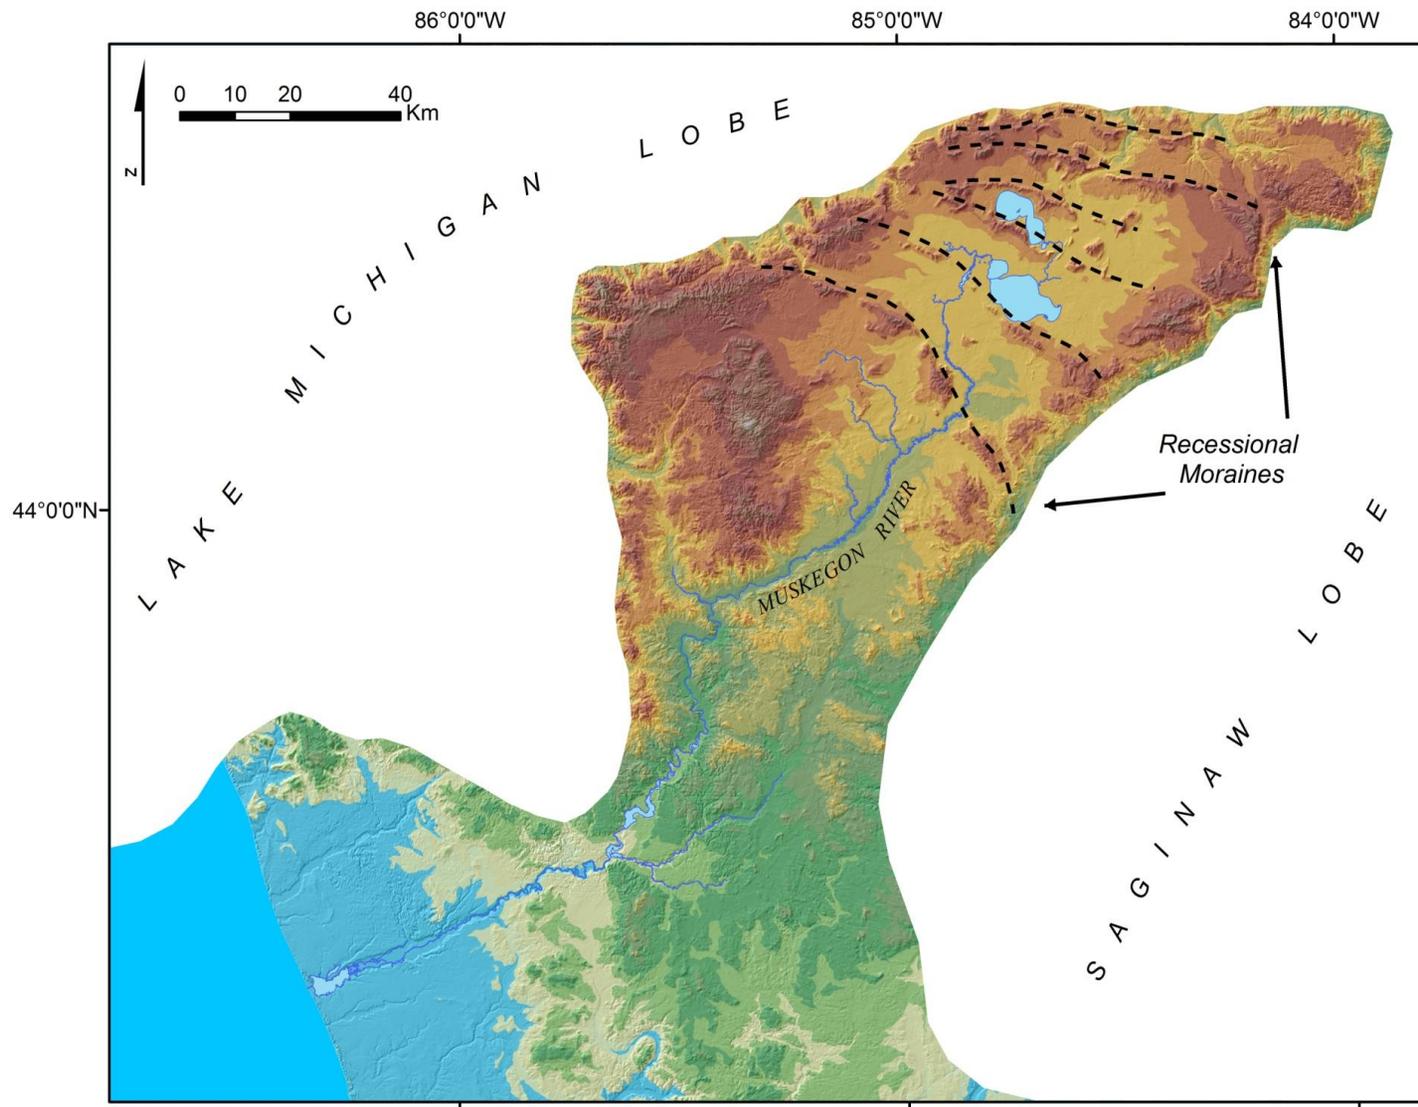
**Figure 3.2.** The Muskegon River basin as the Lake Michigan and Saginaw Lobes retreated from the region ~13,000 yrs ago (modified from Kehew et al., 2011).

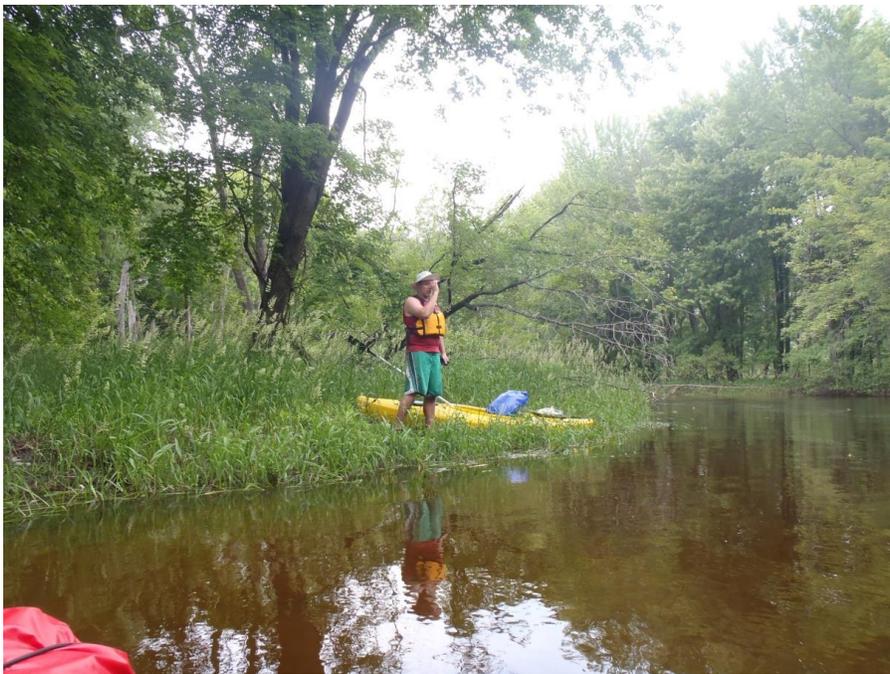
**Figure 4.3.** Collecting bankfull width measurements using a digital rangefinder (photographed by Daniel Kowalski).

measurements were obtained, the same locations were used to collect width measurements in the field for comparative purposes. Floating the river with a kayak allowed access to otherwise inaccessible sample locations. Predefined waypoints were created on a Global Positioning System (GPS) to identify the relevant section lines. Michigan Department of Natural Resources survey markers were often present at these locations, providing ground truth for the waypoint (Figure 4.2). At each of these sample locations, a bankfull-width measurement was taken using a Simmons LRF600 TI laser rangefinder, which has a range of up to ~550 m and a +/- 0.91 m accuracy. Width measurements were taken from on top of one bank, and the digital rangefinder sent a laser to the opposing bank (Figure 4.3). The bankfull widths at sampling locations were identified by the flat surface near the channel boundary (e.g., adjacent floodplain) and denser vegetation (e.g., tree line). All measurements and field notes were recorded on waterproof paper, to assure that data would not be erased by water.

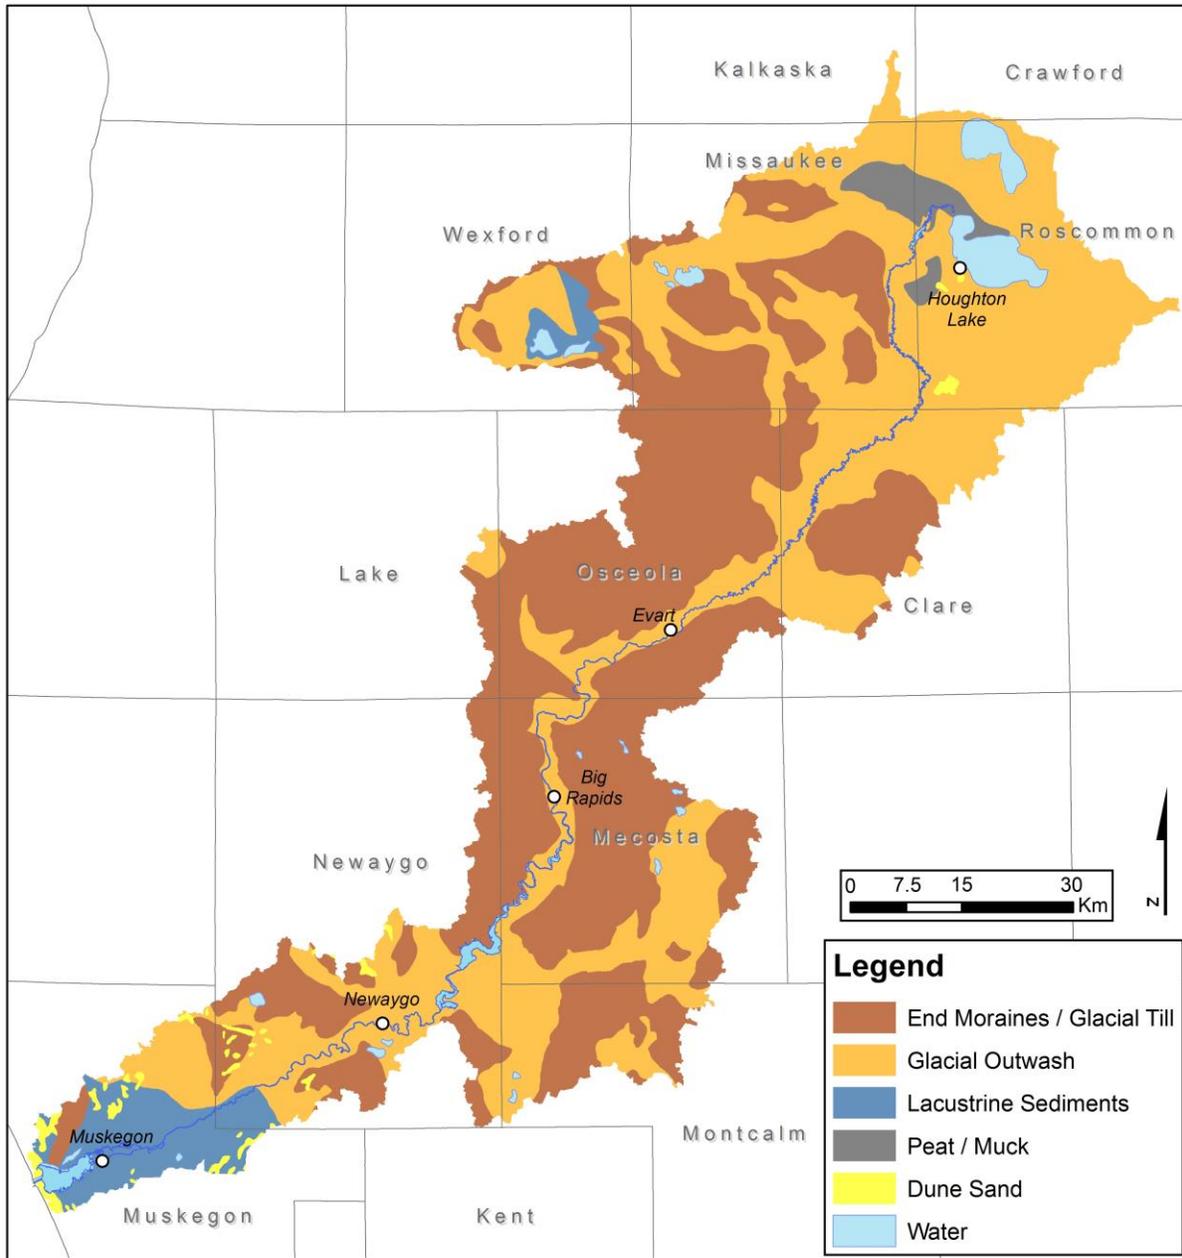
**Figure 5.1.** A Quaternary geology map of the Muskegon River Basin. Note that the stream flows largely on glacial outwash until it reaches the lower reach, where the stream flows on lacustrine sediments. Also note that the stream is confined by several end moraines in the middle reach.

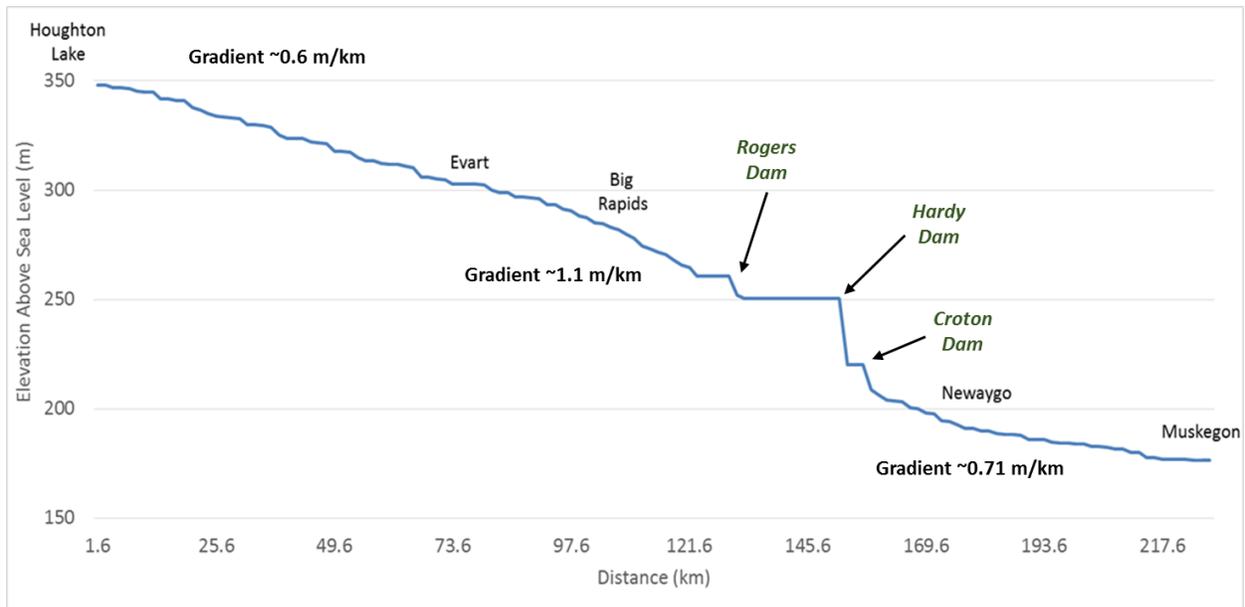
**Figure 5.2.** Longitudinal profile of the Muskegon River.

As the Muskegon River flows into Osceola and Mecosta Counties channel gradients increase (Table 5.1; Figure 5.2), averaging 1.1 m per km. Higher gradients in this portion of the basin are related to the surrounding Cadillac Morainic Uplands (Schaetzl et al., 2013),

The Muskegon River below the Croton Dam has a lower gradient [0.71 m per km] than in the middle reach (Figure 5.2). This decrease in slope is likely associated with the stream flowing out of the Cadillac Morainic Uplands (Figure 5.1) into a portion of the basin with more moderate relief (i.e., the Fruit Ridge Terrain; Schaetzl et al., 2013). In this reach, several high (i.e.,  $\sim 15$  m) sandy cutbanks are apparent, indicating that the channel has incised considerably into the surrounding Newaygo Outwash Plain (Figure 5.5). Several large hills (i.e., likely remnants of the Lake Border Moraine) also surround the Muskegon

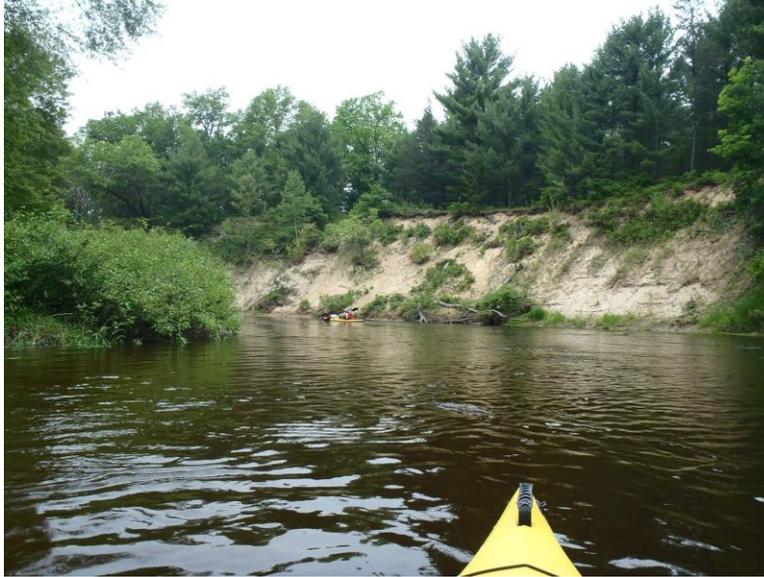
**Figure 5.3.** A high cutbank in the upper reach of the Muskegon River (photographed by author).

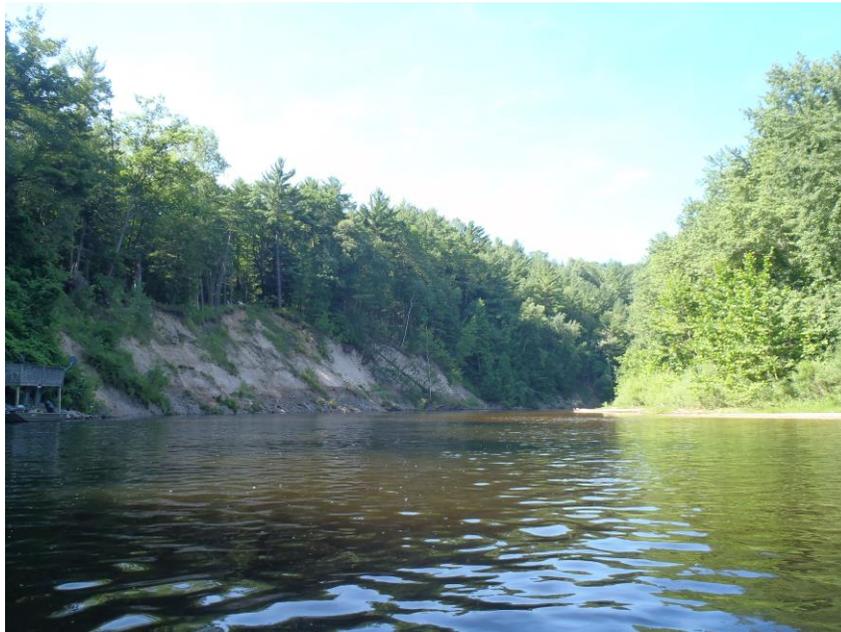
**Figure 5.5.** A high cutbank on a meandering stretch of the lower Muskegon River, near Croton (photographed by author).

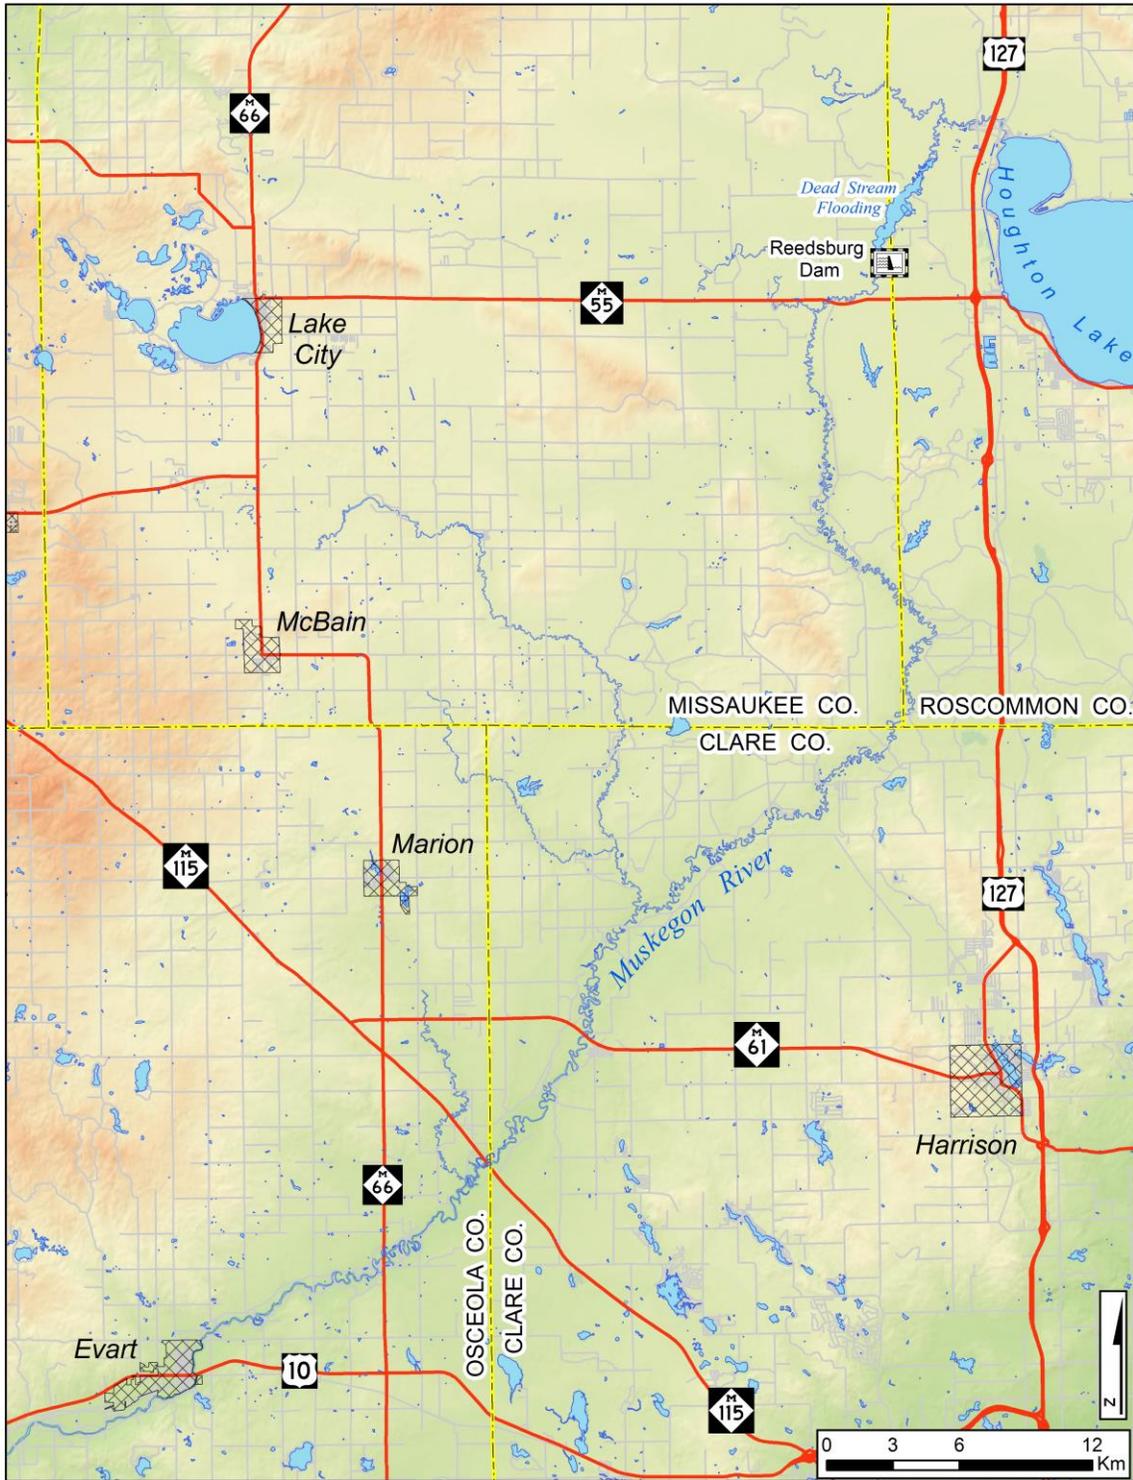
**Figure 5.6.** Map of the upper Muskegon River. In this reach the stream has a distinct meandering pattern, with sinuosity values up to  $\sim 3.2$ .

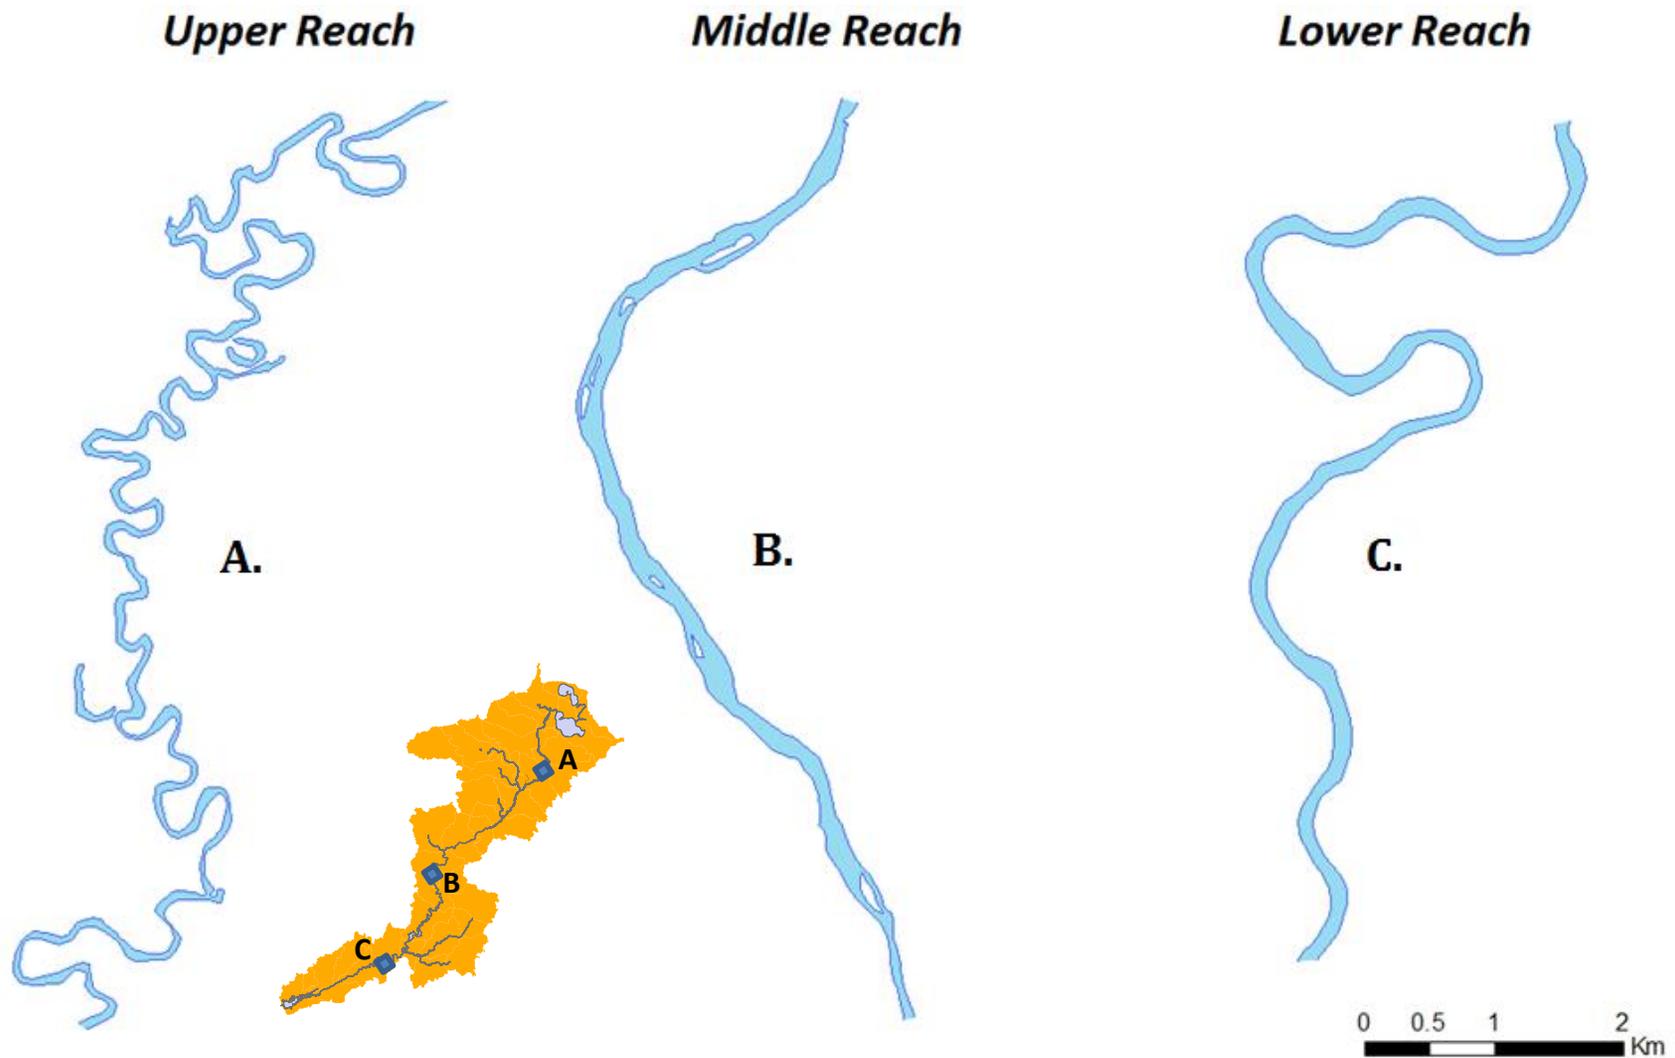
**Figure 5.7.** Representative meandering patterns for the distinct reaches of the Muskegon River. A.) the tortuously meandering upper reach, B.) the less sinuous to almost straight middle reach, and C.) the moderately meandering lower reach. Note the differences in channel sinuosity, width, and pattern between the reaches.

As the Muskegon River flows into Mecosta County south of Hersey (Figure 5.8), the stream becomes much straighter, with large/broad meanders (Table 5.1; Figure 5.7 B.). Channel sinuosity in this middle reach drops substantially, ranging between 1.5 to 1.1. This change is also reflected by large radius of curvature values that increase to between 231 m and 876 m. Meander wavelength and amplitude in this reach are similar to those in Osceola County, ranging from  $\sim 1.8$  to 2.6 km, respectively. While this reach is similar to the upstream portion of the Muskegon River in Osceola County, some important differences occur, such as distinct riffle-and-pool sequences, large rapids, and several mid-channel bars (Figure 5.7 B.). These features are likely a product of local alternating energy losses/gains and sediment loads due to a higher gradient. The gradient of the middle reach is

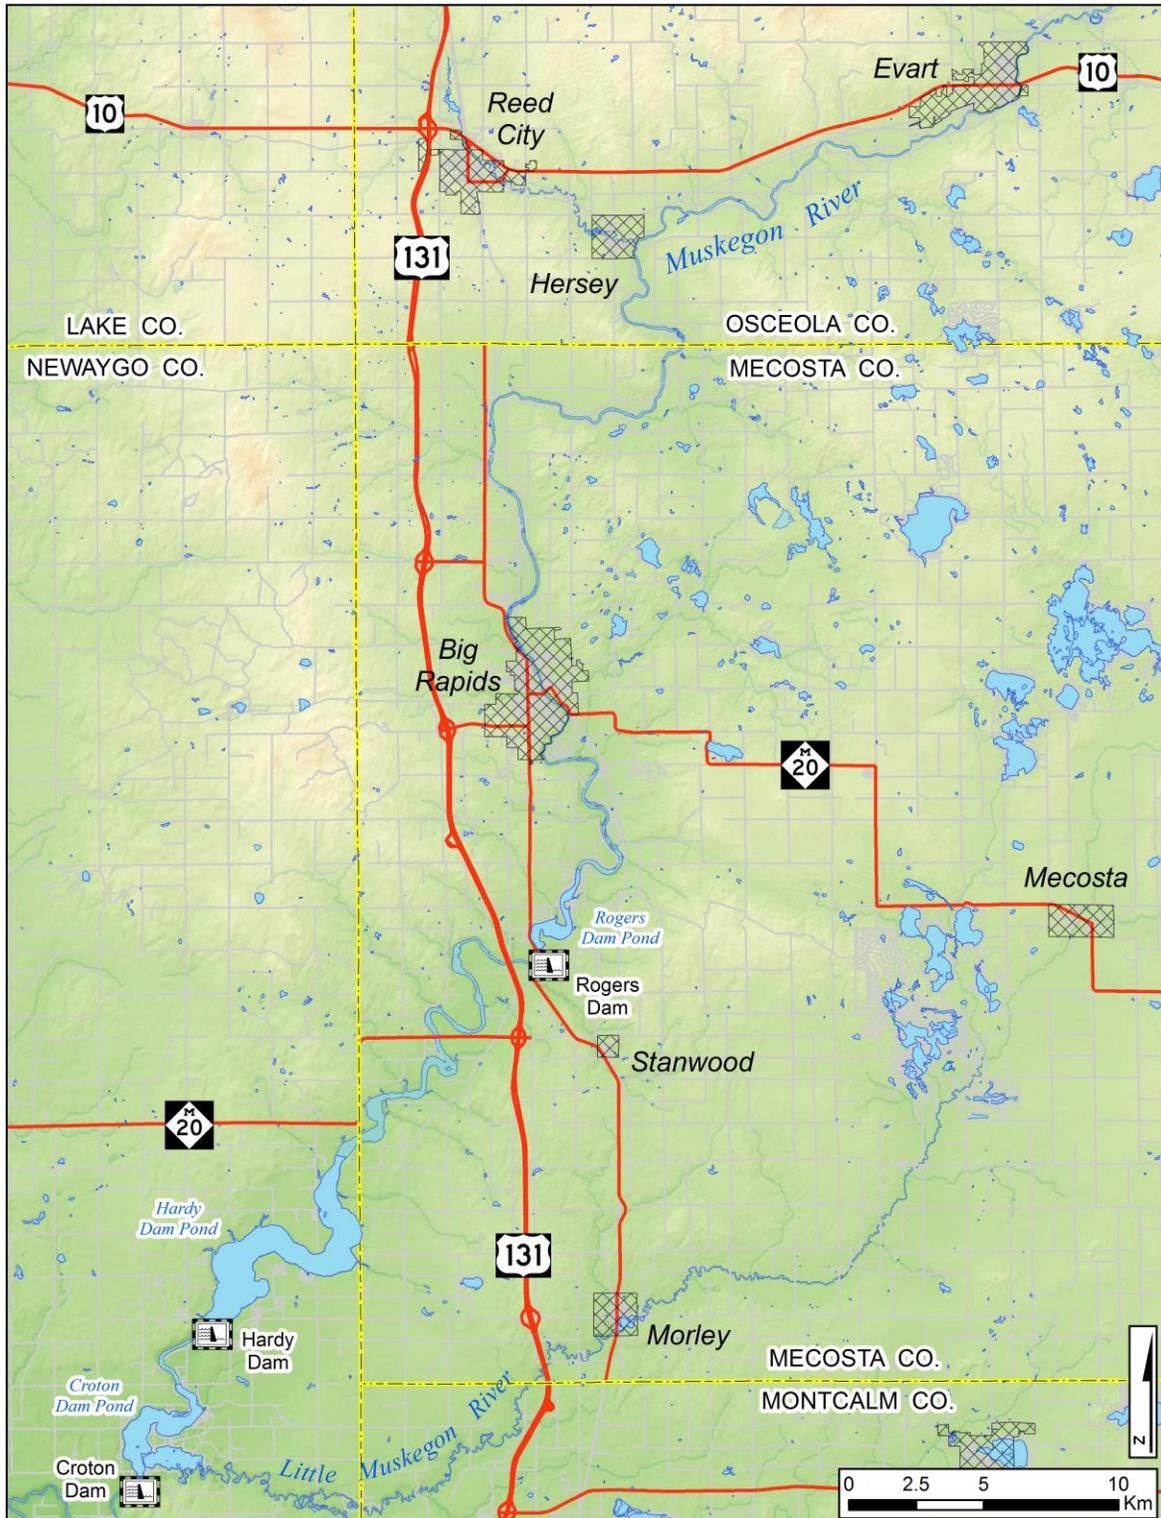
**Figure 5.8.** The middle reach of the Muskegon River between Ewart and the Hardy Dam. Note the broad, sweeping meanders in southern Osceola and northern Mecosta Counties, as well as Rogers, Hardy, and Croton Dams.

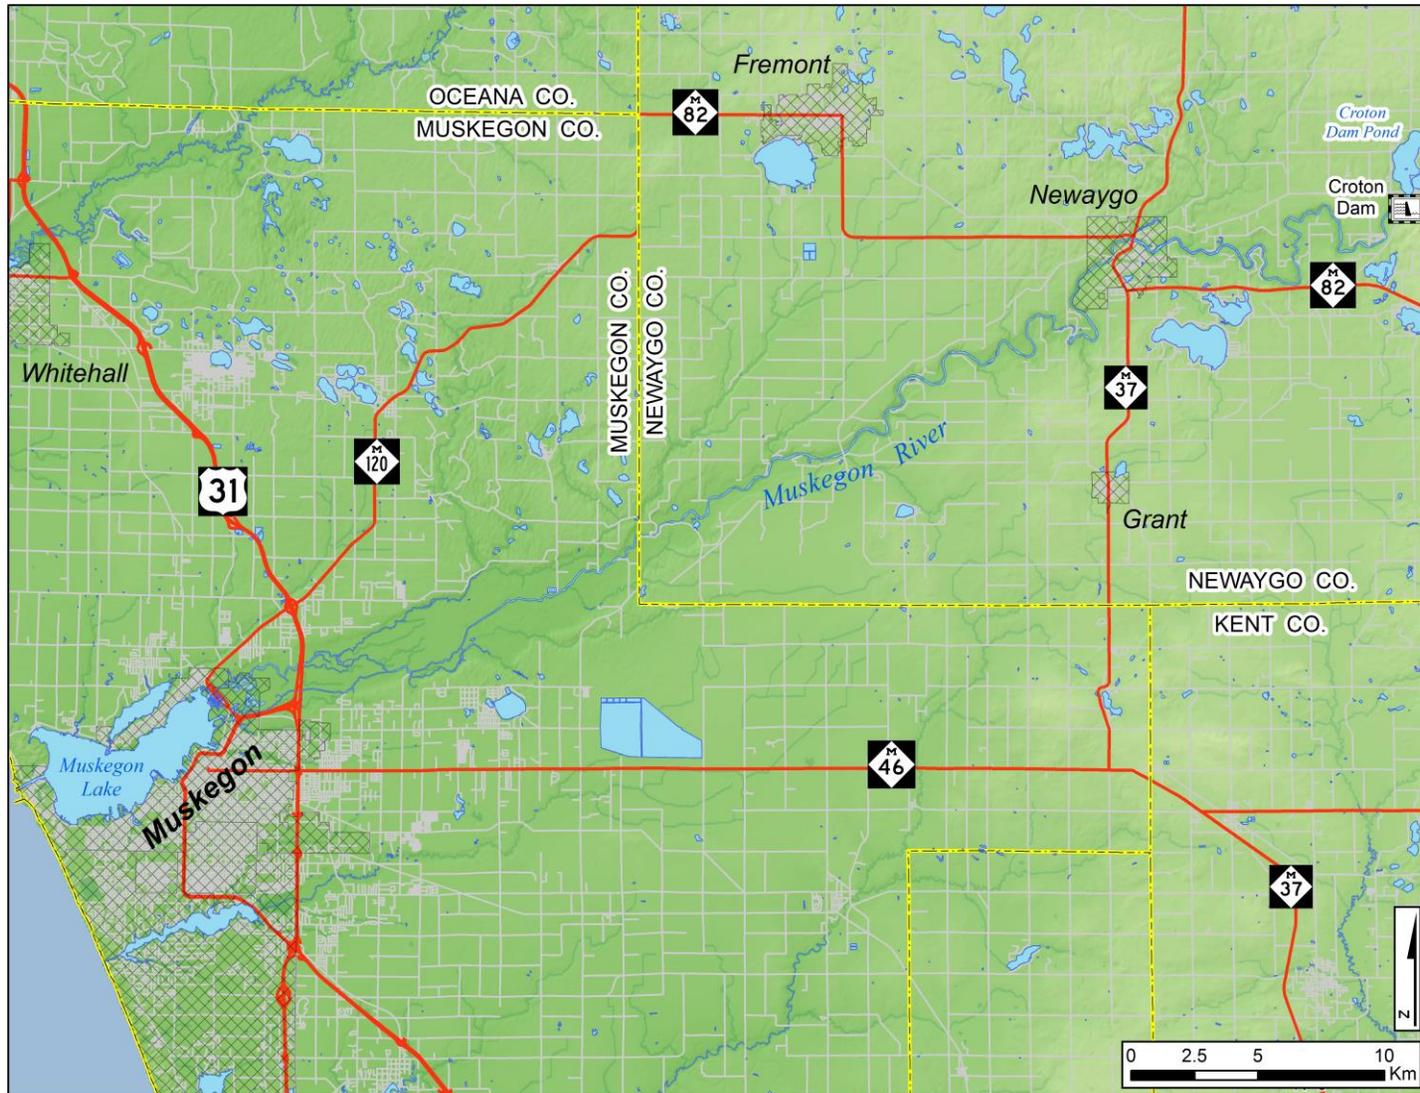
**Figure 5.9.** The lower reach of the Muskegon River between the Croton Dam and Muskegon Lake. Note the moderately meandering portion of the stream in Newaygo County, as well as the anastomosing pattern in central Muskegon County.

Further downstream in Muskegon County, the channel becomes less sinuous (Figure 5.9), with a maximum sinuosity of  $\sim 1.4$ . The decrease in sinuosity also has a direct effect on radius of curvature values, which range between 114 and 197 m. In this reach, meander wavelength ranges from 0.2 to 0.45 km and amplitudes range from 0.32 to 0.51 km, both of which decrease as the stream becomes straighter. As the Muskegon River continues to flow downstream it takes the form of an anastomosing channel near Muskegon Lake (Figure 5.9). This pattern likely formed because the channel floods more frequently near Muskegon Lake, due to a relatively low valley gradient and high stream discharge (Nanson and Knighton, 1996).

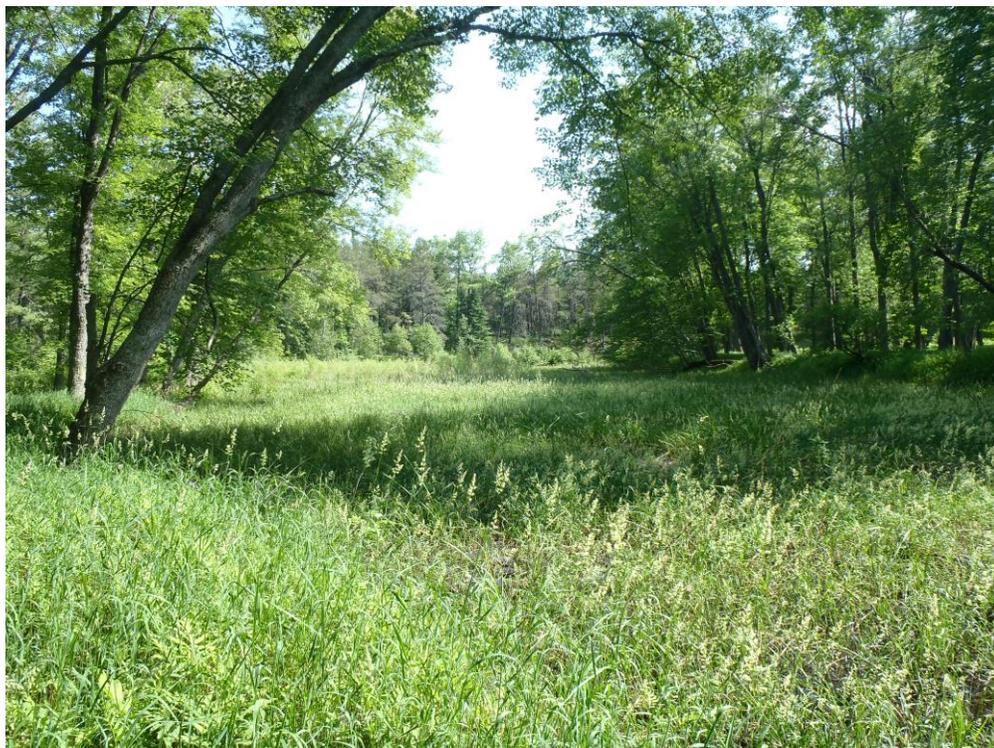
**Figure 5.10.** An oxbow from the upper Muskegon River. This portion of the stream was found to be abandoned in the 1960s using repeat photography (photographed by author).

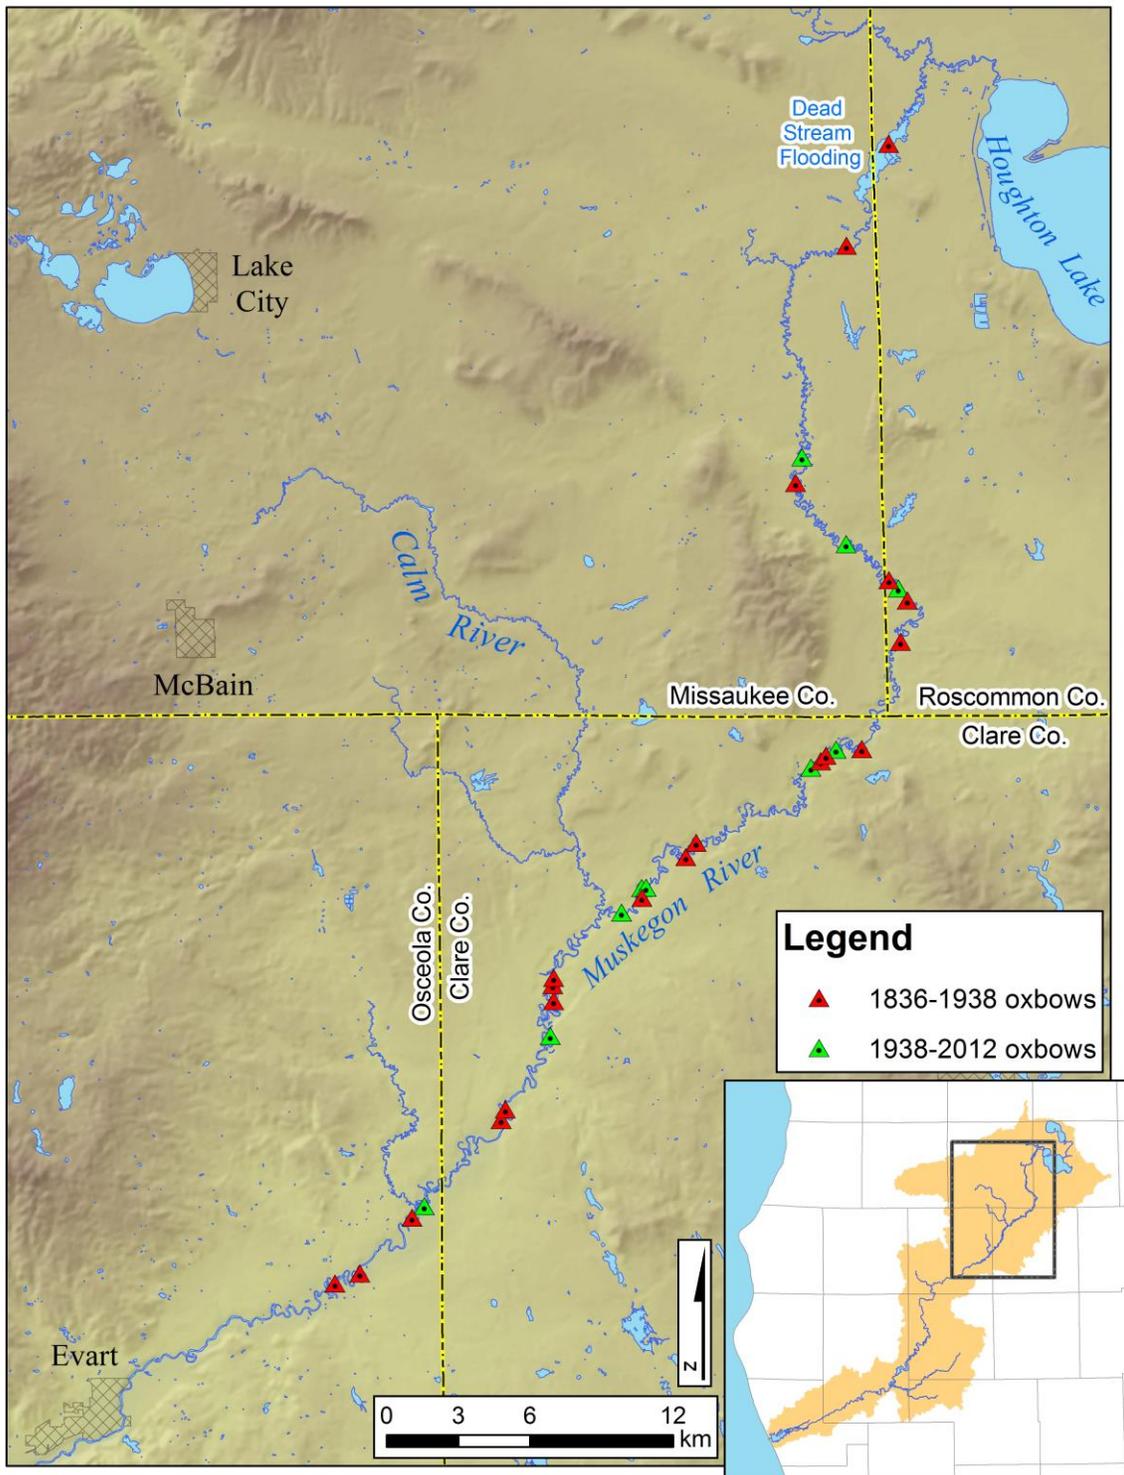
**Figure 5.11.** The location of abandoned meanders in the upper system during the historic record. Red triangles represent oxbows that formed between 1836 and 1938, whereas orange triangles represent oxbows forming between 1938 and 2012. Note the spatial extent of channel change between the two periods.

As the Muskegon River flows into Osceola County, the number of abandoned meanders progressively decreases (Figure 5.11) until none occur downstream of the M-66

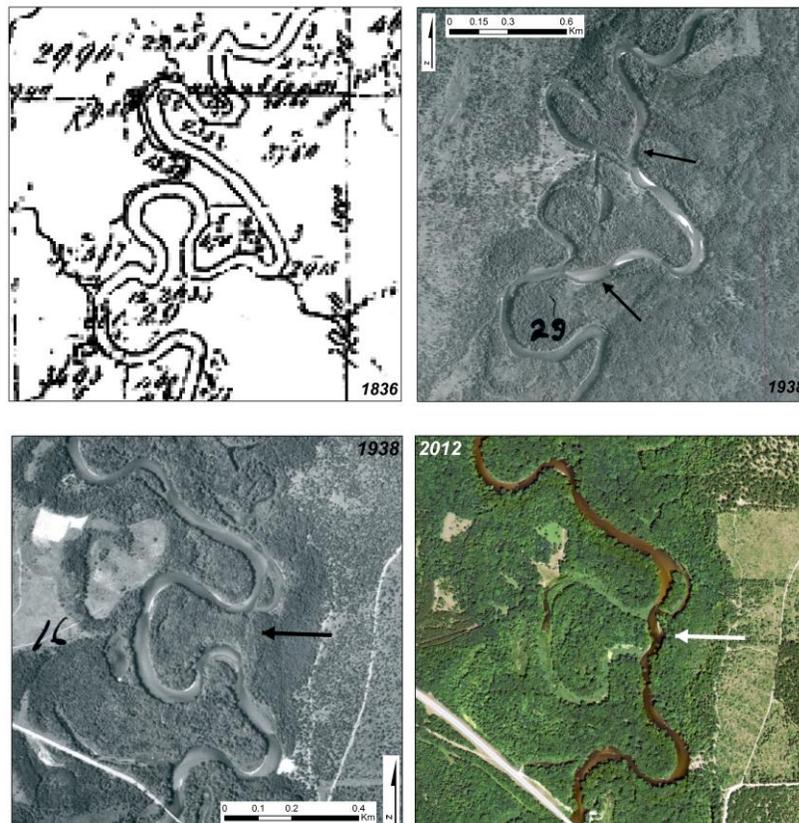
**Figure 5.12.** Historic meander cutoffs (arrows) from two separate areas in the upper part of the Muskegon River system.
