HISTORIC CHANNEL CHANGES IN THE MUSKEGON RIVER, NORTH-CENTRAL MICHIGAN,  
USA

A THESIS

Geography - Master of Science

2015

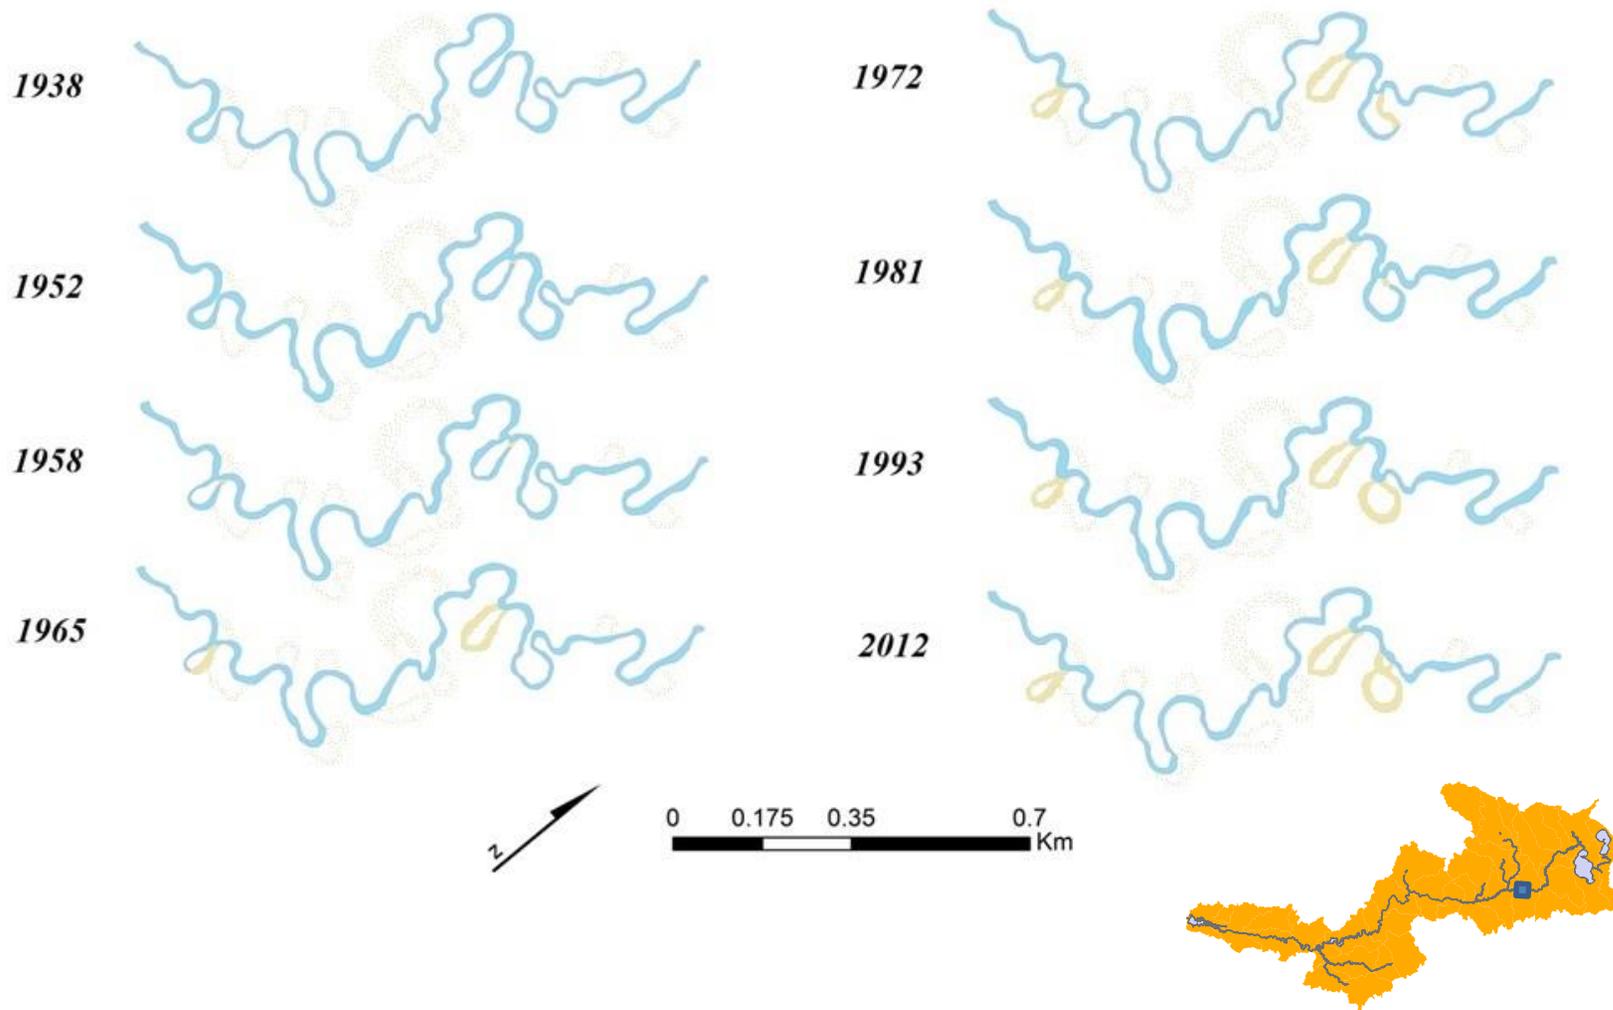
**Figure 5.13.** The progression of channel changes on a highly sinuous reach of the upper Muskegon River between 1938 and 2012. Note the series of abandoned meanders (i.e., light green) that have formed during the time period.

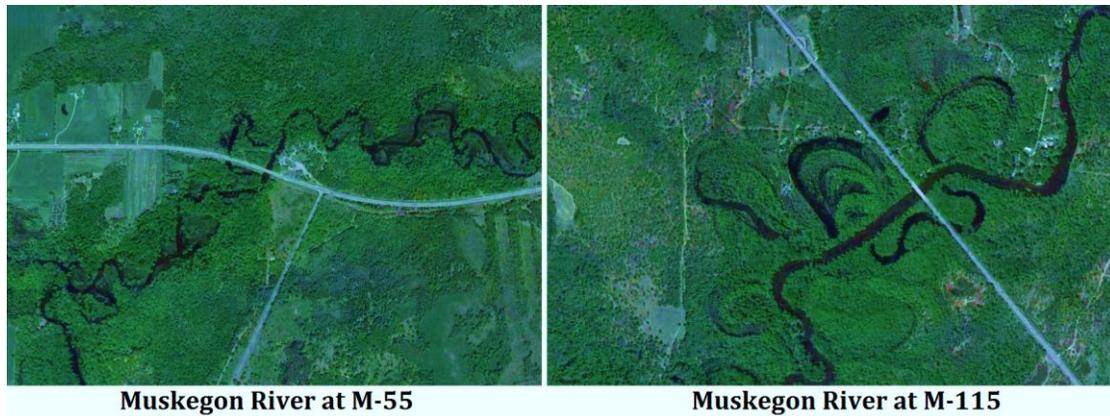
**Figure 5.14.** Aerial images showing the effects of channel dredging. Note the straightened reaches at the M-55 and M-115 Muskegon River overpasses.

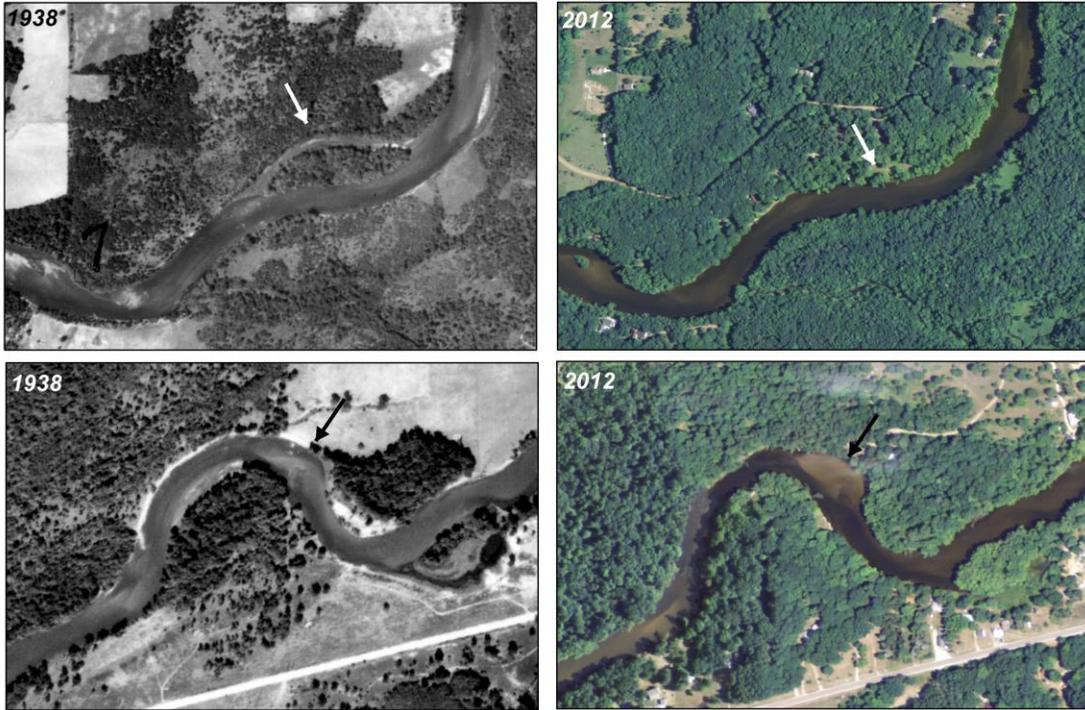
**Figure 5.15.** Aerial images showing representative locations of channel change on the middle reach of the Muskegon River. Note that arrows indicate an area of channel change.

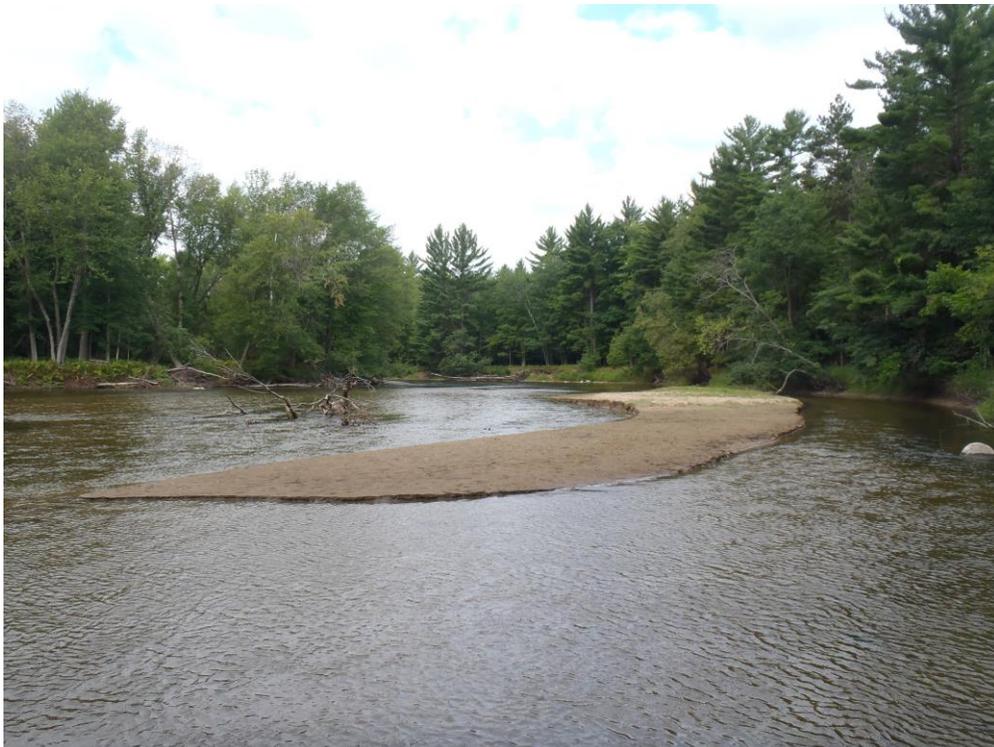
**Figure 5.16.** A mid-channel bar downstream from Evart (photographed by author).

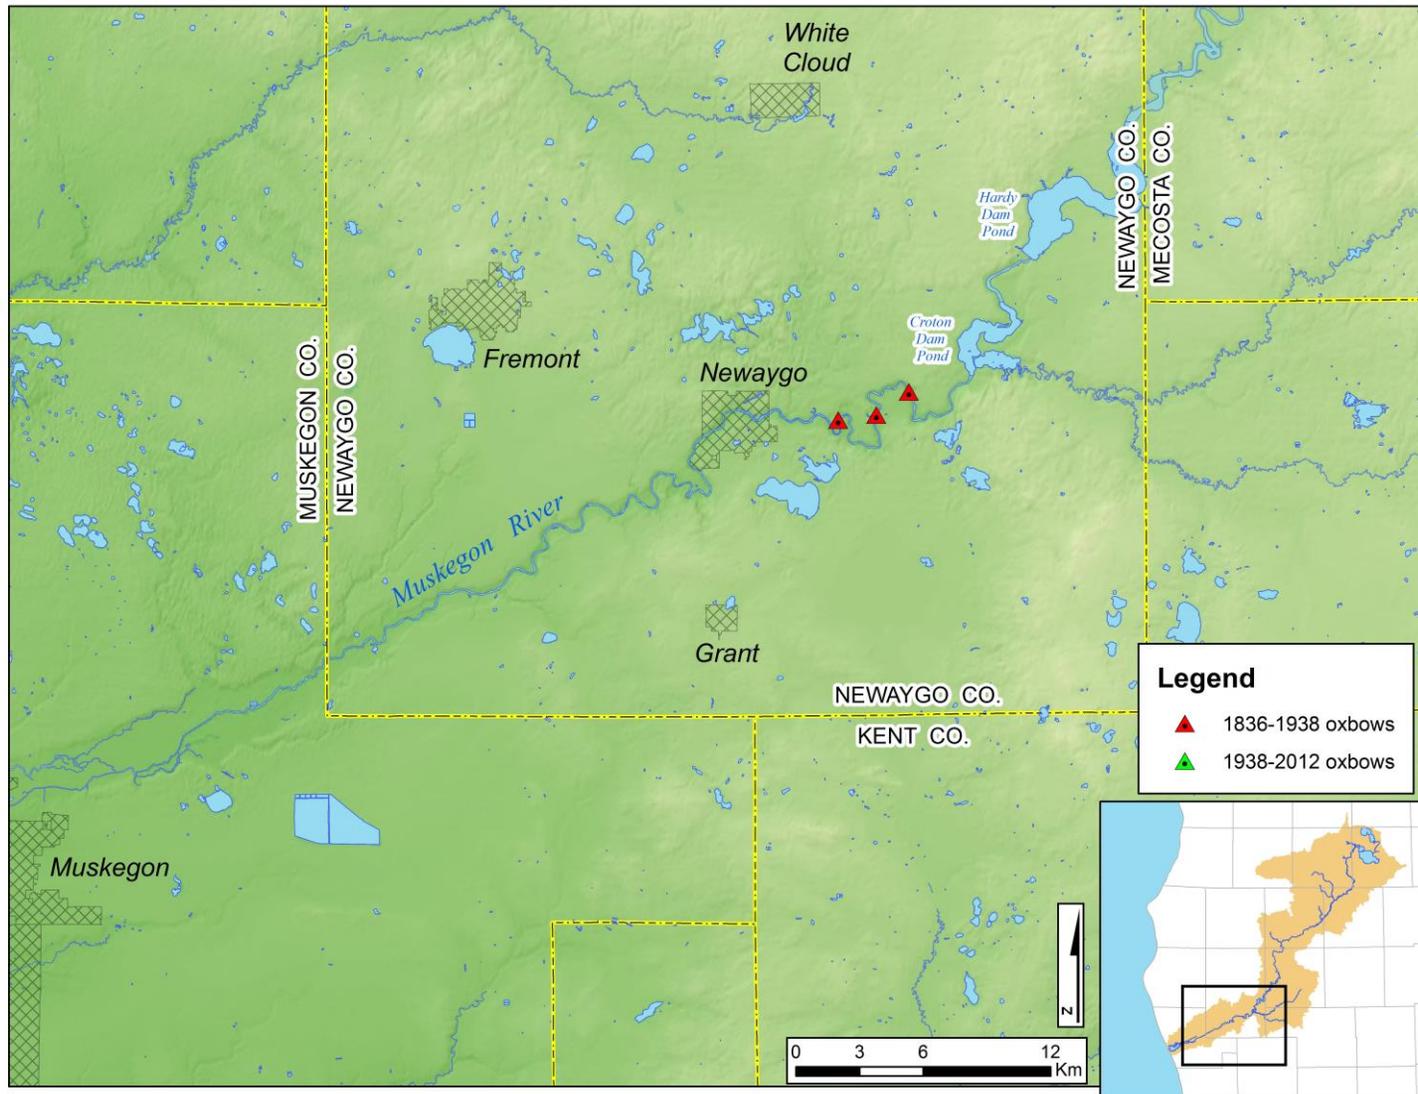
**Figure 5.17.** The location of abandoned meanders in the lower system during the historic record. Red triangles represent oxbows that formed between 1836 and 1938.

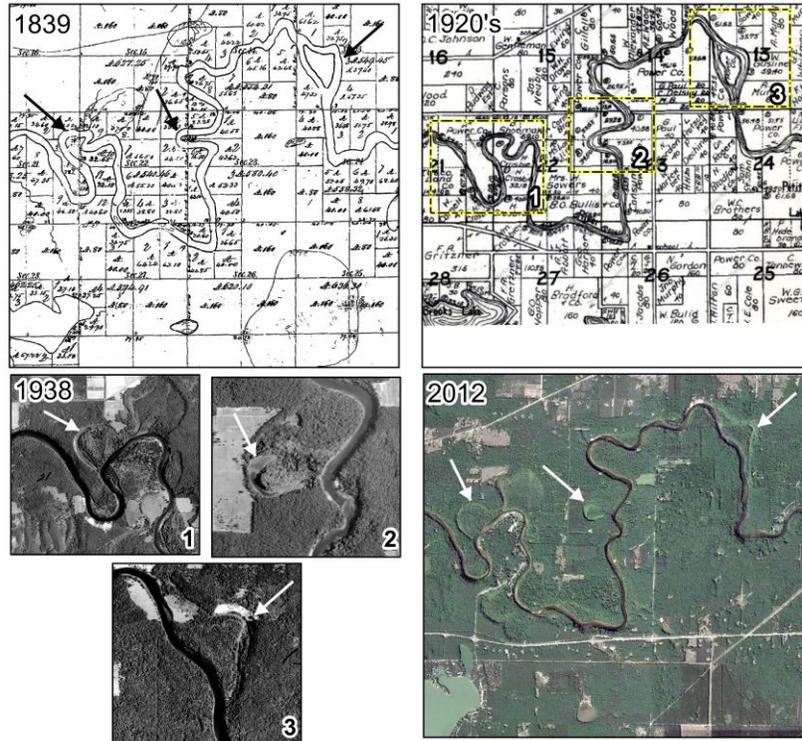
**Figure 5.18.** Survey map (1839), plat map (1920s), and aerial imagery (1938 and 2012) showing channel changes that occurred in the lower reach of the Muskegon River. Note that arrows indicate the location of abandoned meanders.

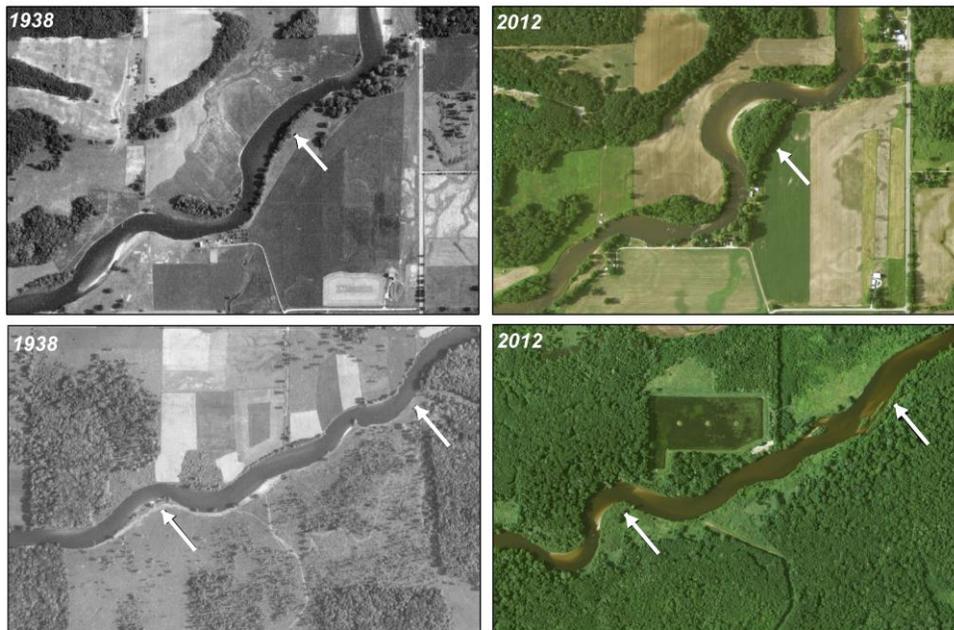
**Figure 5.19.** Aerial images showing locations of channel change on the lower reach of the Muskegon River. Note that arrows indicate an area of channel change.

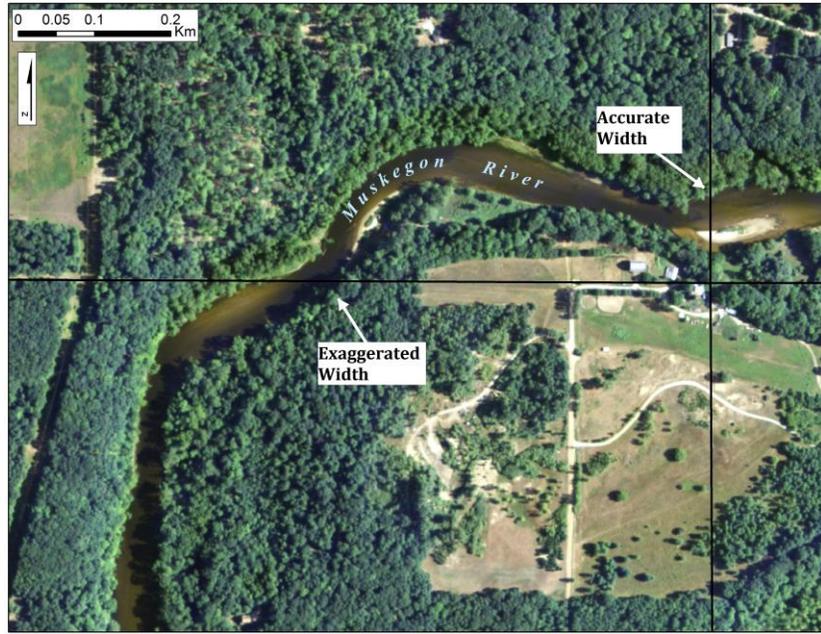
**Figure 5.20.** Examples of accurate and exaggerated channel widths when using the section line methodology.

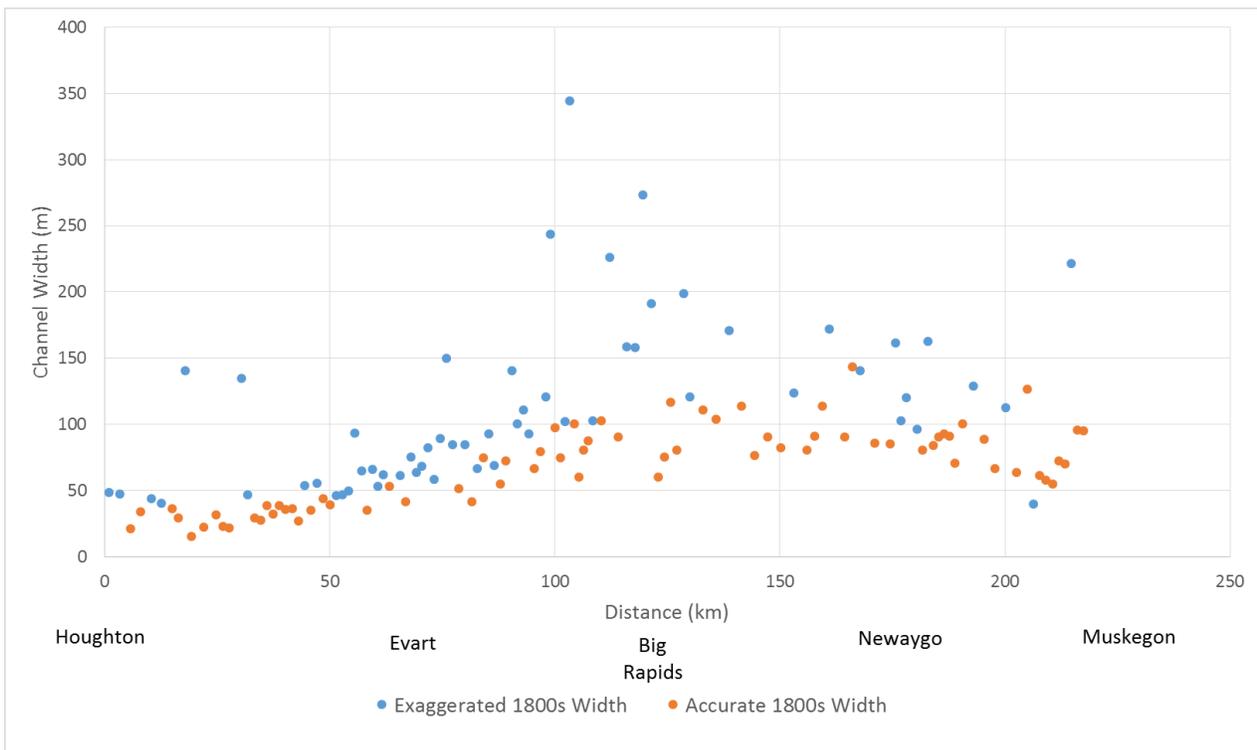
**Figure 5.21.** Initial survey measurements of channel width on the Muskegon River. Blue dots represent widths that are considered exaggerated, whereas orange dots represent accurate widths.

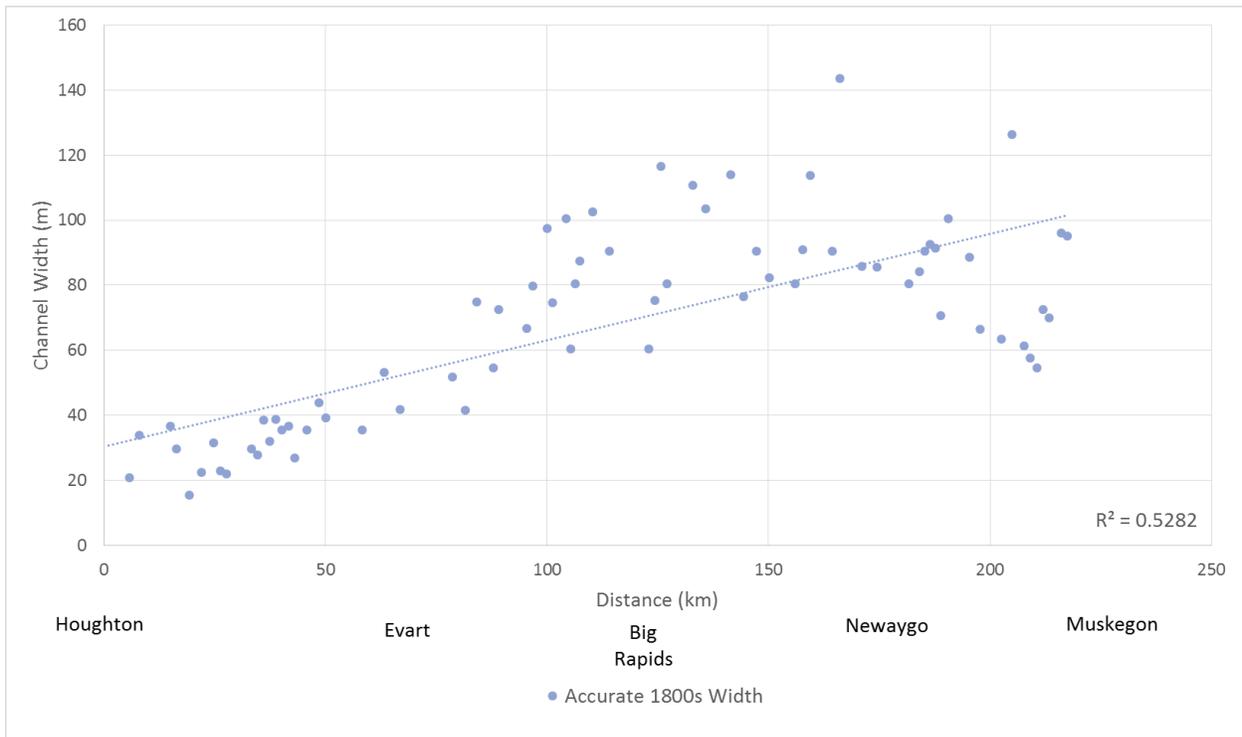
**Figure 5.22.** Accurate Muskegon River channel widths from the initial survey.

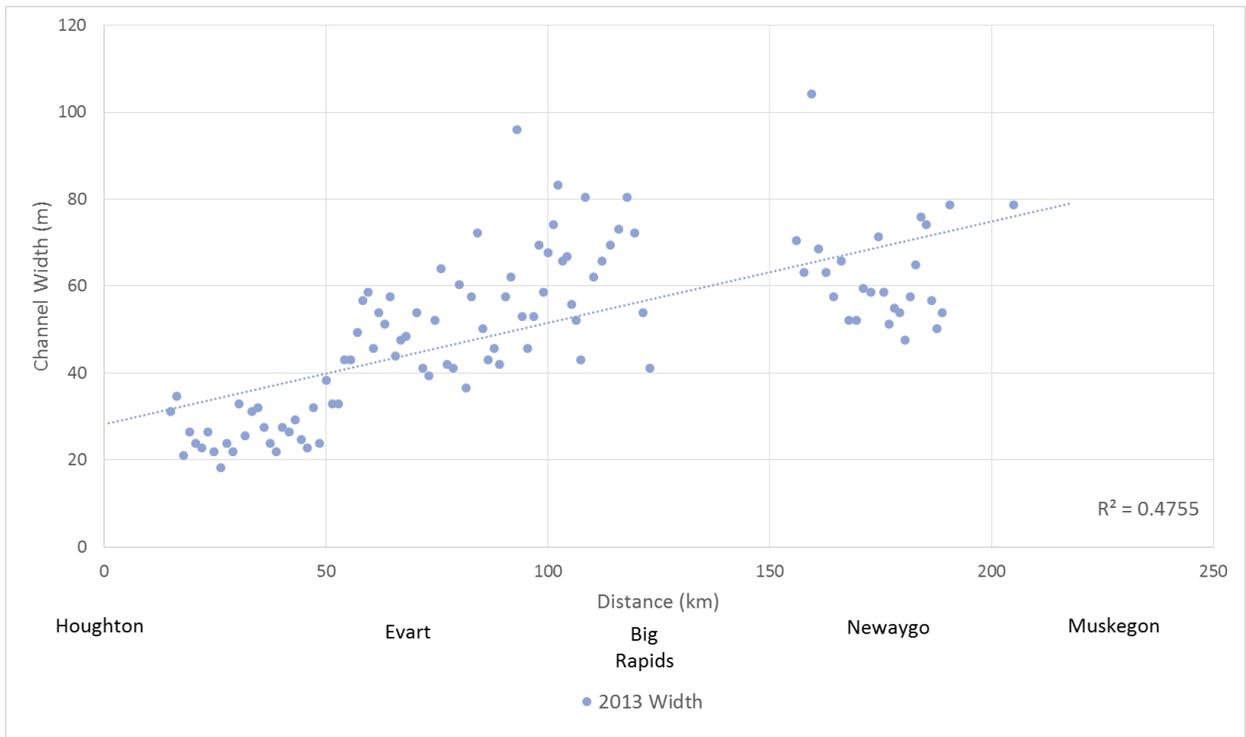
**Figure 5.23.** Muskegon River channel widths from the summer of 2013.

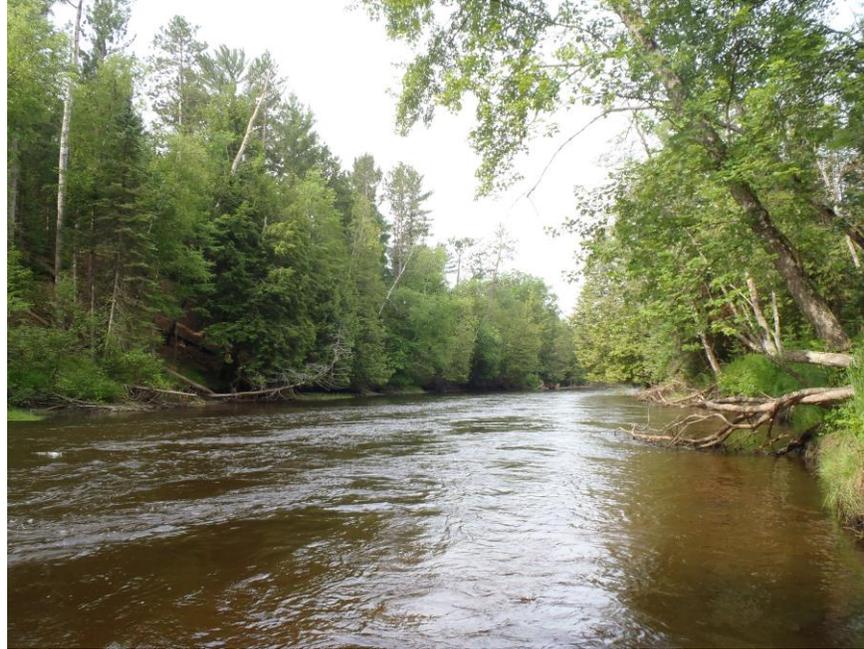
**Figure 5.24.** A photograph showing the typical stream width of the Muskegon River between Houghton Lake and Clare County (photographed by author).

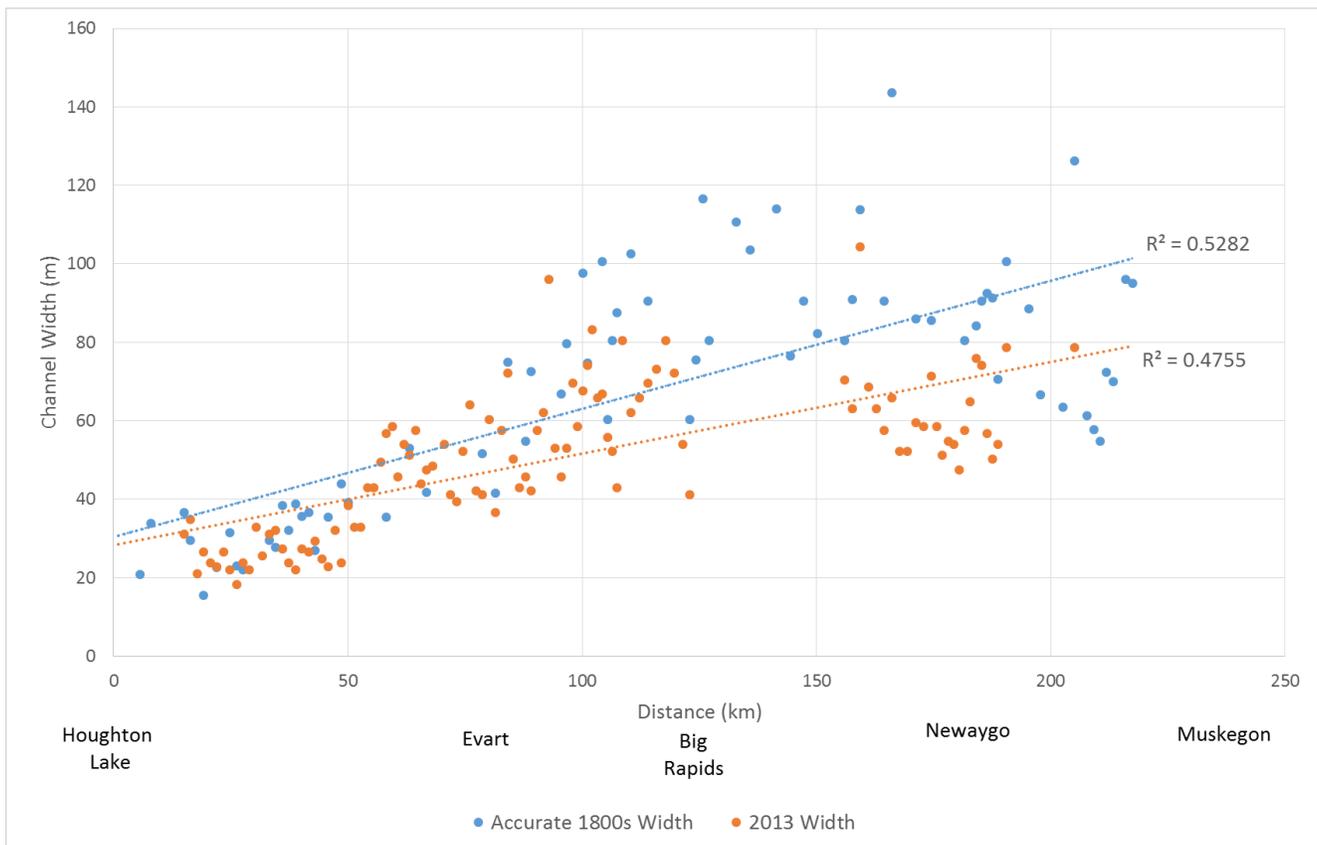
**Figure 5.25.** Channel widths recorded on the Muskegon River during the initial survey and the summer of 2013.

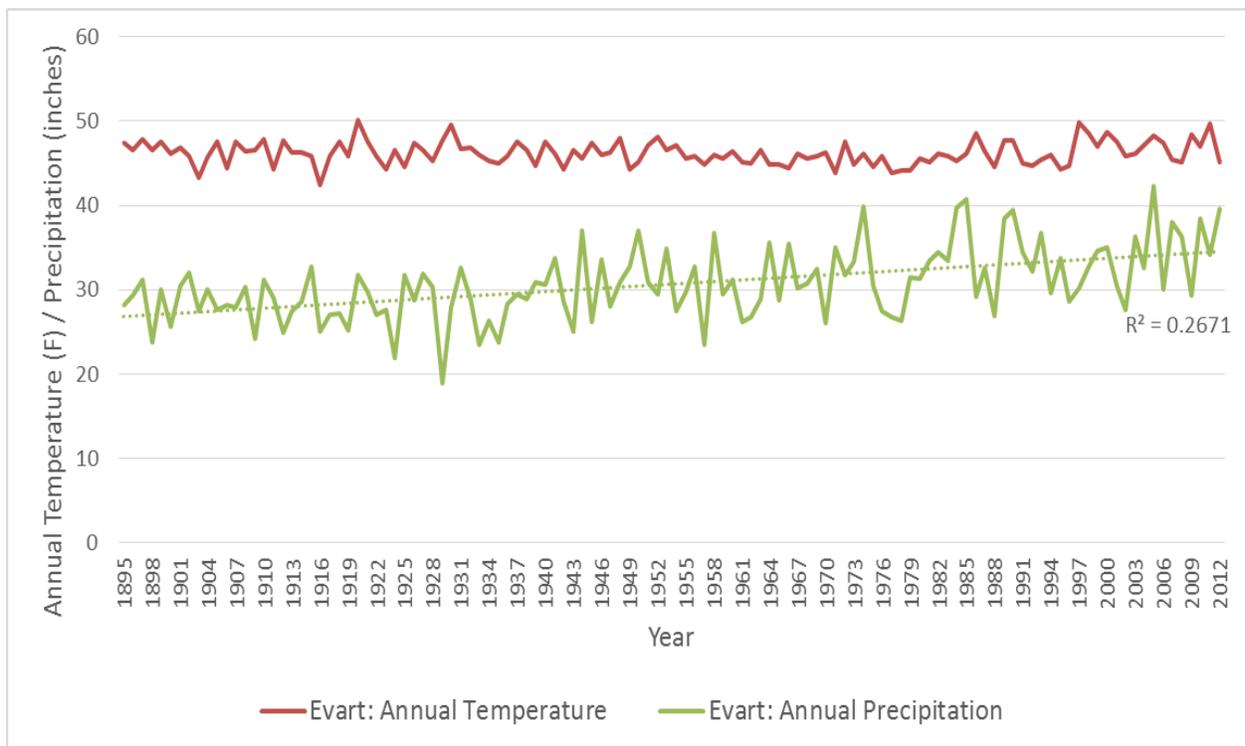
**Figure 5.26.** Annual temperature and precipitation at Evert since 1895. (adopted from Midwestern Regional Climate Center, 2014)

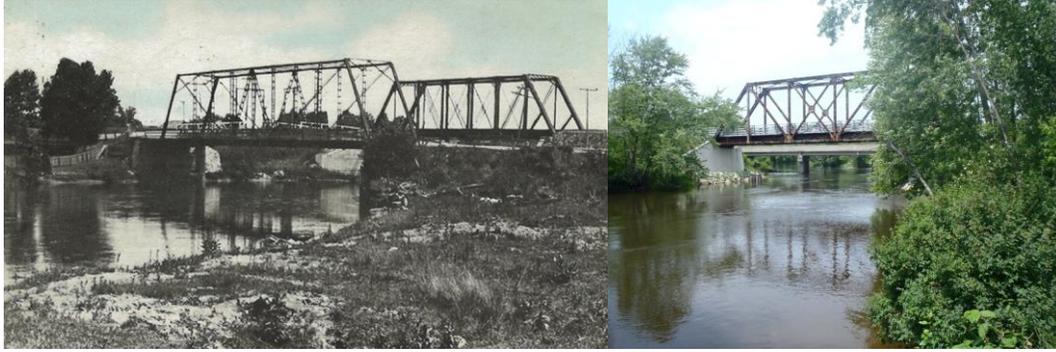
**Figure 5.27.** The revegetation of a channel reach in Ewart from 1919 (left: unknown) to 2013 (right; photographed by author).

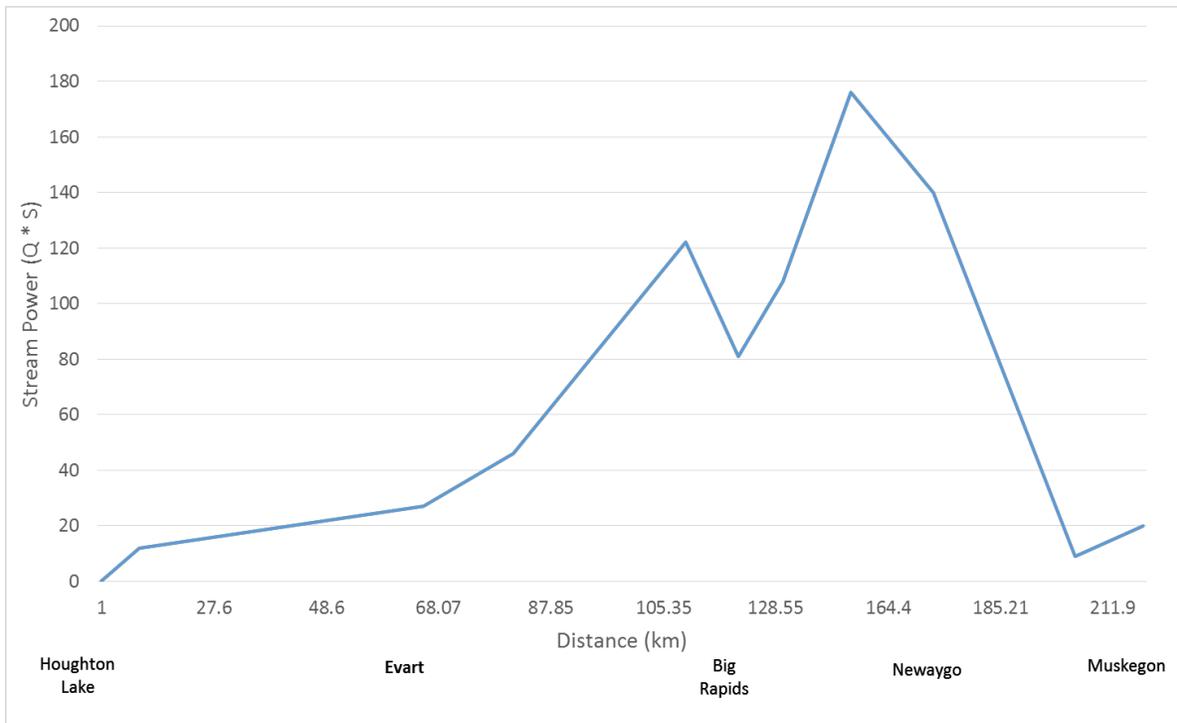
**Figure 5.28.** Present-day estimated stream power for the entire Muskegon River.

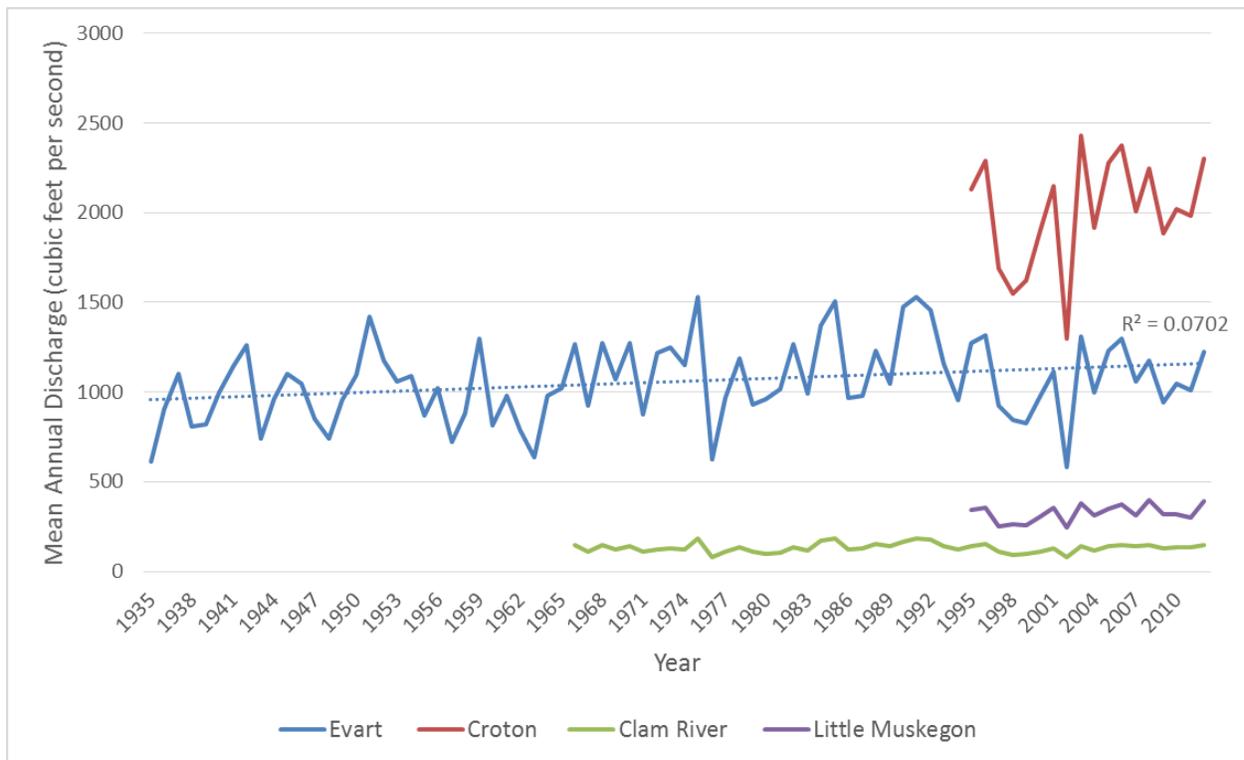
**Figure 5.29.** Annual mean discharge records of gauges in the Muskegon River basin. (adopted from USGS, National Water Information System: Web Interface)

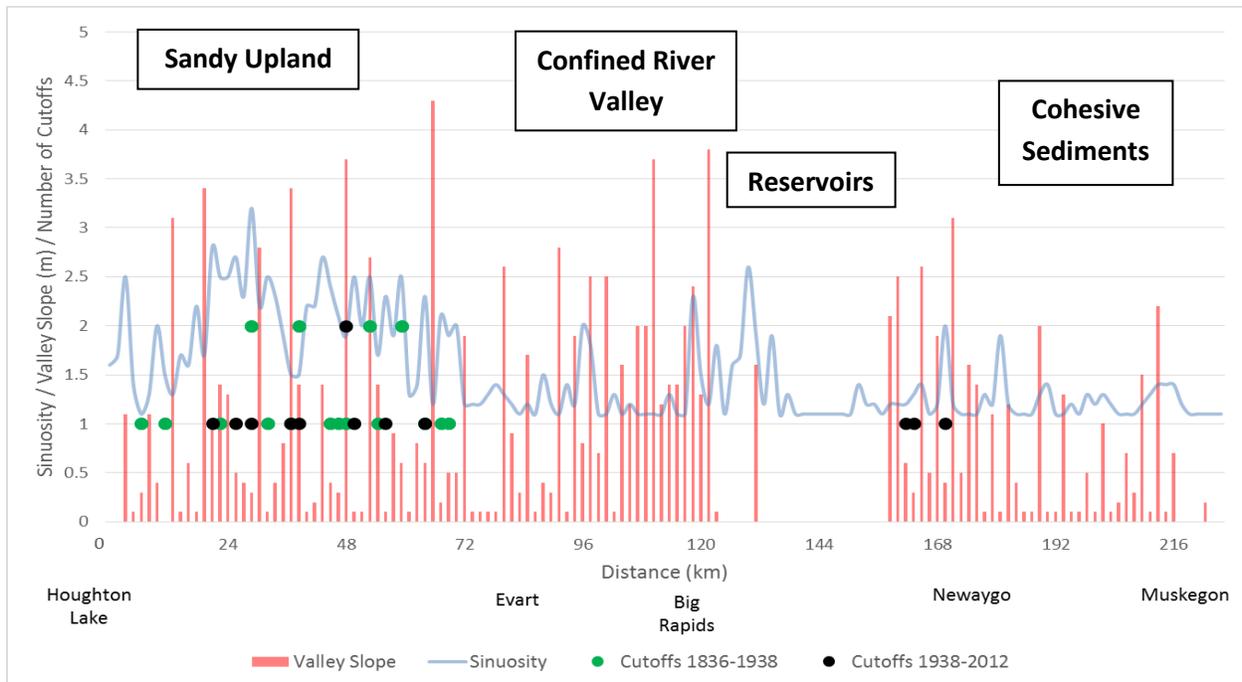
**Figure 5.30.** Average of sinuosity and channel slope measurements for the entire reach of the Muskegon River. Black dots represent meanders cutoffs that occurred between the initial survey and 1938, whereas the red dots represent cutoffs forming between 1938 and 2012. Note the character of the stream in the sandy upper reach, confined middle section, and on the silty lake-plain sediments of the lower reach.

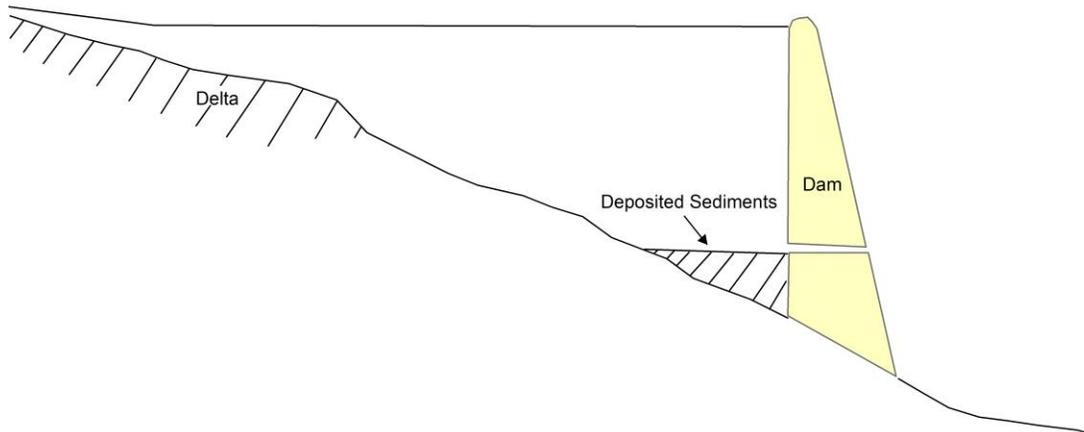
**Figure 5.31.** Diagram illustrating coarse bedload being deposited behind a dam as dead storage, while suspended fines are released as regulated flow. (modified from Childs, 2010)

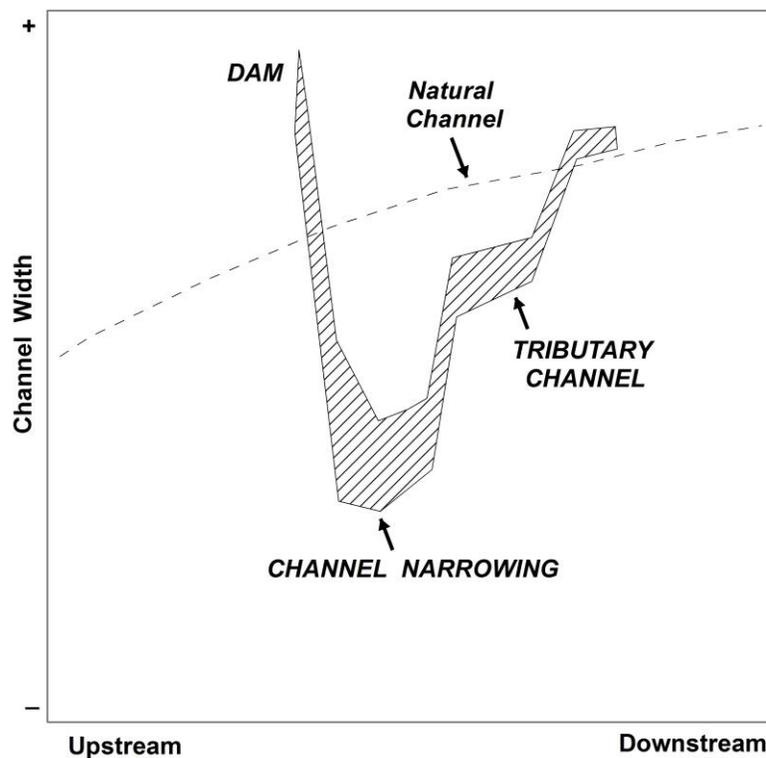
**Figure 5.32.** Channel responses to stream damming. Note how the channel narrows in response to stream damming. Prolonged narrowing may occur below dams at the confluence of tributary channels, as additional sediment enters the system. (modified from Petts, 1980)

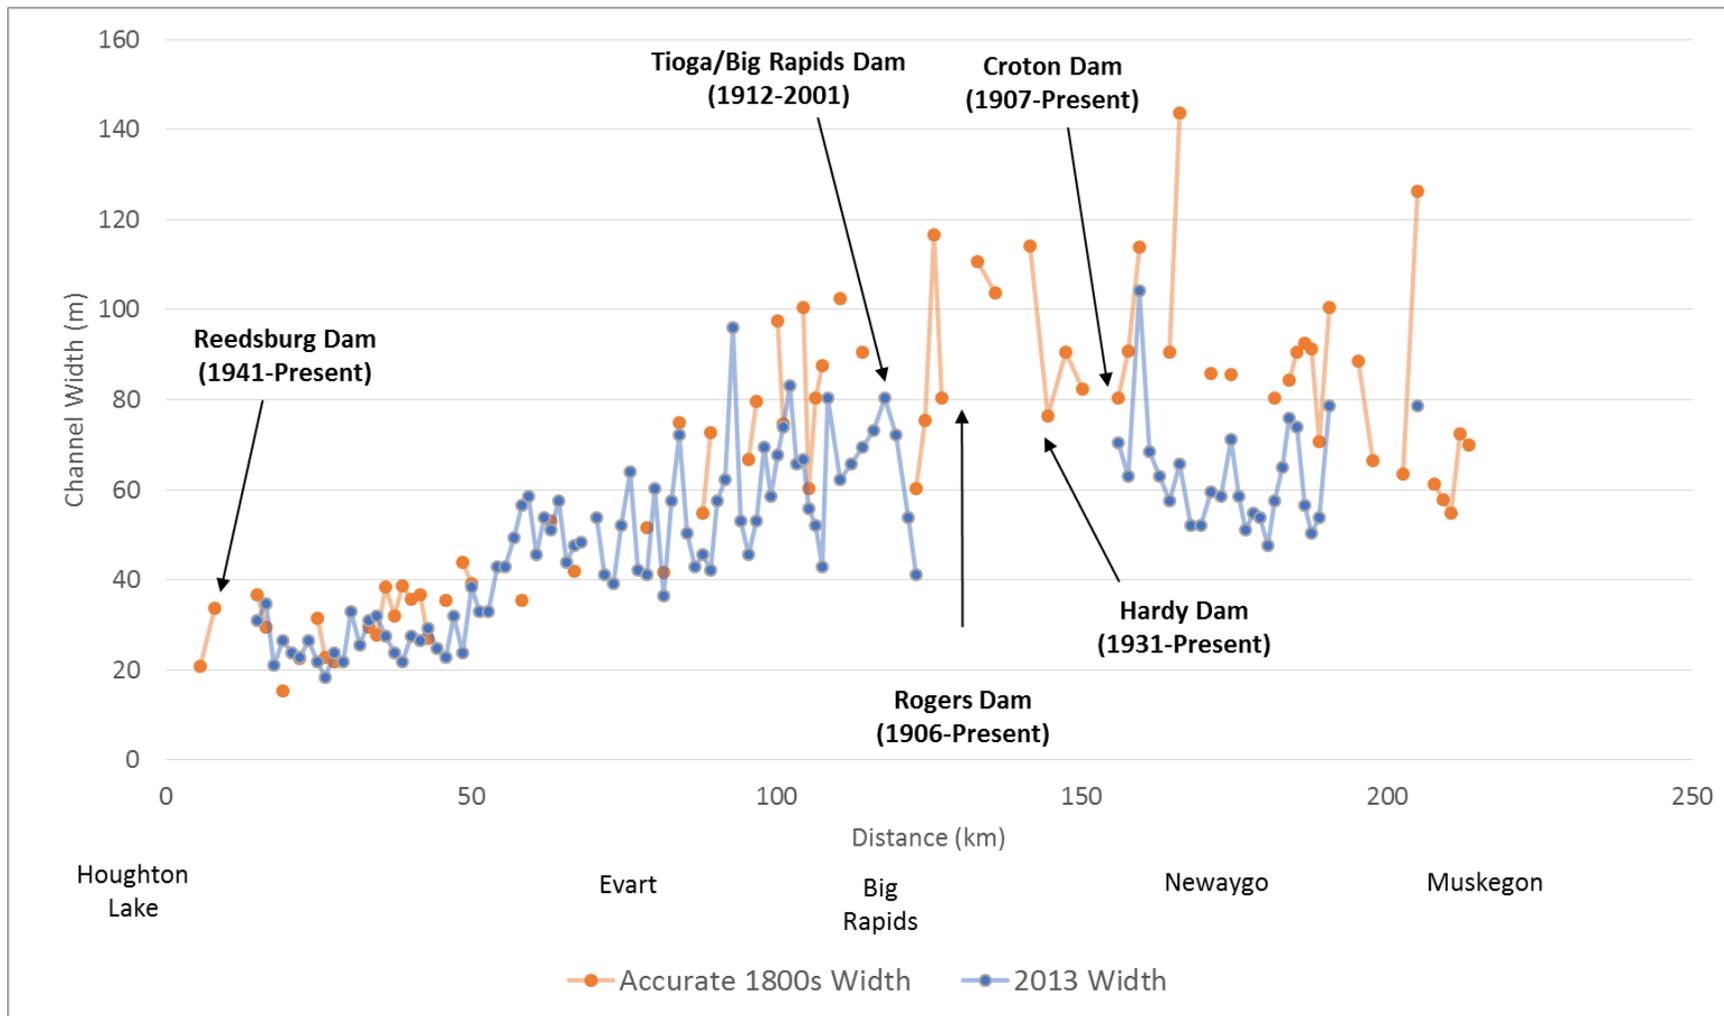
**Figure 5.35.** Diagram showing 1800s and 2013 channel widths and channel narrowing below past and present dams.
