THESIS  
THE DESIGN AND CONSTRUCTION  
OF A RETAINING WALL  
AT L'ANSE, MICH.

The Design and Construction of a Retaining Wall.

Candidate for the degree of  
Bachelor of Science.

February, 1920.

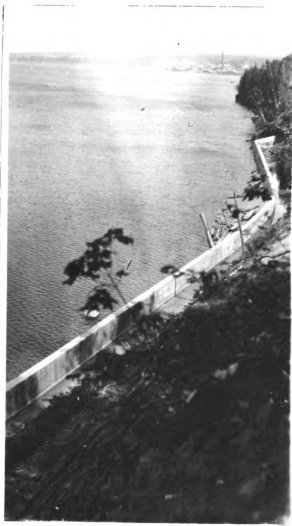
The Completed Wall.

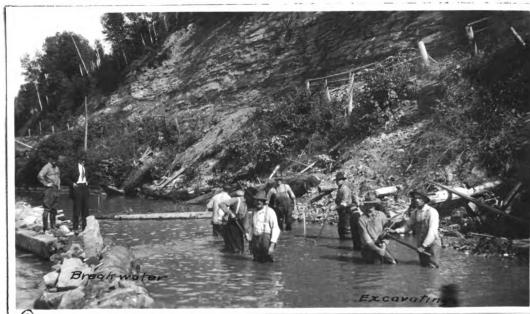
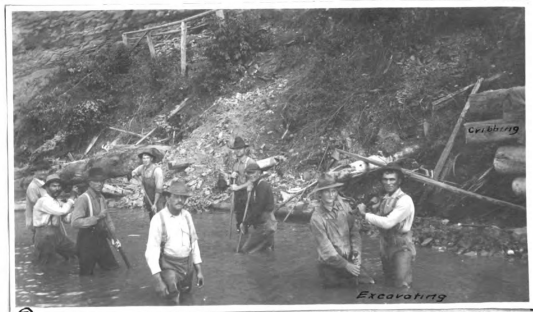
In the excavation for the foundation of the wall, it was necessary to conduct the work on a State Force Account Basis. The material to be removed was composed mostly of beach sand and large loose rocks. To remove this material eight men were employed as shovelers and two men employed to blast away the larger of the rocks. The work of excavating began July 29th, 1919. The dirt removed being used to form a breakwater to protect the trench from the action of the water. As the work progressed, it was found necessary to build a more permanent form of breakwater. This was accomplished by chaining two or more logs together and sinking them in the desired position by means of rock, removed from the trench. The accompanying photographs show more clearly how this was accomplished, and the conditions under which the men worked.

Due to the depth of the lake at the site the men were unable to wear boots or any other form of protection but worked in the water at times up to their arm-pits. Extremely bad weather made the work of excavating very slow and but thirty feet of the work was accomplished during the first week.

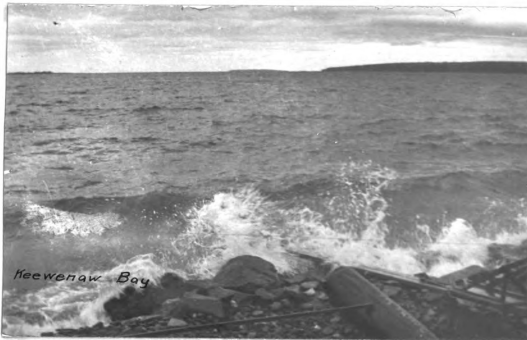
After the first week the work of excavating and placing of the tie rods just kept ahead of the construction company but at no time during the making of the wall were the forms setters hindered by lack of space in which to place the forms. During high winds it was necessary to keep a man with the form setters to clean out what dirt would wash in the trench. The breakwater helped considerably in protecting the excavation from the action of moderate waves but whenever a storm arose the low breakwater was of little value. Photo No.5 shows how just a light wind made the waves come in, and several times the wind was strong enough to drive the water as high as the road level.

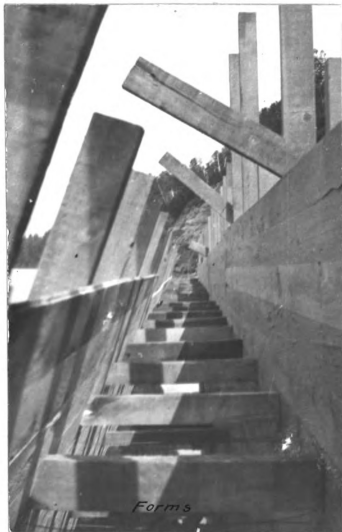
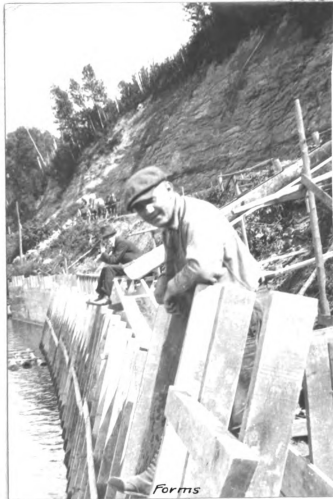
The following photos show clearly how the forms were set up and how the bracing was accomplished. The studs were placed two feet apart and the braces used to hold the sections apart were o two by four lumber.

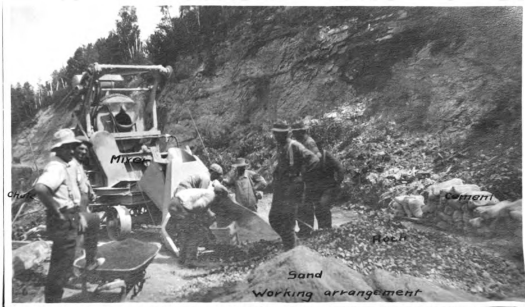
To place the concrete in the forms the mixer was placed on the road above and the concrete conveyed by troughs to the forms. The pump for forcing the water up to the mixer was placed on the shore of the lake and a one inch pipe laid along the road to a point about a thousand feet from the mixer where a section of pipe about twenty feet in length was raised into the air. To get water taps were provided along the pipe at convenient places. The object of the raised pipe was to give the mixer a uniform pressure and the length of pipe acting as a reservoir. The materials for mixing were arranged around the mixer as shown in the following photo.

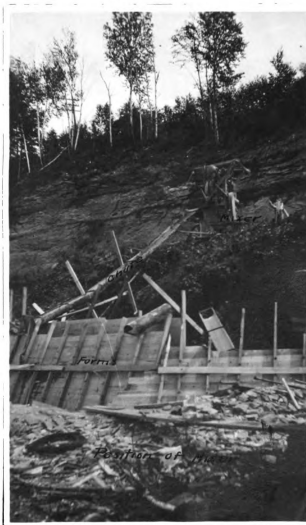
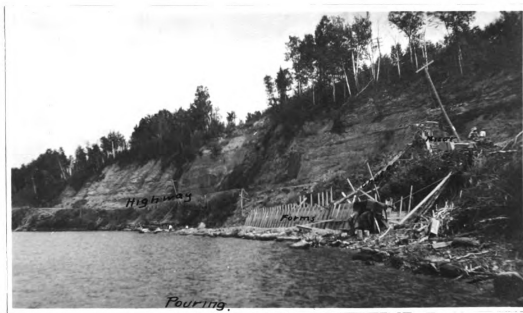
The next photo shows the relative position of the mixer forms and pump when at work. The angle of the chute changes for each location of the mixer.

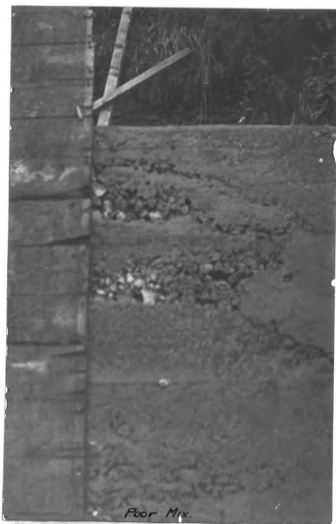
In order to have the concrete poured in horizontal layers the chute was placed in the middle of the section and the concrete from here spread by hand.
