BUCKLER, WILLIAM ROGER

RATES AND IMPLICATIONS OF BLUFF RECESSION ALONG THE LAKE
MICHIGAN SHOREZONE OF MICHIGAN AND WISCONSIN

Michigan State University

PH.D. 1981

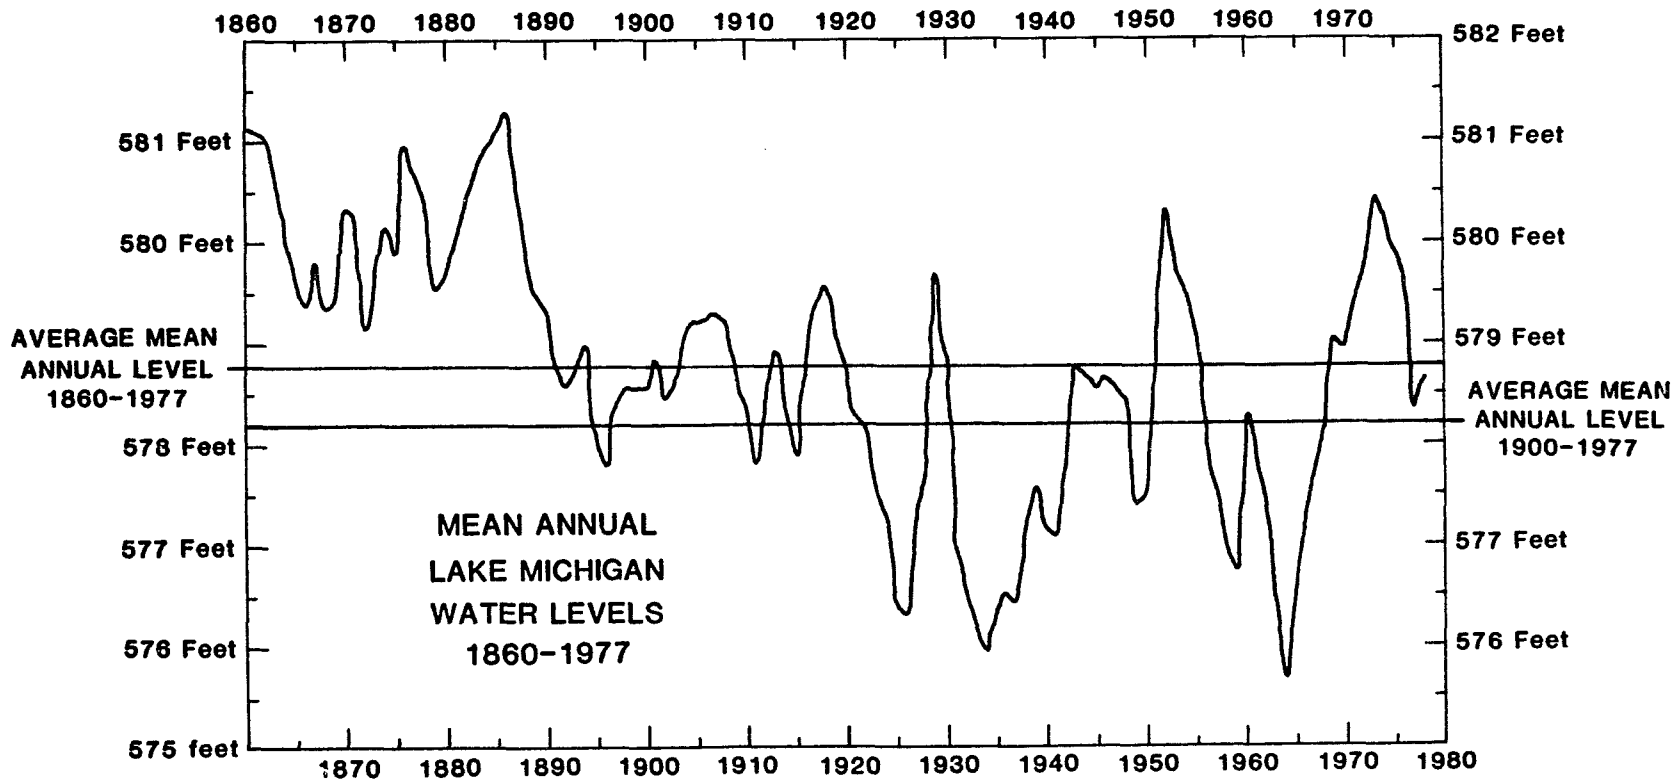
Figure 3. Long-term average annual water levels of Lake Michigan.

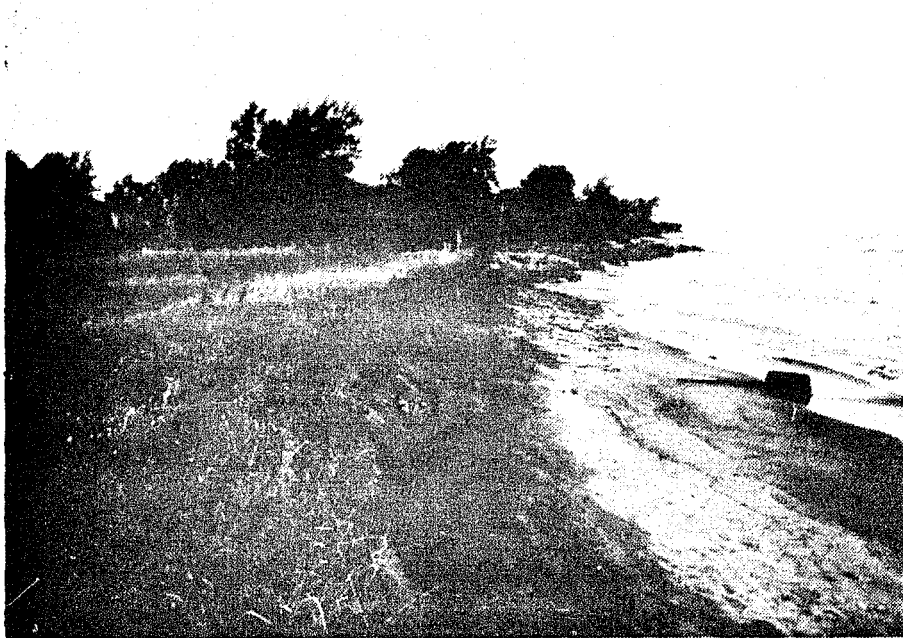
Figure 5. The shorezone at site W3, South Line / Section 17 / T1N,R23E, Kenosha County, Wisconsin. Average annual bluff recession between 1835 and 1976 is 6.33 feet (1.929 m). This photo was taken on September 19, 1976.

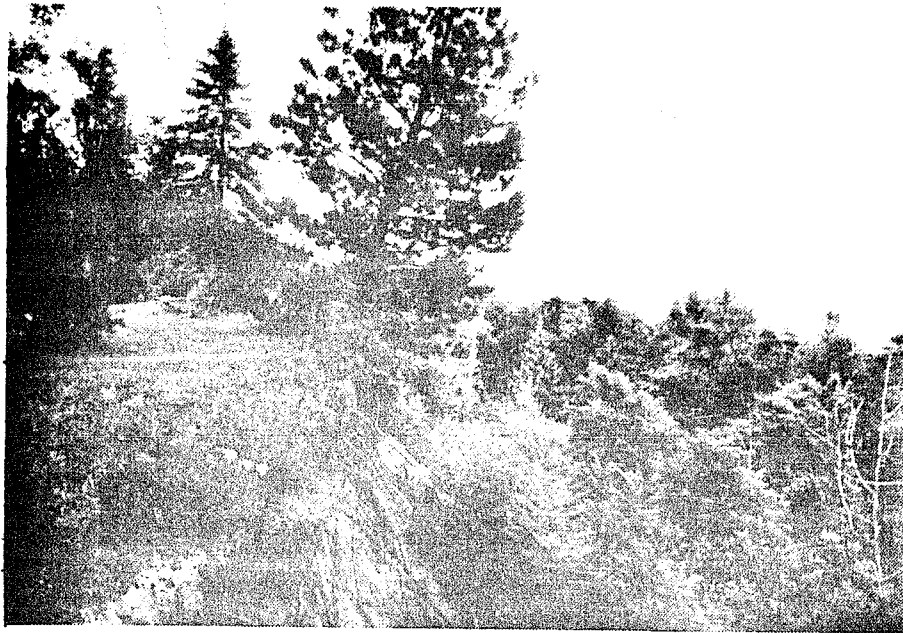
Figure 6. Bluff recession resulting from wave erosion and mass-wasting. The photos were taken in August, 1977 in Section 4 / T9N,R22E, approximately 750 feet south of site W22 (South Line / Section 33 / T10N,R22E), Ozaukee County, Wisconsin.

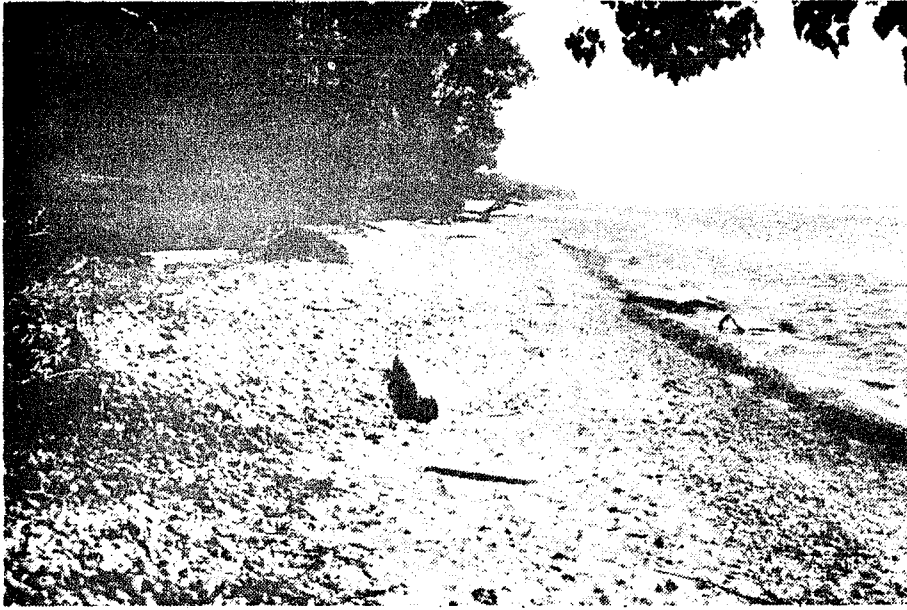
Figure 9. The shorezone at site W27, South Line / Section 25 / T12N,R22E, Ozaukee County, Wisconsin. Average annual bluff recession between 1835 and 1976 is 0.12 feet (0.037 m). This photo was taken on July 9, 1976.

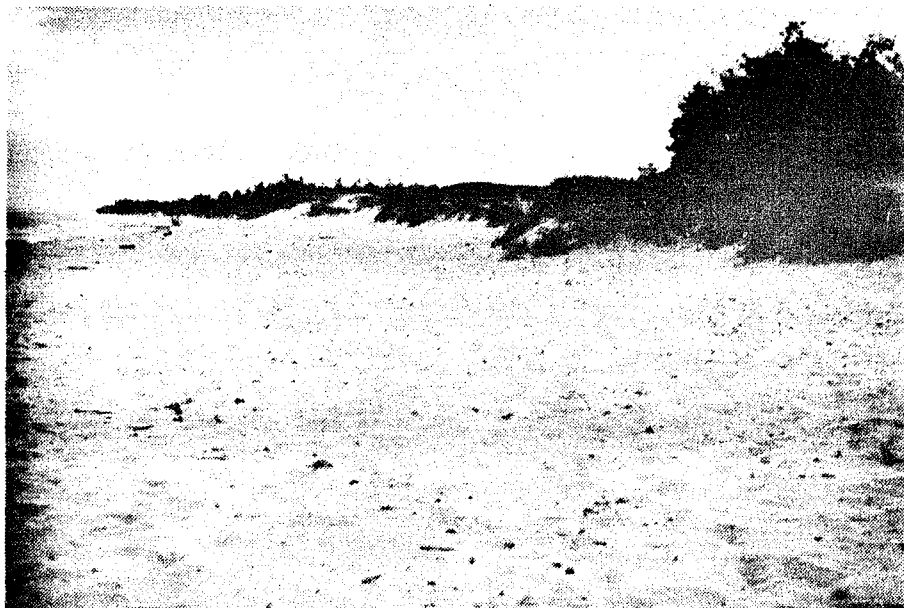
Figure 10. The shorezone at site W35, South Line / Section 14 / T14N,R23E, Sheboygan County, Wisconsin. Average annual net accretion at this sand dune location is 0.06 feet (0.018 m) for the period between 1835 and 1976. This photo was taken on August 12, 1976.

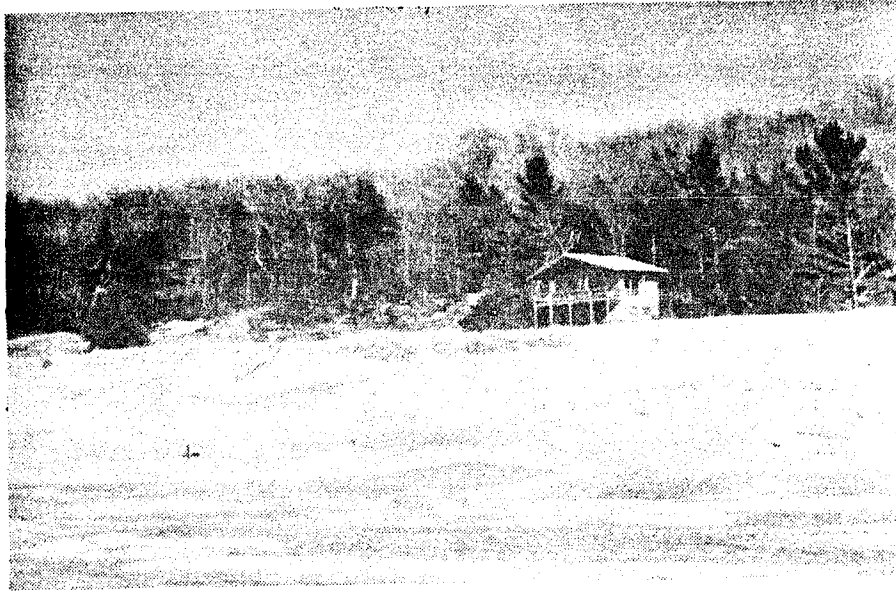
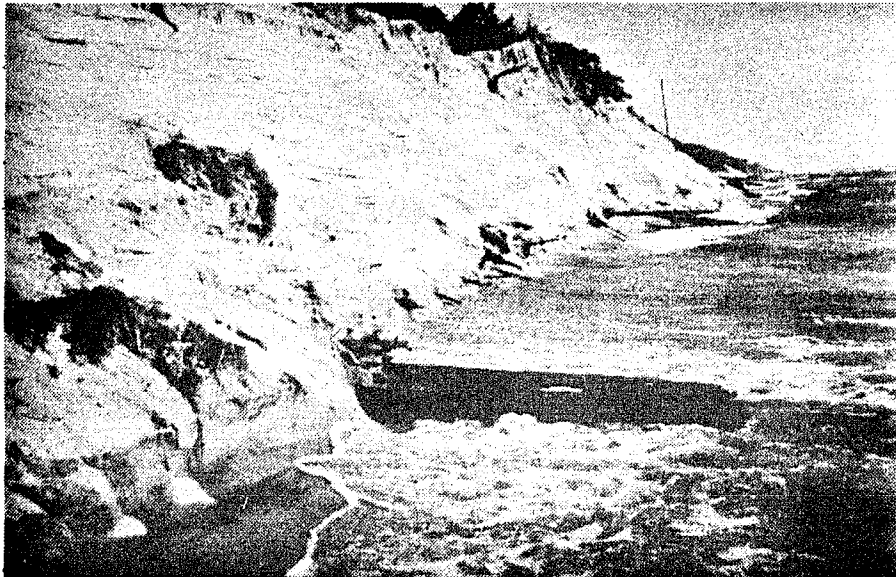
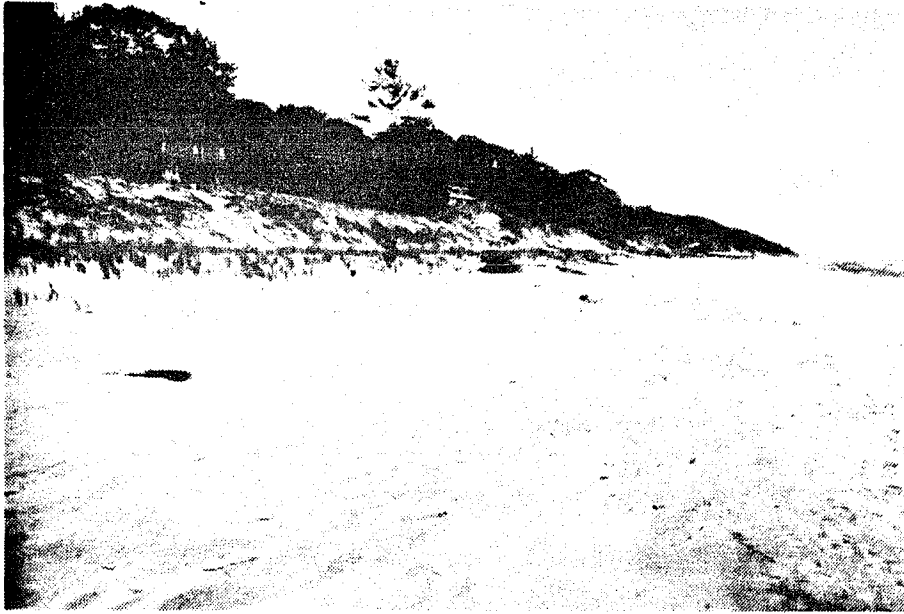
- (D) September, 1978: Although the lake level has risen slightly from the year before and beaches are somewhat narrower, actively accreting foredunes have established themselves fronting the previously eroded dune bluff.

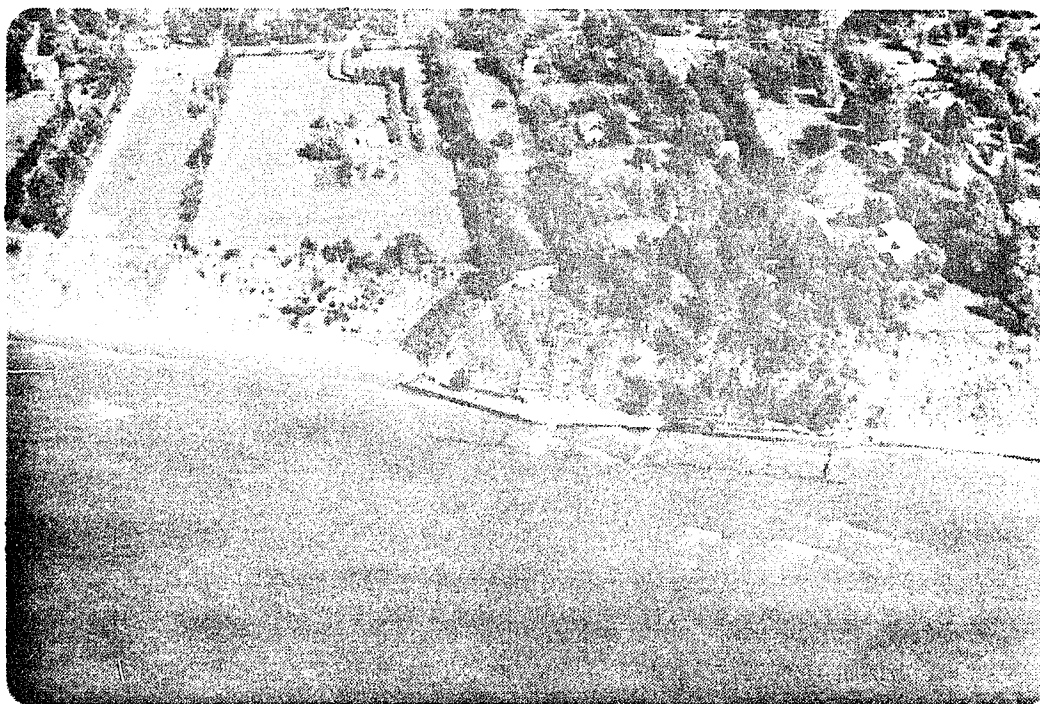
(B) August 29, 1978

Figure 22. Site of a feeder beach, 1977-1978. This type of artificial beach is designed to "feed" sand to downdrift shores so that beaches there may widen and protect the bluff from storm waves. This location (site S4, Table 13, Figure 18) is in the South $\frac{1}{2}$ / Section 3 / T5S,R19W, Shoreham, Berrien County, Michigan.

unsatisfactory for preventing bluff losses; without continual sand supplement these feeder beaches are soon completely removed by shorezone processes (Figure 22).

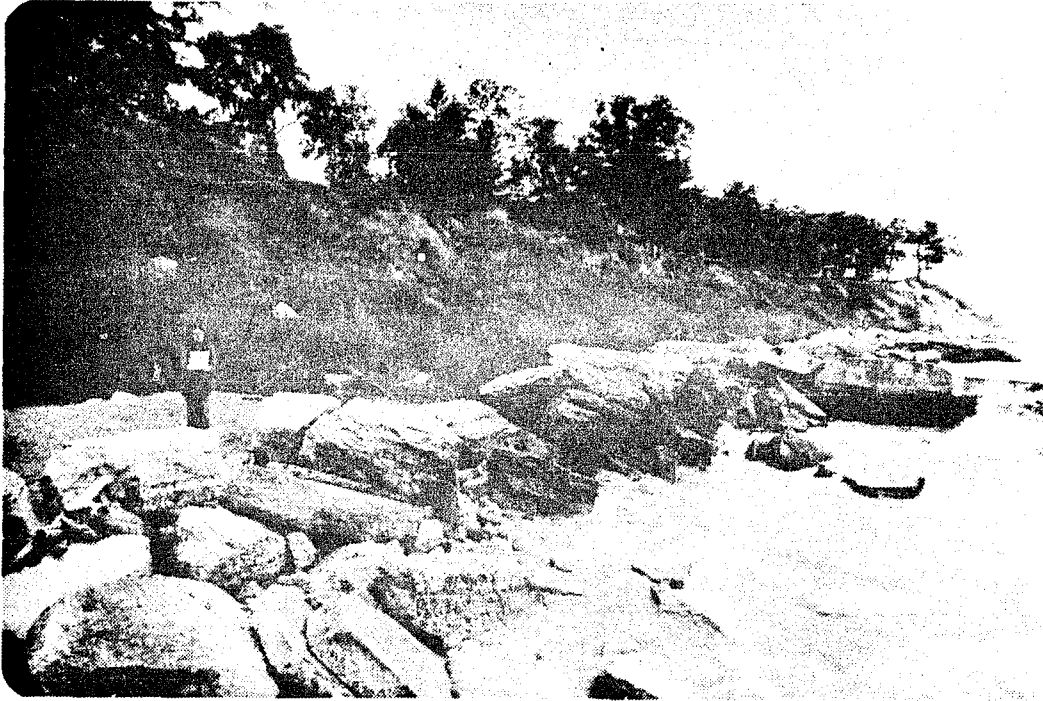
Figure 29. Bluff protection measures in the North $\frac{1}{2}$ / Section 8 / T2N,R23E, Kenosha County, Wisconsin. This photo was taken on July 30, 1978

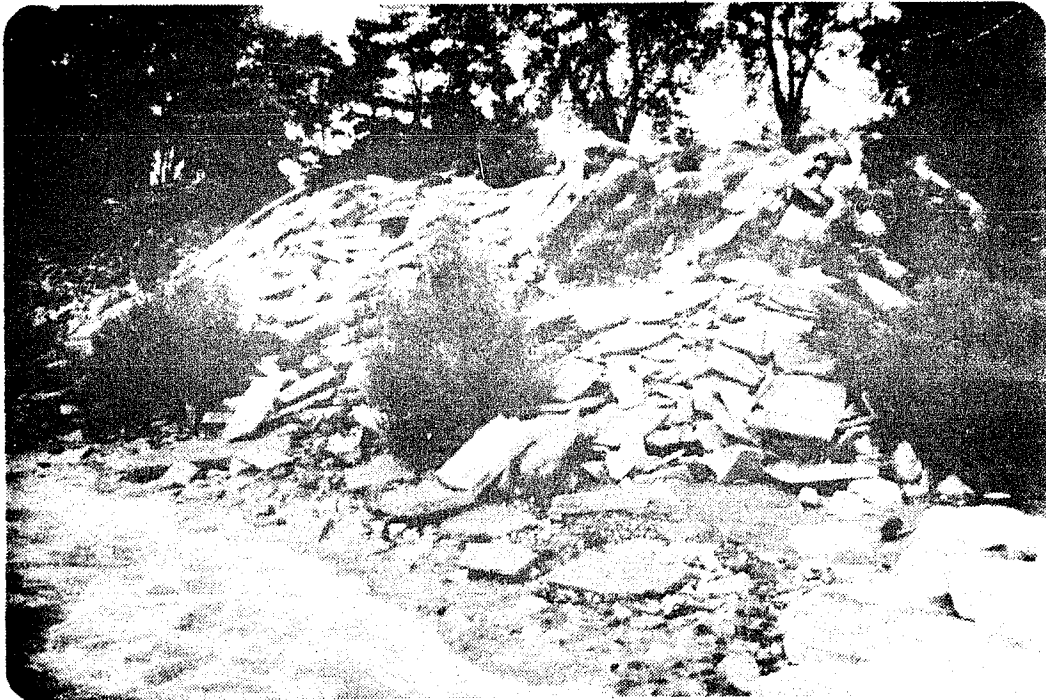
Figure 30. Broken concrete slabs armoring the bluff slope in the South $\frac{1}{2}$ / Section 8 / T2N,R23E, Kenosha County, Wisconsin. This photo was taken on July 30, 1978.
