AN INVESTIGATION OF BEACH EROSION ALONG LAKE HURON NEAR LEXINGTON, MICHIGAN

Thesis for the Degree of B. S.

MICHIGAN STATE COLLEGE

Bruest V. Keckonen - Robert C. Patterson
1948

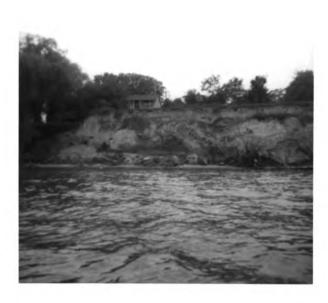
Fig. 1- Eroded cliff, southern end of Lexington village limits

The Lexington area has a narrow sandy or sandy-gravel beach, usually about twenty to two hundred feet wide, which terminates at the foot of a wave cut clay cliff that rises very steeply thirty to fifty feet. The summer homes and cottages are located at the top of this clay cliff. A view of this cliff is shown in Fig. 1.

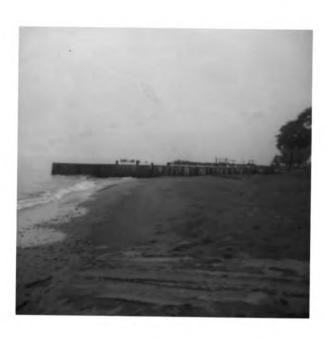
Fig. 3- North side (top) and south side of a groin, showing littoral drift trapped on north side of groin.

Both the prevailing wind and greatest stretch of water for the Lexington area are from the northeast causing the waves to strike the shore obliquely from this direction so that the beach drift is to the south. This southerly drift is shown by existing groins which have trapped sand on the north side and allowed erosion to take place on the south side. Dee Fig. 3.

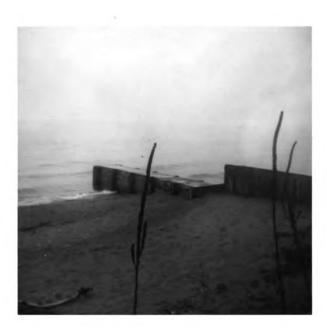
Fig. 4- Typical groin of Lexington area.

Most of the groins are made of two rows of piling about four feet apart with three inch planks forming a wall along each row of piling. The space between the sheeting walls is filled with large stones, and the surface is finished with concrete. See Fig. 4

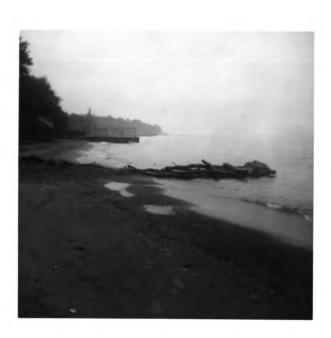
Fig. 5- Timber-stone groin shortly after completion.

unfinished timber and stones. A frame of timber about four feet wide and the desired length of the groin is constructed, with woven wire fencing nailed to the bottom to form a basket. The frame is floated into position perpendicular to the shore then filled with stones. The shore end of the groin is firmly anchored with piling but there is no anchoring of the other end. Desirable qualities of this type of groin are: the piling is not undermined by action of the water, can be built with little equipment and of cheaper materials, therefore is less costly to construct. An example of this type of groin is shown in Fig. 5 which was built by one man and his two sons a few days before the picture was taken.

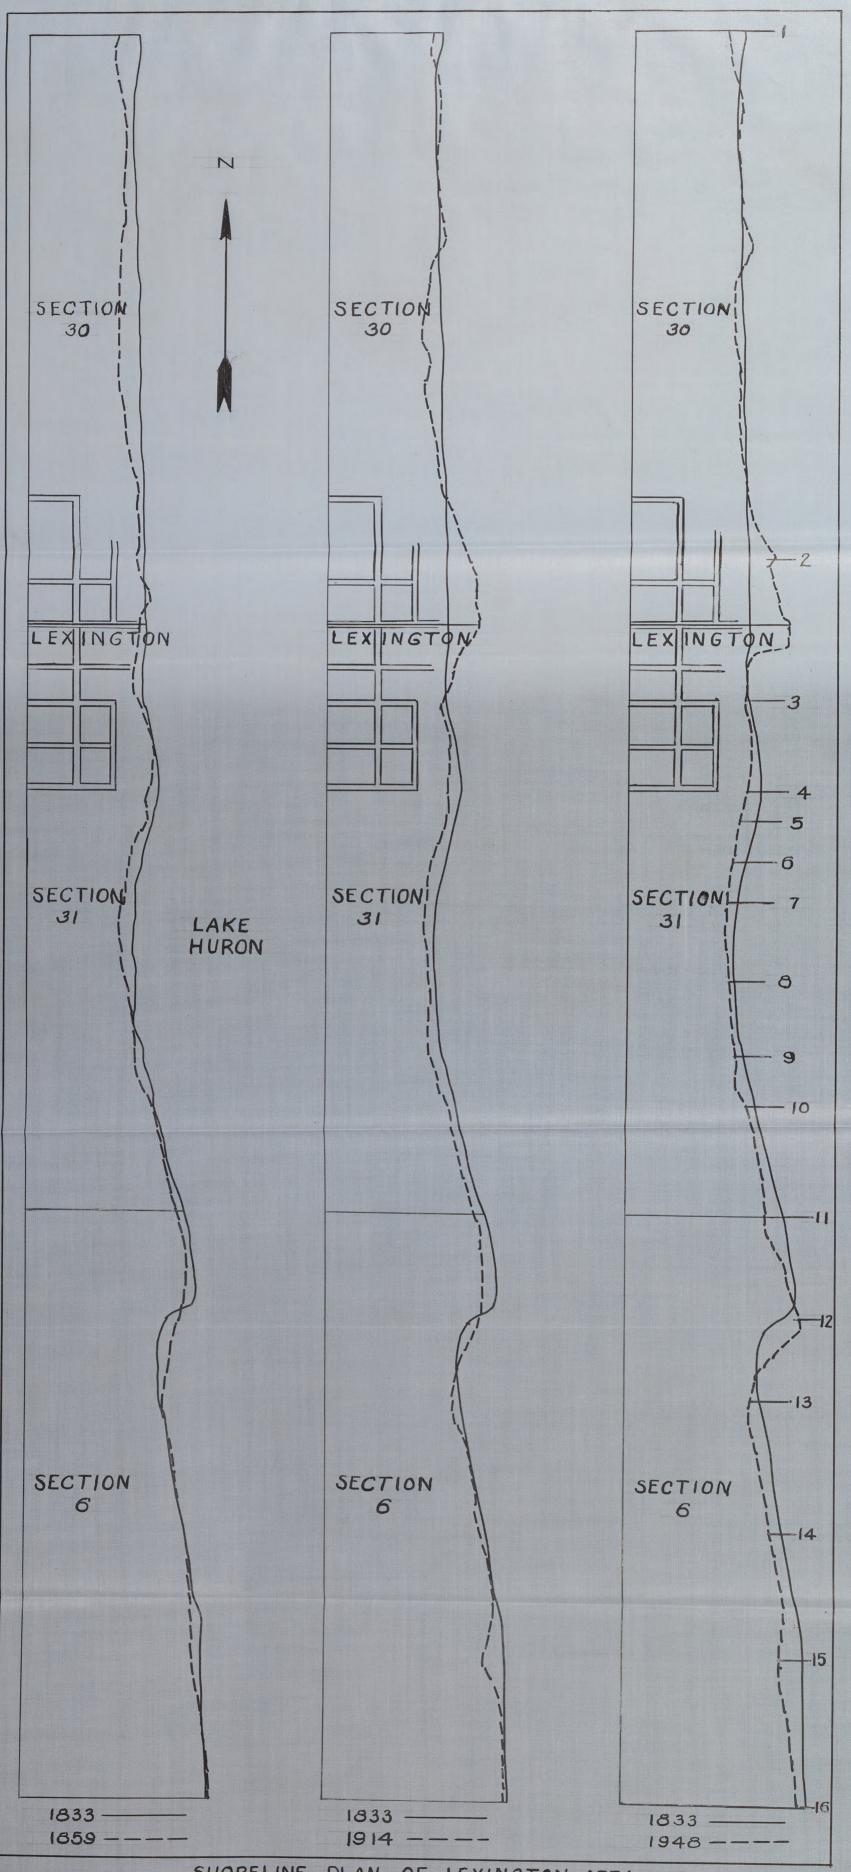
SHORELINE PLAN OF LEXINGTON AREA

SCALE~ 1:10,000

At point 12 on the shoreline chart a pier was built that extended 200 feet into the lake, but the pier began to

trap littoral drift and therefore acted as a groin. There has been an accretion of 200 feet on the north side of this pier. This example shows that much more beach stabilization could be obtained by building groins that extended to a greater depth than is now practised.

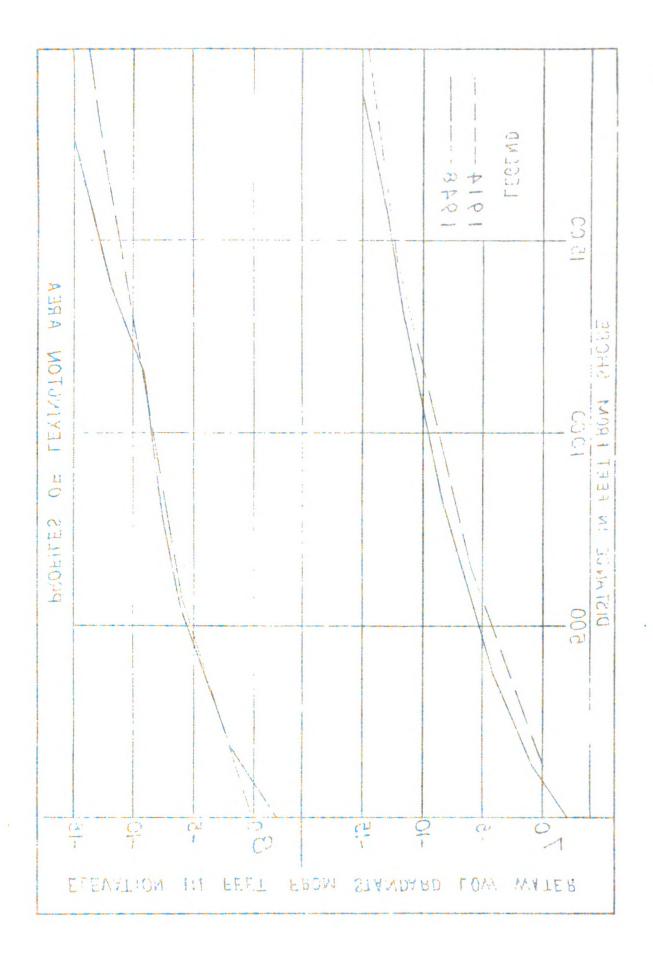
15,00	LEGEND	1914 ————				- - 	
DISTANCE IN FEET FROM SHORE	1000 005							PROFILES OF LEXINGTON AREA
	TER O		NOT 48		т. /О	N FEE	TAVELE

The offshore depth changes as shown by the profiles and in Table 1. Shoreline and depth contour changes, show that the offshore depth has increased at all points, indicating that storm waves have swept much of the beach away. (1) This is corroborated by residents of the area who attest to the fact that most erosion takes place during storms. A storm in July, 1945, caused the greatest erosion in recent years, scouring the beach and moving the shoreline back about sixty feet.

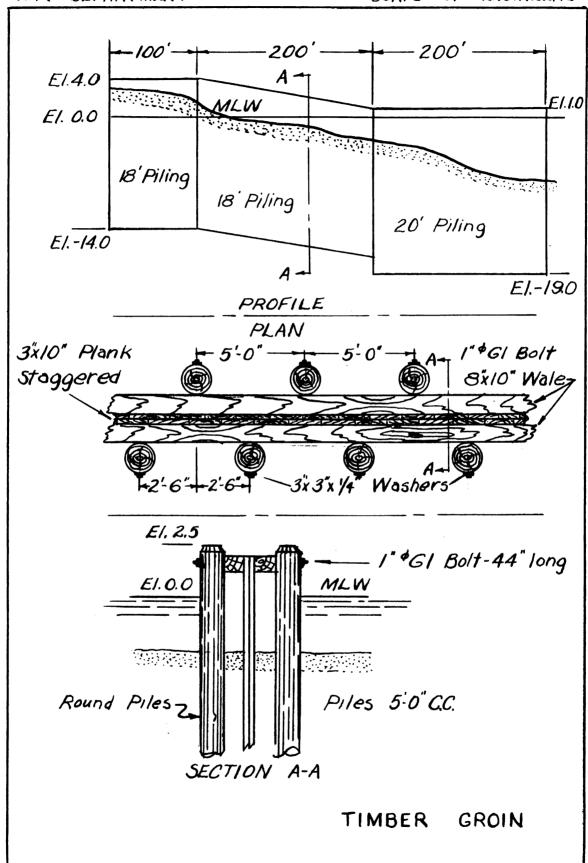
PLATE 10

A groin of the type shown in Plate 10 is recommended for this area. Less material per foot of groin is required than is now normally used in the Lexington area thereby making this type of structure less costly. Because piers supported by wooden piling have withstood many years of ice forces so groins made of timber should similarly withstand these forces.
