GULLY FORM AND DEVELOPMENT ON KAROO SEDIMENTS IN CENTRAL ZIMBABWE: A PRELIMINARY SURVEY

R. WHITLOW

and

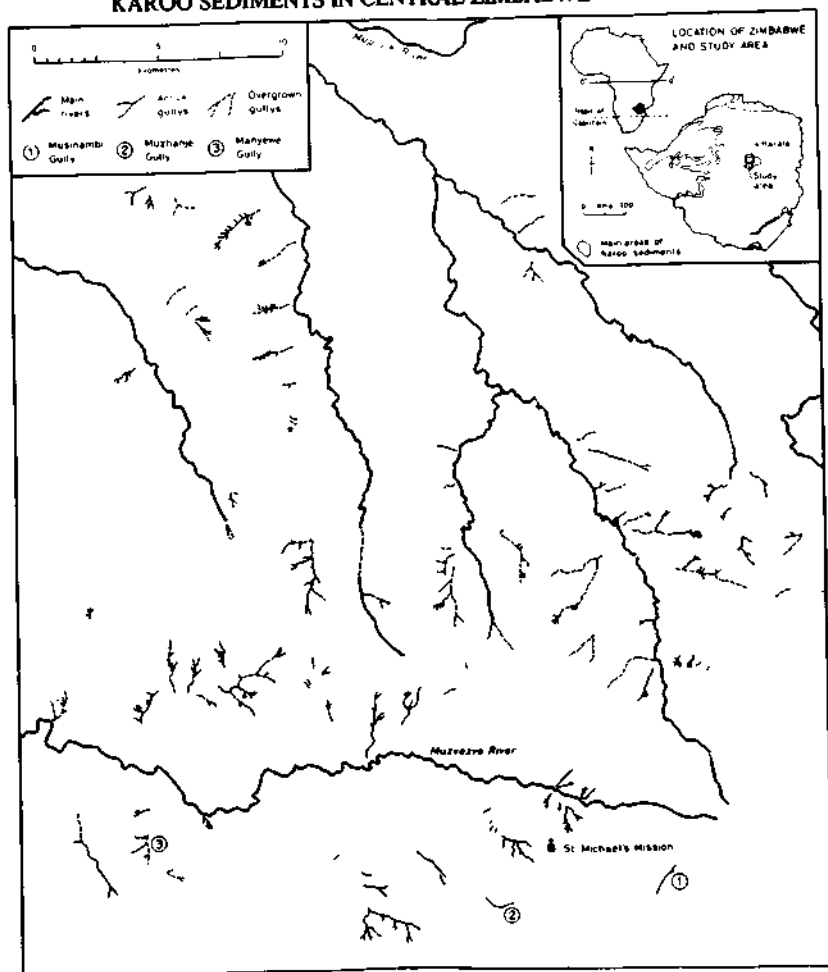
Figure 1: DISTRIBUTION OF ACTIVE AND STABILIZED GULLIES ON KAROO SEDIMENTS IN CENTRAL ZIMBABWE

half of the area underlain by Karoo sediments (Fig. 1 inset). More detailed mapping of this western area was carried out using 1:50 000 topographical base maps and 1:25 000 aerial photographs taken in 1976. The results of the survey are presented in Figure 1.

A total of 116 gullies or gully segments (where active and stabilized channels were linked) were identified, of which 62 appear to be active and the remainder

have the plan forms of gullies, but are overgrown with herbaceous and shrub vegetation. The total length of active gullies is 73 575 m giving an average length per gully of 1 187 m and a density of 70 m per km². Although there are fewer stabilized gullies, their total length is greater than that of the active systems giving an average length of 1 605 m per gully and a density of 83 m per km². The density of natural streams in this area, excluding the main rivers shown in Figure 1, is in the order of 425 m per km². Therefore, the gullies represent a significant extension of the overall drainage network.

Three general observations can be made regarding the distribution of the gullies. Firstly, although active gullies occur throughout the area they are especially common in the upper reaches of the Muzvezve River. Here gully density is around 237 m per km² — over five times that for active gullies elsewhere in the study area. Secondly, stabilized gullies are prevalent in the lower reaches of the river along with the gullies draining into the northward flowing tributaries of the Mupfure River. Thirdly, there are several gullies where the lower portions of the incised channels are now vegetated and stabilized but where the upper portions are still devoid of plant cover and apparently actively eroding. The reasons for these differences are not known as yet but may relate to variations in the nature of the Karoo sediments and rejuvenation of the major river systems.

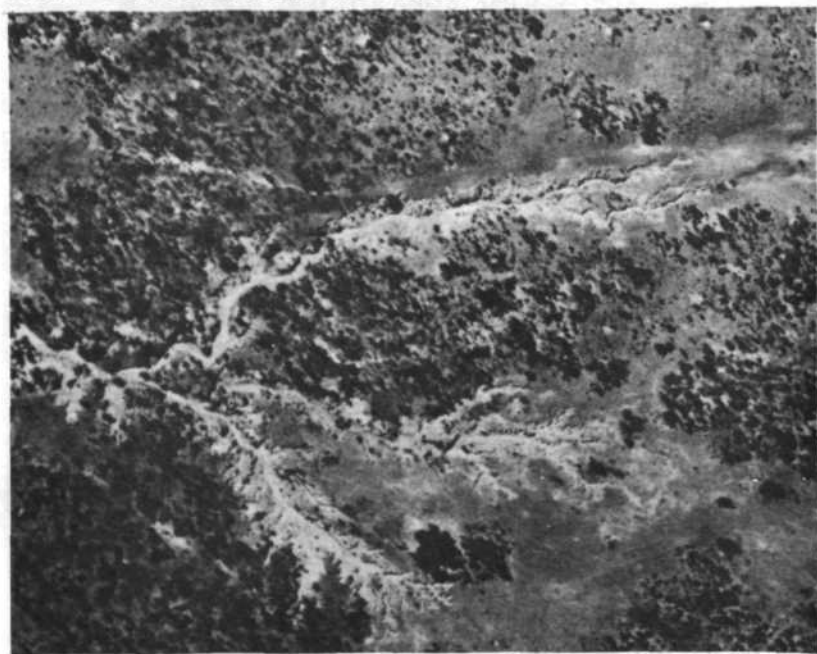
Plate 1: DENDRITIC GULLY SYSTEM 1:12 500

Generally, the active gullies in this area are 'Type 3 gullies' as defined by Imeson and Kwaad (1980); that is, they have U-shaped cross-sections, are formed in colluvial or weathered materials and are characterized by subsurface piping due to the influence of high levels of exchange sodium. Although the gullies are typically dendritic in form (Plate 1), at least three other types are present. Firstly, at least 7 of the 62 active gullies have a compound form (Plate 2; Ireland *et al.*, 1939). This gully form is believed to represent an advanced stage in the degradation of a dendritic system whereby tunnelling between adjacent headcuts results in the formation of residual ridges and the opening out of the gullies as

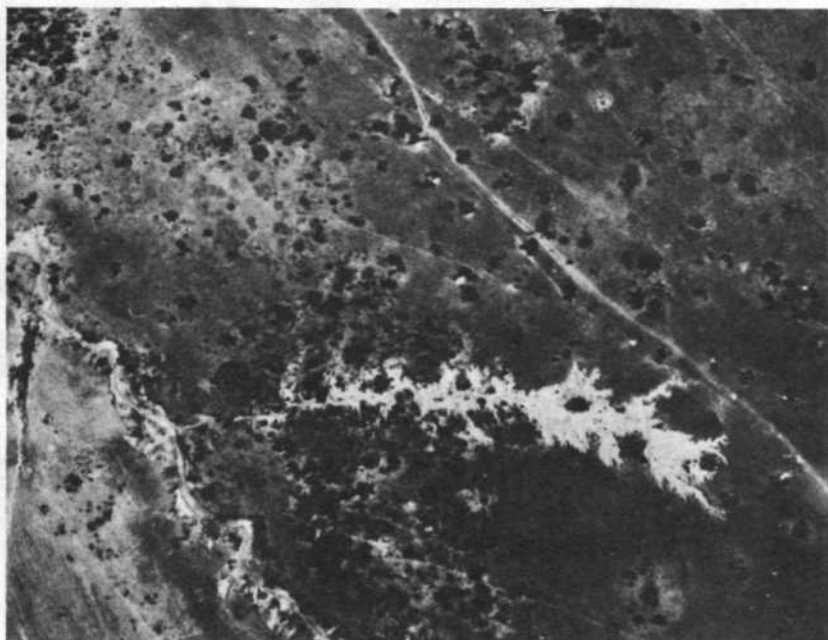
Plate 2: COMPOUND GULLY SYSTEM 1:12 500

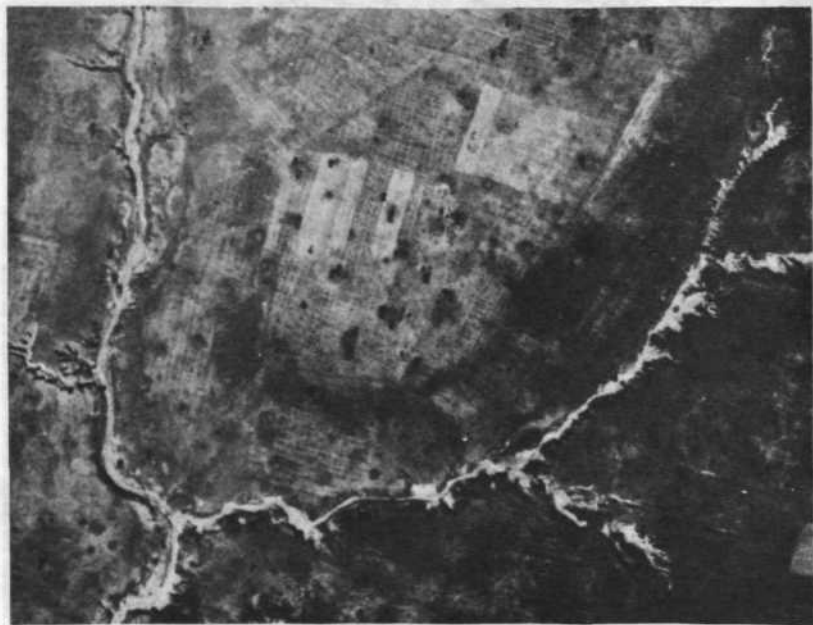
Plate 3: LINEAR GULLY SYSTEM 1:12 500

channels coalesce. Secondly, there are ten distinctly linear gullies (Plate 3), these being relatively narrow channels with very few lateral headcuts (Ireland *et al.*, 1939). Thirdly, there are three examples of broad, shallow gullies with distinctive bulbous forms (Plate 4). In a detailed study of headcuts on dendritic gully systems Stocking (1978b) recognized five major plan forms (pointed, rounded, notched, digitate and bulbous), these being related to the processes of subsurface and overland flow affecting the headcuts. Similarly, at the scale of the gully system as a whole, the variations in a plan form are likely to reflect dominant processes as well as the nature and depth of the unconsolidated materials within which the gullies are formed. Further field observations are required to verify these points.

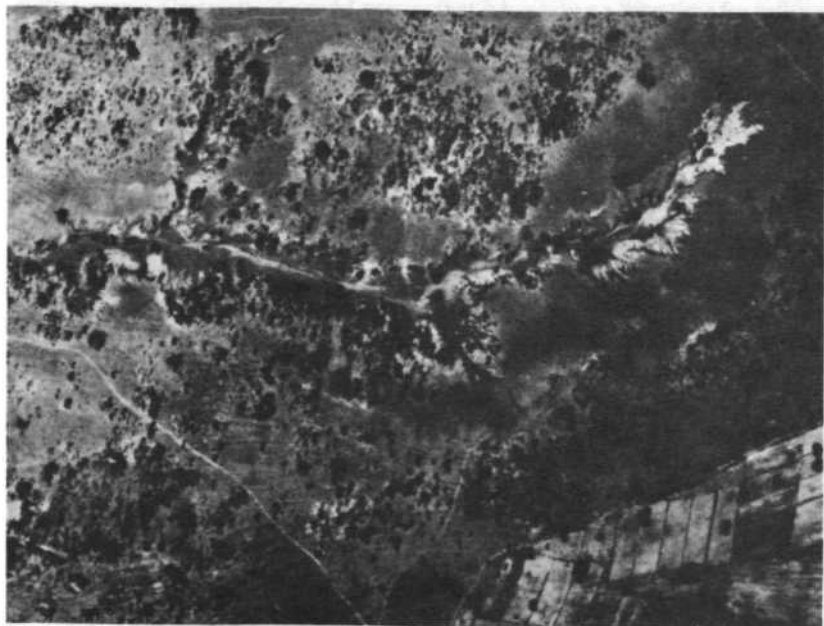
Plate 4: BULBOUS GULLY SYSTEM 1:12 500

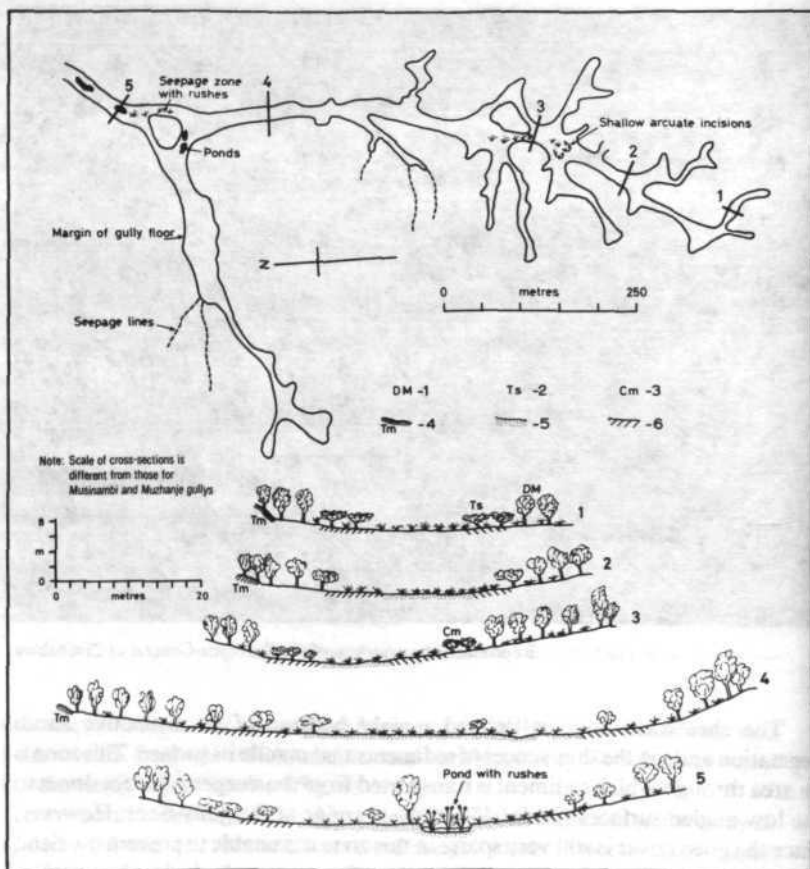
Figure 2: MORPHOLOGY OF MANYEWE GULLY

Manyewe Gully: This was selected as an example of a stabilized gully, now choked with sediment, in the lower Muzveze basin. The outline plan of the gully (Fig. 2) defines the junction between the relatively flat gully floor covered in dense herbaceous vegetation, a vivid red colour on the false colour imagery, and the adjacent sparsely-wooded degraded slopes. The gully system is 2 810 m in length, up to 6 m in depth and, using the basal width of the infilled floor, between 6 and 42 m wide. The former headcuts have a distinct broad lobate form and are distinguished on the ground mainly through contrasts in vegetation rather than

clear breaks in slope. For example, the fringes of the gully floor are characterized by a narrow (3–8 m) zone of stunted, frosted shrubs, mainly *Terminalia sericea* and *Colophospermum mopane* (Fig. 2).

Three morphological units could be identified in this stabilized gully — these being degraded slopes, a sheetwash zone and the gully floor. The degraded slopes, lowered through processes of sheetwash and rilling, were characterized by a dry miombo woodland dominated by *Brachystegia* spp., very similar to that in areas surrounding the gully. The upper margins of these slopes were poorly defined, but generally convex in form. Slope angles (see sections 1–5 in Fig. 2) were generally between 8° and 12° along the main gully, although locally much greater. Extensive areas of bare ground are exposed beneath the discontinuous tree canopy, and numerous calcareous nodules 1–2 cm in diameter occur on these denuded surfaces. The bases of these degraded slopes are sometimes marked by a clear break in slope with the lower sheetwash zone. More commonly, however, deposition of sheetwash material gives rise to a gradual change in slope on rather hummocky ground.

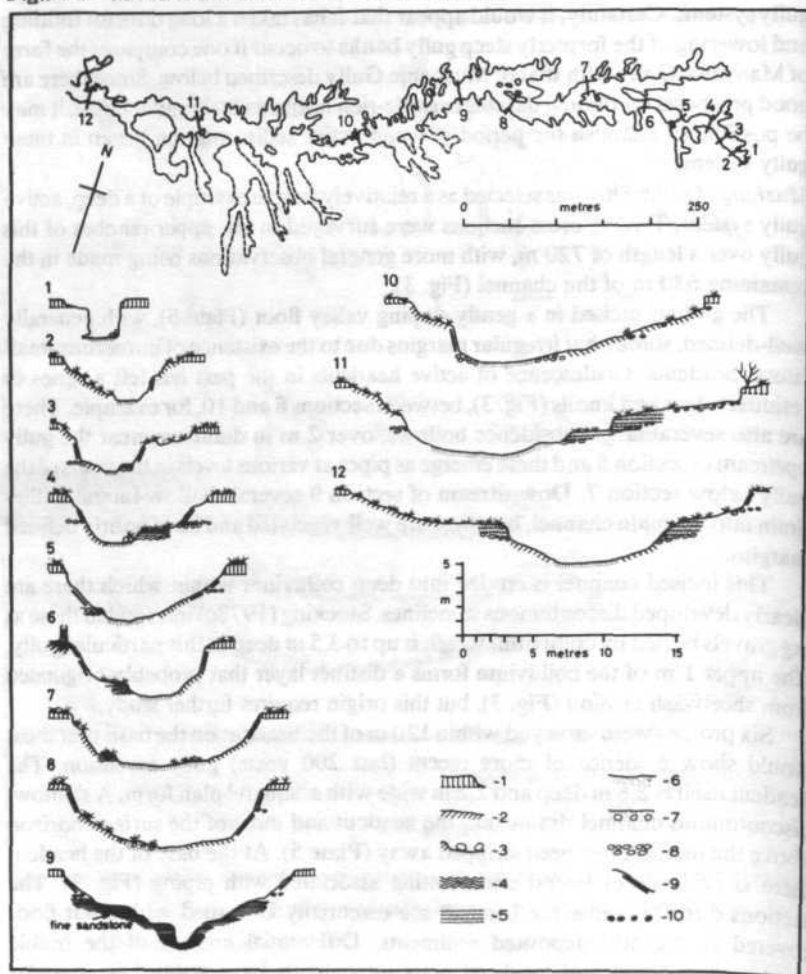
Figure 3. MORPHOLOGY OF MUZHANJE GULLY

Muzhanje Gully: This was selected as a relatively simple example of a deep, active gully system. Twelve cross-sections were surveyed in the upper reaches of this gully over a length of 720 m, with more general observations being made in the remaining 630 m of the channel (Fig. 3).

This incised channel is eroded into deep colluvium within which there are clearly developed discontinuous stonelines. Stocking (1978c) interpreted these as lag gravels buried by colluvium which is up to 3.5 m deep in this particular gully. The upper 1 m of the colluvium forms a distinct layer that probably originated from sheetwash erosion (Fig. 3), but this origin requires further study.

Six profiles were surveyed within 120 m of the headcut on the basis that these would show evidence of more recent (last 200 years) gully extension. The headcut itself is 2.8 m deep and 2.2 m wide with a 'square' plan form. A shallow, discontinuous channel drains into the headcut and most of the surface horizon above the incision has been stripped away (Plate 5). At the base of the headcut there is evidence of lateral undercutting associated with piping (Fig. 3). The sections directly below the headcut are essentially U-shaped with a flat floor covered in recently deposited sediments. Differential erosion of the friable sheetwash material and localized mass movements have resulted in irregular hummocky and stepped gully walls, with the steeper banks (over 40°) being characterized by fluting. There is a terrace-like feature some 0.8 m above the present floor in this upper reach of the gully (Plate 6). It is composed of poorly stratified sediments which could have been produced from materials derived from sidewall erosion rather than movement down the channel. It suggests a recent phase of localized entrenchment of the gully of up to 1.5 m into infill deposits that extend 0.5–0.7 m below the present gully floor.

Below the junction of a major right-bank tributary, the main gully widens appreciably to about 13,5 m at section 7, but does not exhibit a comparable increase in depth (Fig. 3). There is still evidence of a terrace feature in this portion of the gully. Further downstream (section 8) the gully increases to a width of 14,4 m and a depth of 4,4 m and the banks are strongly fluted with numerous pipe outlets entering the gully about 2 m below the ground surface. This part of the gully is extremely dissected due to the coalescence of several right-bank tributaries. Vertical incision has exposed the well-jointed, partially weathered Karoo sediments (Plate 7) in the basal 3 m of section 9 and for 80 m either side of this section. Channel erosion has exploited the vertical joints in the Karoo sandstone forming a cleft 1,3 m deep and 1–1,2 m wide in the base of the channel (section 9, Fig. 3).

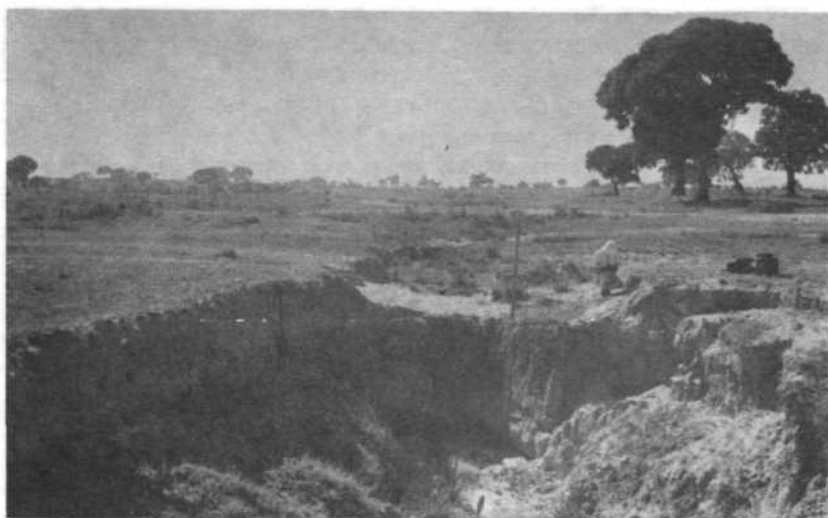
Plate 5: MAIN HEADCUT ON MUZHANJE GULLY WITH HANDLE OF SPADE MARKING THE SUSPECTED SHEETWASH HORIZON

The gully is incised in a gently sloping valley floor (Plate 5), with generally well-defined, somewhat irregular margins due to the existence of numerous small lateral headcuts. Coalescence of active headcuts in the past has left a series of residual ridges and knolls (Fig. 3), between sections 8 and 10, for example. There are also several large subsidence hollows, over 2 m in diameter, near the gully upstream of section 8 and these emerge as pipes at various levels in the walls of the gully below section 7. Downstream of section 9 several shallow lateral gullies drain into the main channel, but these are well vegetated and have poorly defined margins.

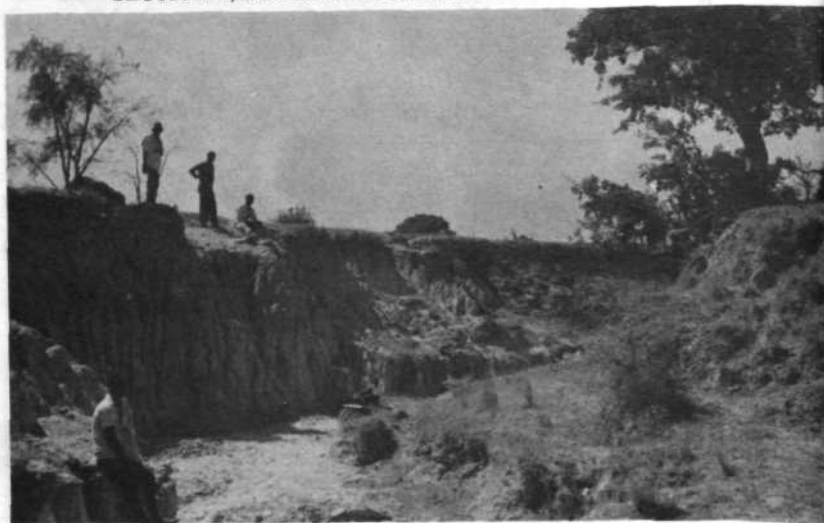
Plate 6: FLUTED VERTICAL BANK AND RESIDUAL BENCH BELOW
SECTION 6, LOOKING UPSTREAM

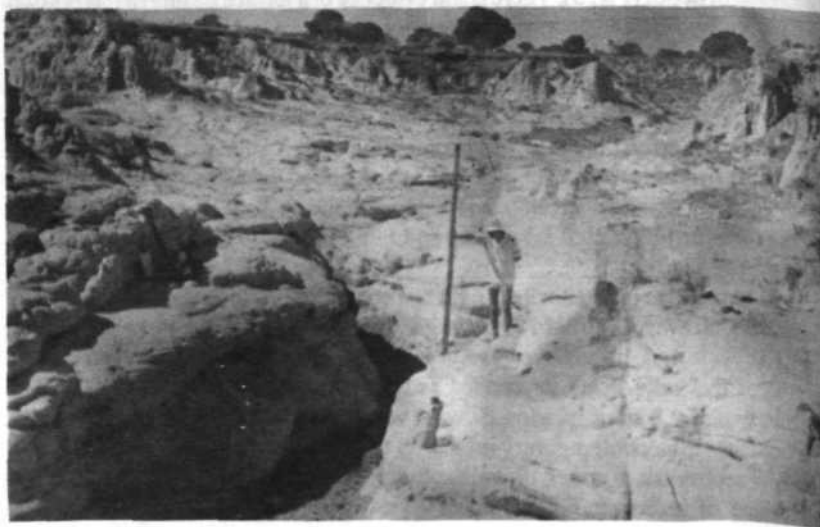
Plate 7: EXPOSED KAROO BEDS AT SECTION 9, LOOKING UPSTREAM

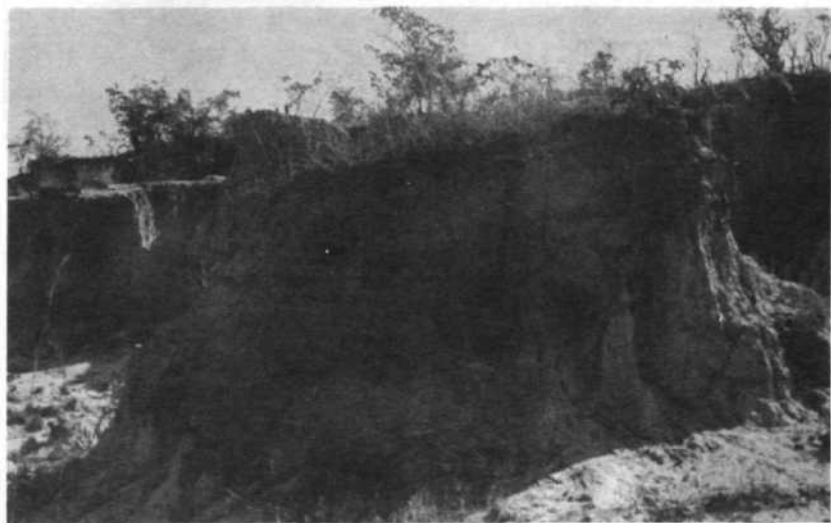
Plate 8: STRATIFIED INFILL IN LOWER REACHES OF MUZHANJE GULLY

distinctive benches between 2,2 and 2,8 m above the present gully floor (Plate 8). These sediments comprise intercalated humic and mineral horizons which are generally underlain by a coarse gravel layer of mainly siliceous nodules. These terraces seem to have been produced as a result of deposition in a broad, flat channel with localized fans from lateral gullies. Below section 12 the gully has near vertical walls up to 8 m deep and a very flat floor, this form being typical of the lower reaches of gullies in this area. However, remnants of the infill terraces persist, sometimes on both sides of the channel, for some distance below section 12.

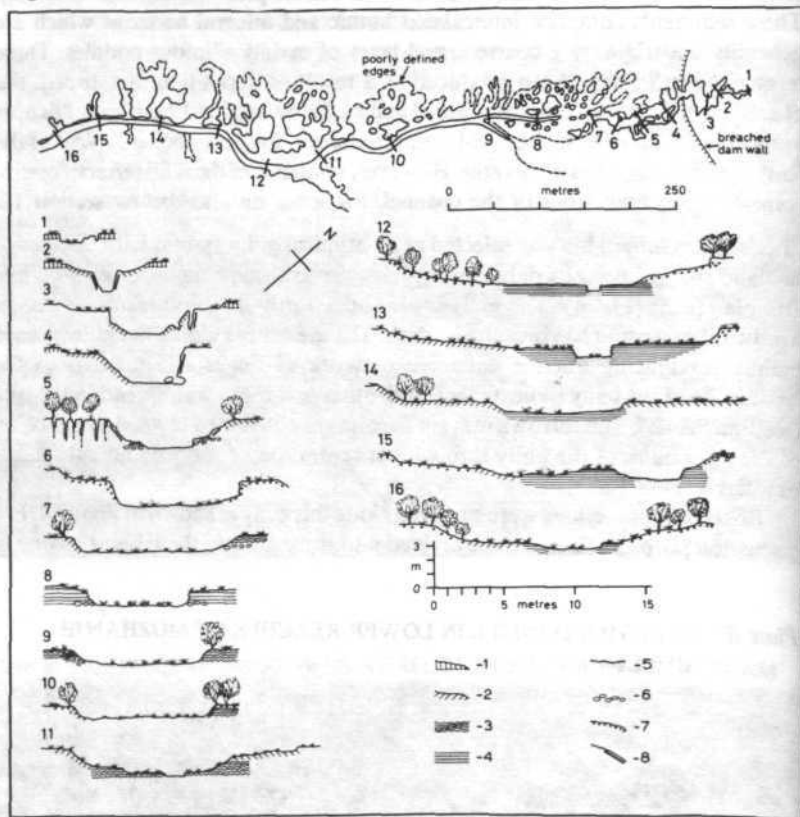
Figure 4: MORPHOLOGY OF MUSINAMBI GULLY

Sixteen cross-sections were surveyed along this gully as shown in Figure 4. For discussion purposes these can be divided into three groups, these being a zone of

incision (sections 1–6), a zone of deposition (sections 7–10) and zone of entrenched infill (sections 11–16). Below section 5 the cross-section surveys were restricted to the inner portion of the gully because of badland erosion extending 30–80 m back from the main axis of the gully. Wherever possible the sections were located where intact remnants of the former ground surface existed, avoiding severely eroded banks. A series of photographs was selected to demonstrate variations in morphology and infill sediments in this gully (Plates 9–12).

Section 1 (Fig. 4) is at the head of the gully where there is a broad rounded headcut some 0,8 m deep. Subsurface piping is evident at the base of the fine sandy A-horizon and appears to be a major cause of headcut enlargement. Some 30 m downstream of this there is an incision 1,4 m deep and 1,7 m wide, with near vertical, fluted walls (section 2, Fig. 4), giving rise to a clear gully-in-gully form (Plate 9). The subsoil material which has been incised is pale grey-brown in colour with localized iron mottling and a distinctive prismatic structure, typical of the weathered Karoo sediments. Below the inner gully headcut the channel widens rapidly to about 6 m and at section 4, below the breached dam, is nearly 2,5 m deep. Deep vertical clefts and pipe outlets up to 0,35 m in diameter, along with loose fresh debris and blocks of soil on the gully floor, show that there is very active erosion, mainly subsurface in nature, in this reach of the gully. Small (under 0,1 m diameter) holes are present up to 35 m away from the outer gully banks and

indicate the existence of an extensive pipe network. Subsurface tunnelling could well have caused the breaching of the dam wall between sections 3 and 4 (Fig. 4).

Sections 7–10 represent a zone of deposition within the inner gully system which itself is incised into infill sediments (Fig. 4). The channel is rectangular in section and about 7.5–12 m wide and about 1 m in depth, with a well-grassed flat floor (Plate 10). Either side of the gully the surface soil has been removed completely giving rise to a series of residual knolls and ridges, especially on the

The third reach of the gully, the zone of entrenchment, is in the order of 1.5–2 m in depth, up to 23 m wide and very irregular in cross-sectional form (Fig. 4). There is a well-defined trench about 1 m deep and up to 3 m wide in the gully floor (Plate 11), beginning with a narrow, vertical headcut at section 12 and extending for some 80 m down the centre of the infilled channel. The trench becomes progressively shallower downstream of section 13 until it eventually disappears. The remaining sections, 14–16, show signs of successive reworking of infill sediments which has left a very hummocky channel floor. The entrenched sediments were clearly stratified (Plate 12) with several thin humic bands separated by fine, convoluted layers of fine sandy clays indicative, perhaps, of gradual accretion of material. Shallow, elongated troughs upstream of the present headcut at section 11, for example, suggest that there is an element of subsurface erosion taking place within the infilled gully floor. The main cause of headward migration of the trench appears, however, to be overland flow.

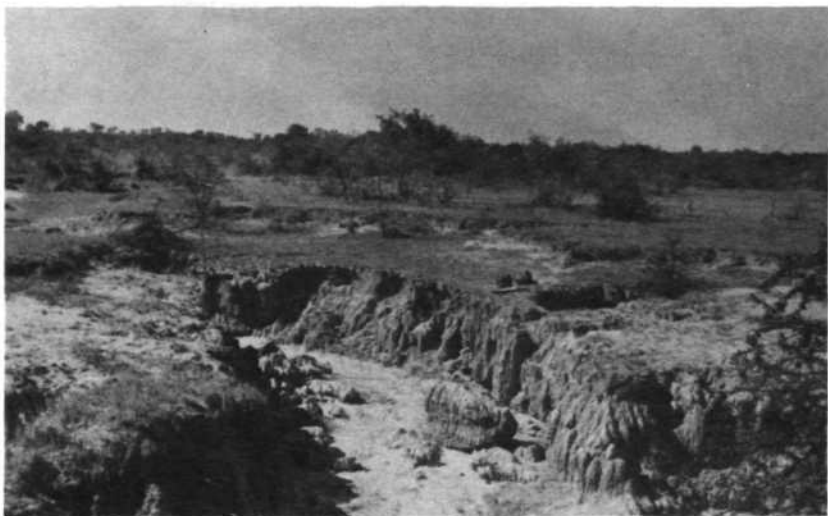
Plate 9: GULLY-IN-GULLY FORM OF THE UPPER REACHES OF MUSINAMBI GULLY

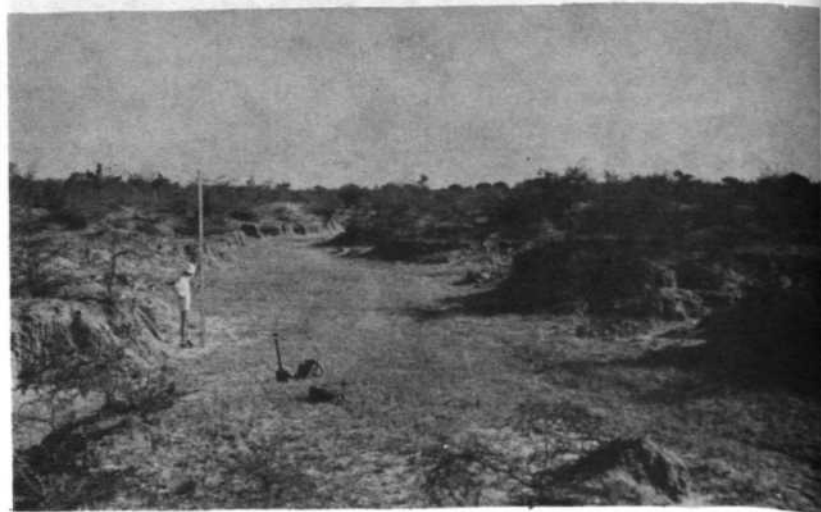
Plate 10: CHANNEL INFILL IN MIDDLE REACH OF MUSINAMBI GULLY
LOOKING DOWNSTREAM WITH C. FIRTH AT POSITION OF
SECTION 7

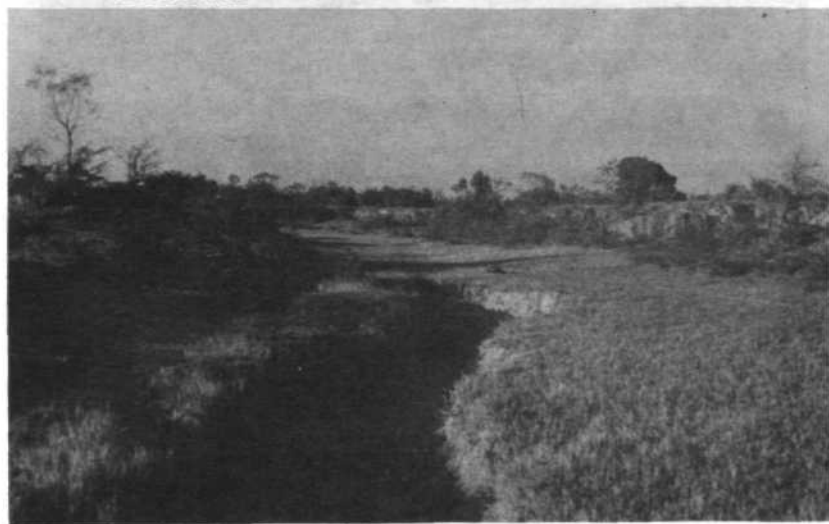
Plate 11: ENTRENCHED INFILL IN LOWER REACH OF MUSINAMBI GULLY, LOOKING UPSTREAM TOWARDS HEADCUT AT SECTION 12

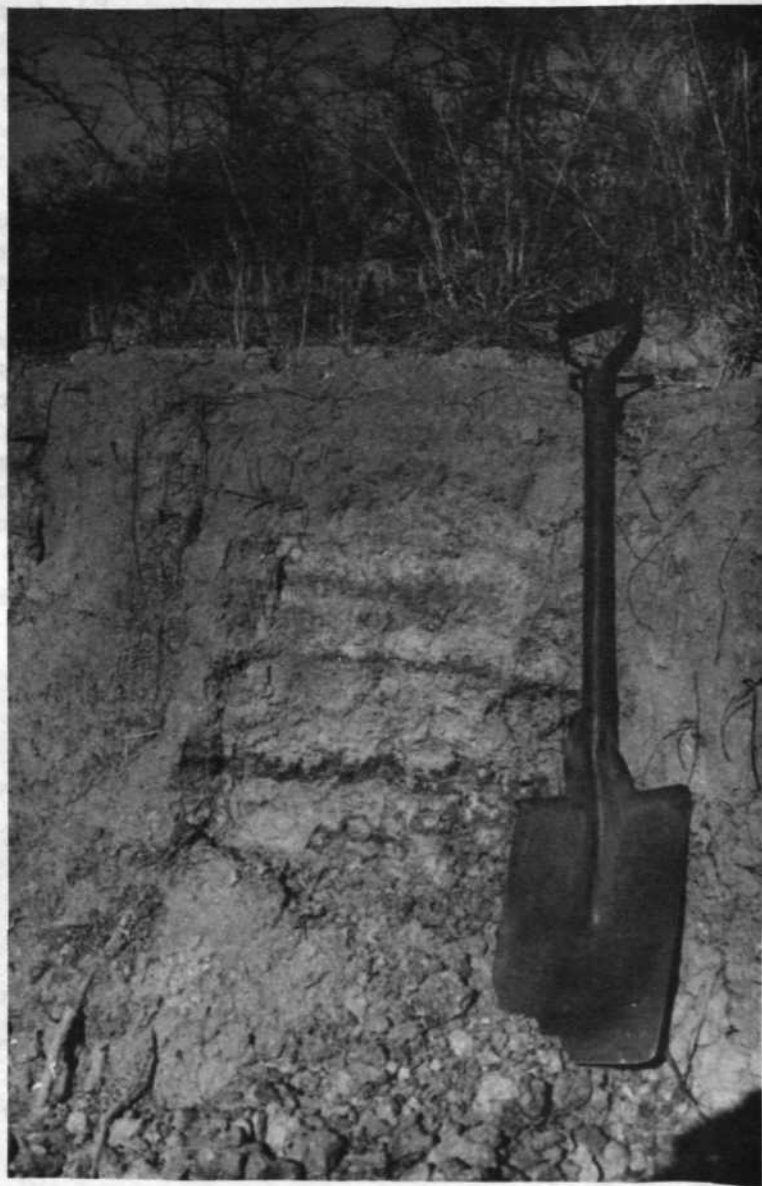
Plate 12: STRATIFIED SEDIMENTS IN ALLUVIAL INFILL NEAR SECTION 12

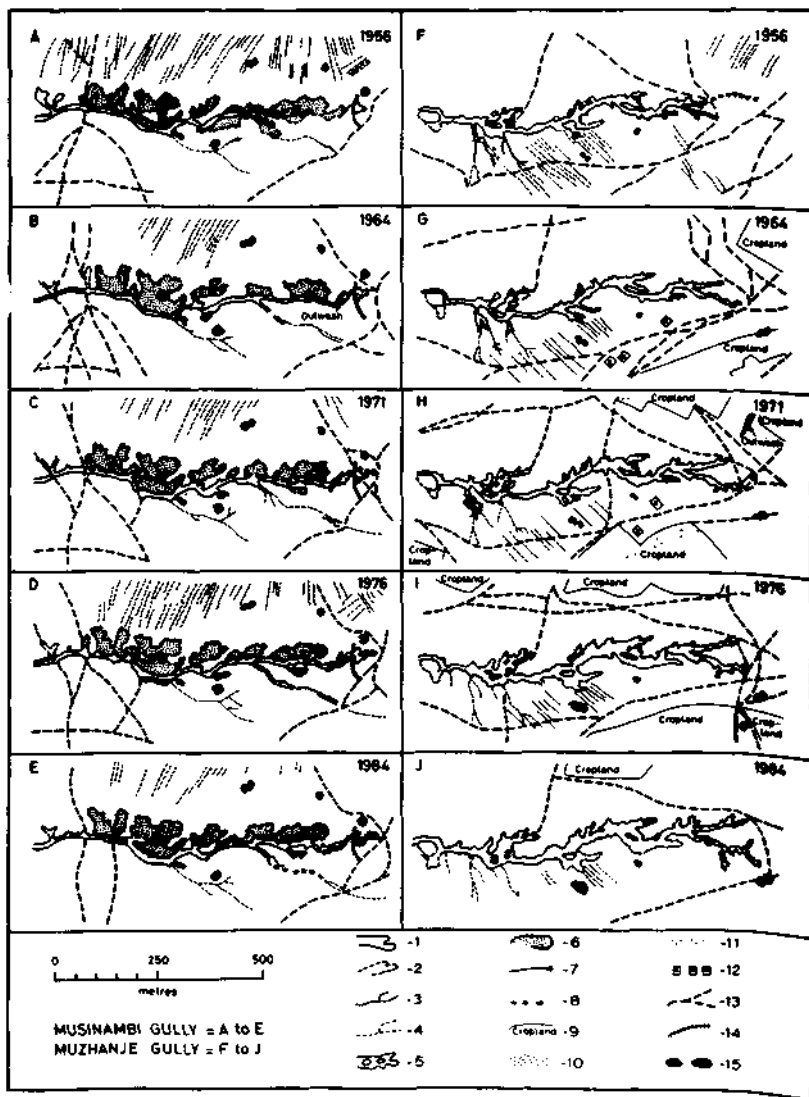
Figure 5: PLAN FORM CHANGES IN MUSINAMBI GULLY AND MUZHANJE GULLY, 1956-1984.

Muzhanje Gully: The changes in plan form of this gully are shown in Figure 5F-J and details on the gully margins and the two main headcuts in the upper part of the gully are summarized in Tables II and III, respectively.

1970s (Fig. 5G, H and I). Extension of croplands at the expense of grazing areas certainly contributed towards growing pressures upon and accelerated degradation of valley sites in the Communal Lands during these years (Cleghorn, 1966; Whitlow, 1979). As a result of this erosion, peasant farmers since Independence (1980) have been persuaded to abandon fields close to gullies as shown here for Muzhanje Gully (Fig. 5J). This may slow down but is unlikely to prevent further growth of this gully.

The left bank, allowing for the exclusion of the stabilized tributary gullies mentioned earlier, is more regular than the opposite bank with relatively low SR values between 1.21 and 1.31 (Table II). Over the 1956-84 period the left bank increased in length by only 178 m, mainly owing to the development and extension of two tributary gullies in the upper reaches of the main channel. The lower of these tributary gullies was poorly defined on the 1976 and 1984 aerial photographs (Fig. 5I and J) owing to the excessive trampling by cattle.

In contrast, the right bank is much more sinuous with SR ratios between 1.88 and 2.47. This is mainly because of the occurrence of three large tributary gullies and numerous smaller lateral headcuts along this bank. The gully margin increased in length by 682 m over the period 1956-84 with the extension of these side channels, and the resulting increased irregularity of the margin is shown by an increase of 0.59 in the SR value. The slight decrease in the length of the right bank in 1976 can be attributed to coalescence of headcuts, leaving isolated ridges and knolls within the main gully (Fig. 5I).
