SURVEY OF BRIDGE SITE
ON SLIDING CLAY FOUNDATION
THESIS FOR THE DEGREE OF C. L.
Louis Frank Levin
1930

INDEX

Page
Title	1
Introduction	2-3
History	4-8
Subject Matter	9-14
Level Tabulations	15-16
Photographs	17-20
Location Sketch	
Federal Aid Plan & Profile	
Approach Plan	
Reference Polygon Plan	
Base Line & Abutment Plan

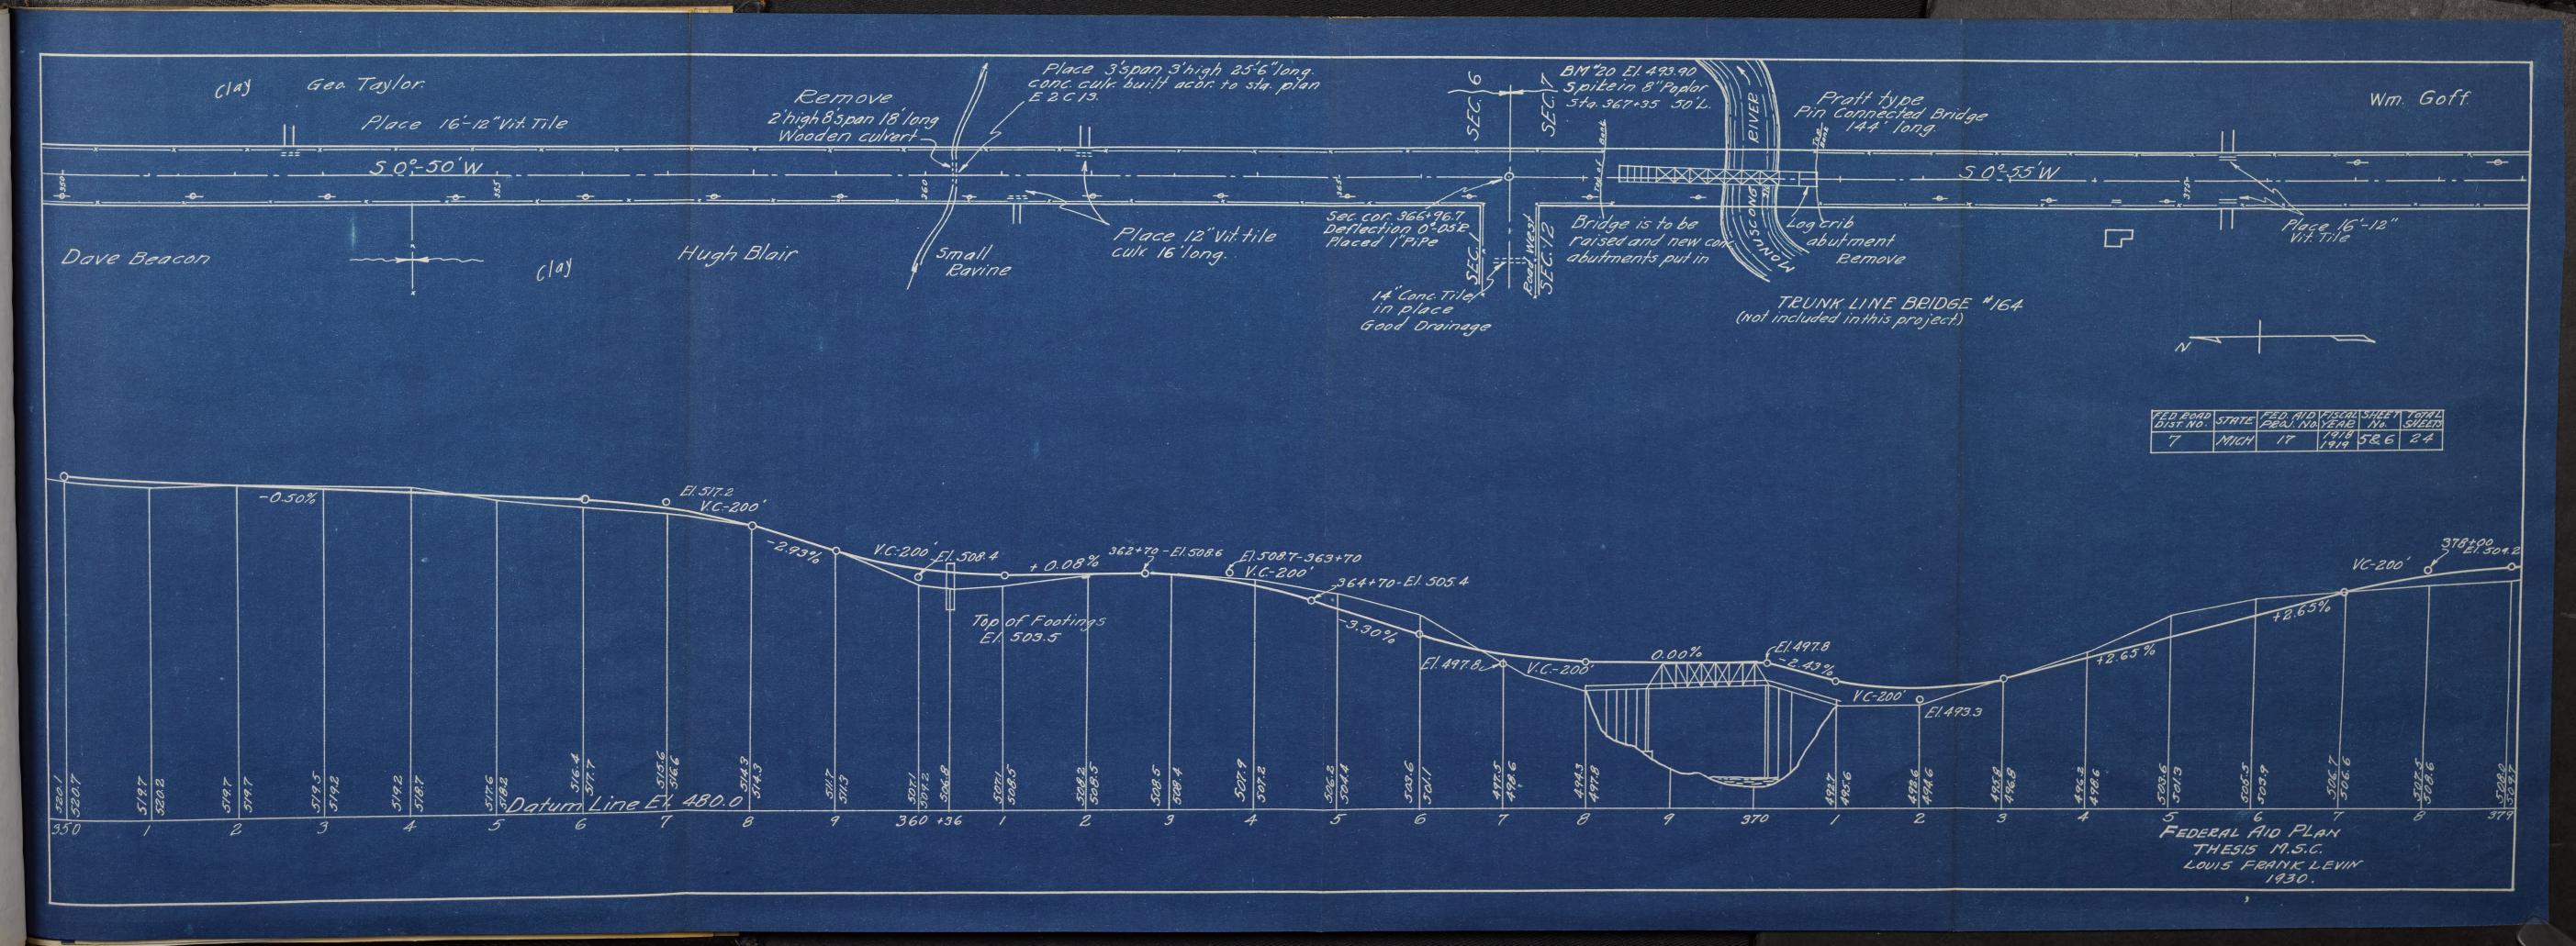
U.S.G.S. Mon. = 5+0. 366+68.97 TT685 of Survey 1918. 243.05 127.47' C-4 C-3 Points C-1 to C-4 show a movement to the east of 0" to 1" between Oct. 21,1929 and May 3,1930. Points A-1 to A-4 incl.

show a movement to the east of 0% to 0% between Oct 21,1929 and May 3,1930. 8-1 Points/from B-1 to B-6 ind/ show from 04/16 14" movement to east between Oct 21,1929 and May 3,1930. A-1 263.51 Reference Polygon BM#1 Top of U.S.G.S. Monument THESIS M.S.C. Survey of Bridge Site No. TT 685. Sliding Clay Foundation Elev. assumed 100.00 = 501.38 as of Fed aid survey of 1918 Scale: - 1" = 50 feet. LOUIS FRANK LEVIN 1930
