MOISTURE RELATED DETERIORATION OF THE WOOD TRUSS SYSTEM:
A SURVEY OF NATURALLY VENTILATED DAIRY BARNS IN MICHIGAN

A THESIS

Submitted to
Michigan State University
in partial fulfillment of the requirements
for the degree of

1985

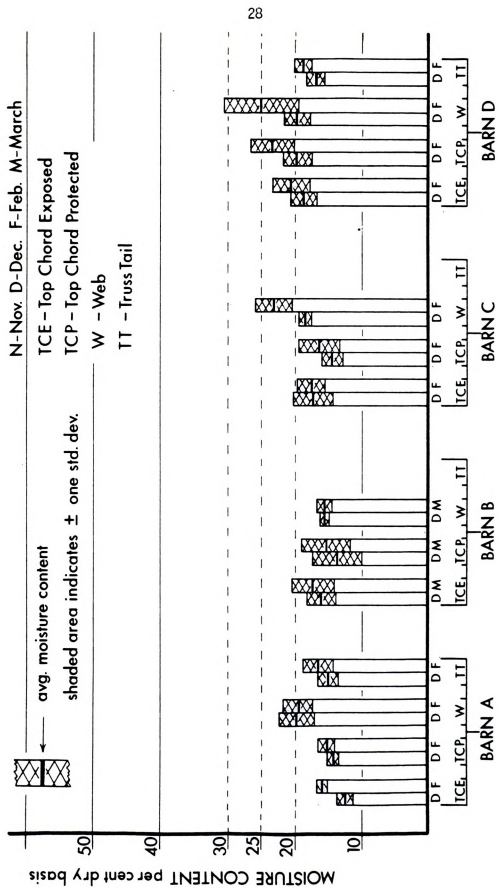
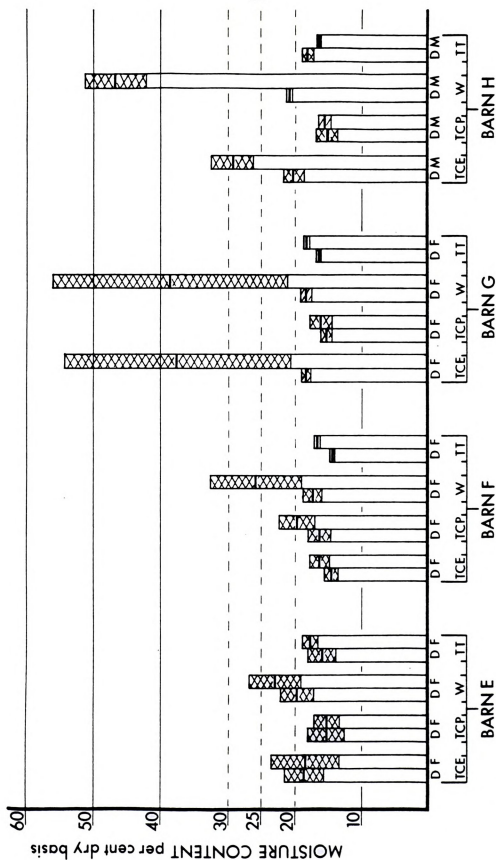
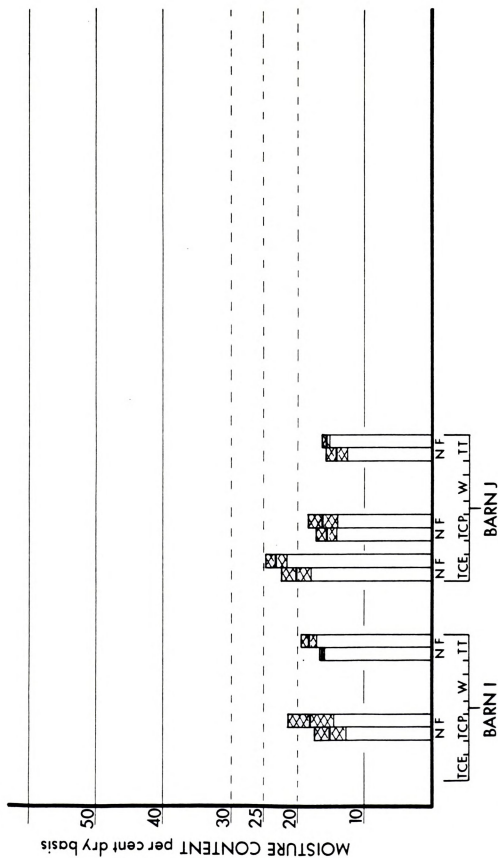
Figure 4.1. Arithmetic Mean Moisture Contents by Location and Date.

The set of histograms in Figure 4.1 indicate wood moisture contents relative to date taken and location within each barn. The following general classifications were used to compare and contrast design and management features of the ten barns surveyed:

1. No excessive (<20%) moisture accumulation
2. Excessive ($\geq 20\%$) moisture accumulation in web members
3. Excessive moisture accumulation in web members and in the exposed top chord (TCE position) at the open ridge
4. Moisture accumulations in excess of 30%

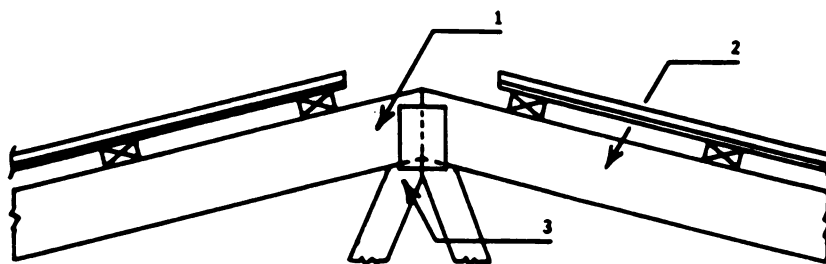
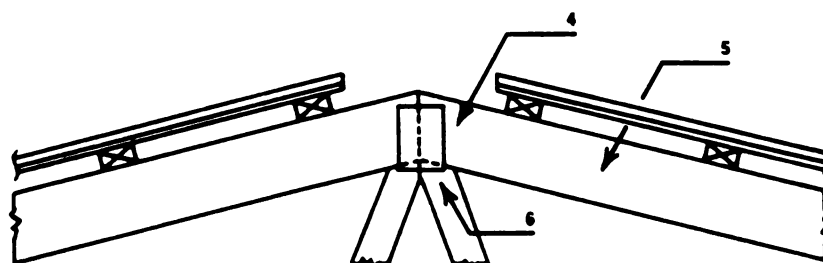
NOTES: Metal ridge gusset plates and flashing at the ridge indicate extensive corrosion. Four 0.91m (36") intake, fans have been installed to improve summer ventilation, two fans in each endwall.
