A STUDY OF DRIVER BEHAVIOR IN HIGHWAY NO-PASSING ZONES

Thesis for the Degree of M. S. MICHIGAN STATE UNIVERSITY James William Burge 1956

# ABSTRACT

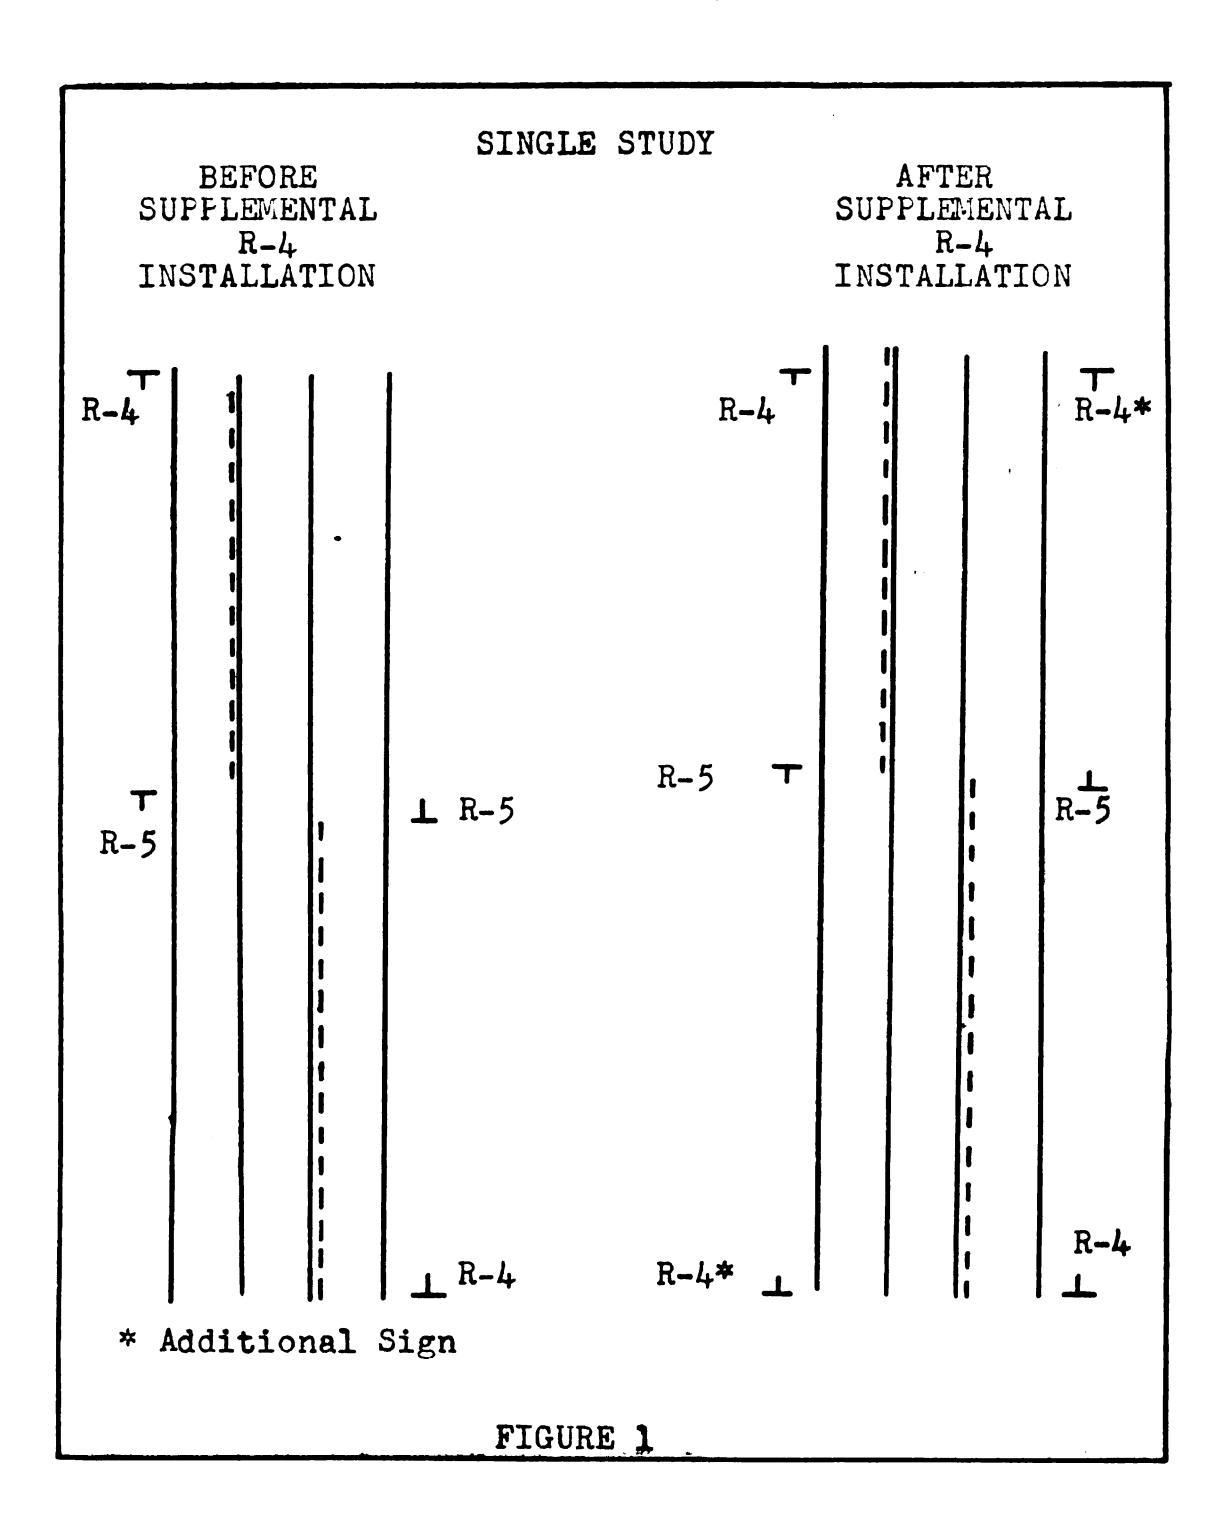
sign in place; then following the addition of a supplemental sign on the left side of the roadway a follow-up study was conducted. (See Figure 1)

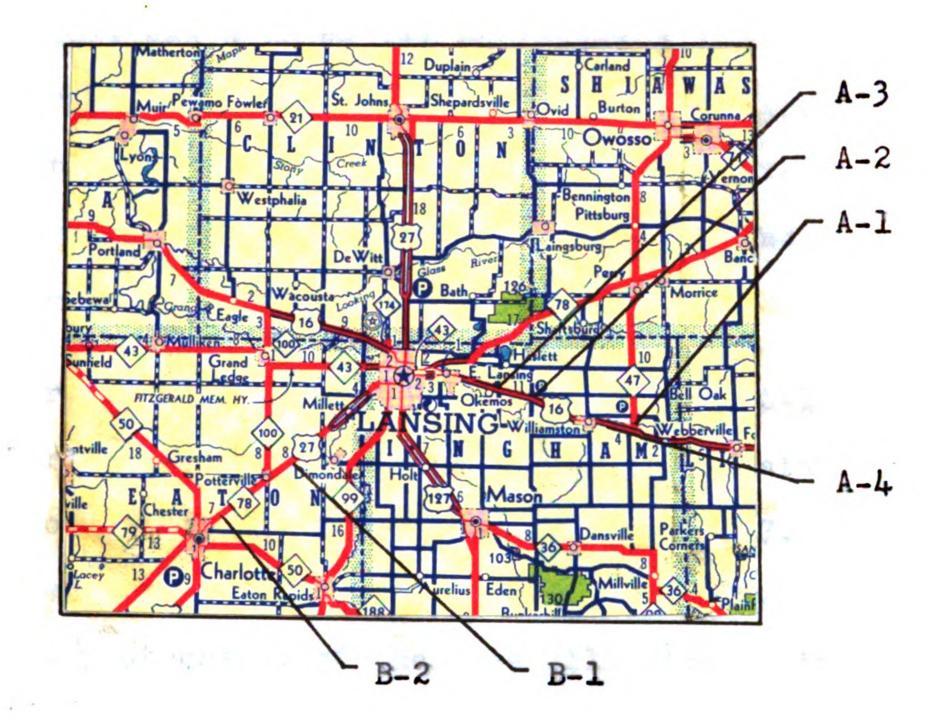
FIGURE 3

# TEST AREA LOCATIONS

Test Area A-1: Single Study Problem Area three-lane highway. Test Area A-2: Single Study Problem Area three-lane highway. Test Area A-3: Double Study Test Section three-lane highway. Test Area A-4: Double Study Test Section three-lane highway. Test Area B-1: Double Study Test Section two-lane highway. Test Area B-2: Double Study Test Section two-lane highway.

The double study zones were located in areas in which the succeeding no-passing zones had similar characteristics. Two were located on three-lane sections of US-16, and two were located on two-lane sections of US-27. (See Figure 3 for location of test areas.)

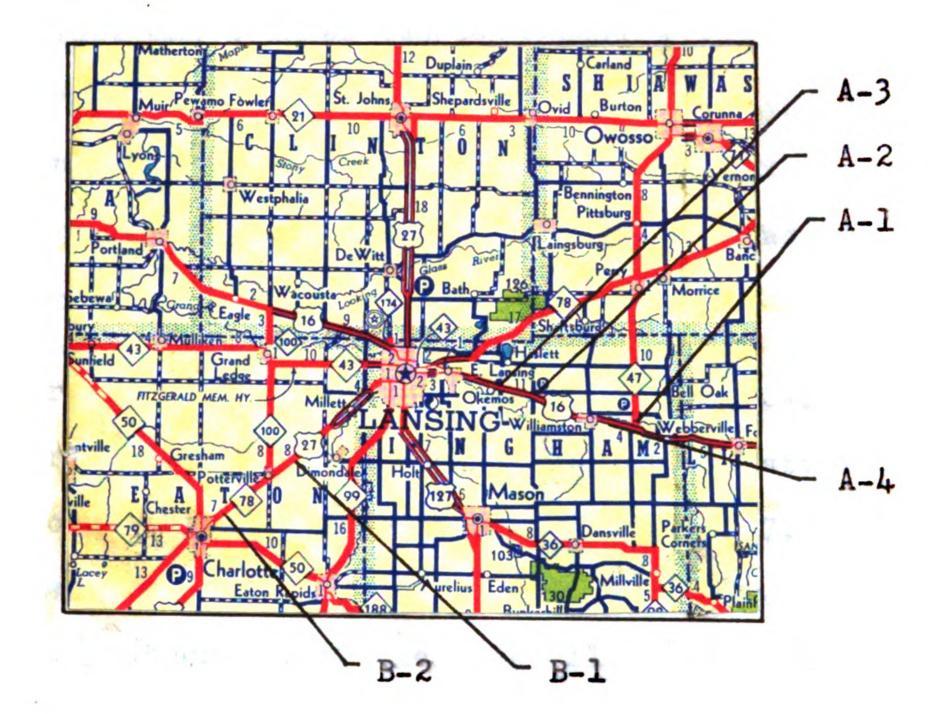
FIGURE 3

# TEST AREA LOCATIONS

Test Area A-1: Single Study Problem Area three-lane highway. Test Area A-2: Single Study Problem Area three-lane highway. Test Area A-3: Double Study Test Section three-lane highway. Test Area A-4: Double Study Test Section three-lane highway. Test Area B-1: Double Study Test Section two-lane highway. Test Area B-2: Double Study Test Section two-lane highway.

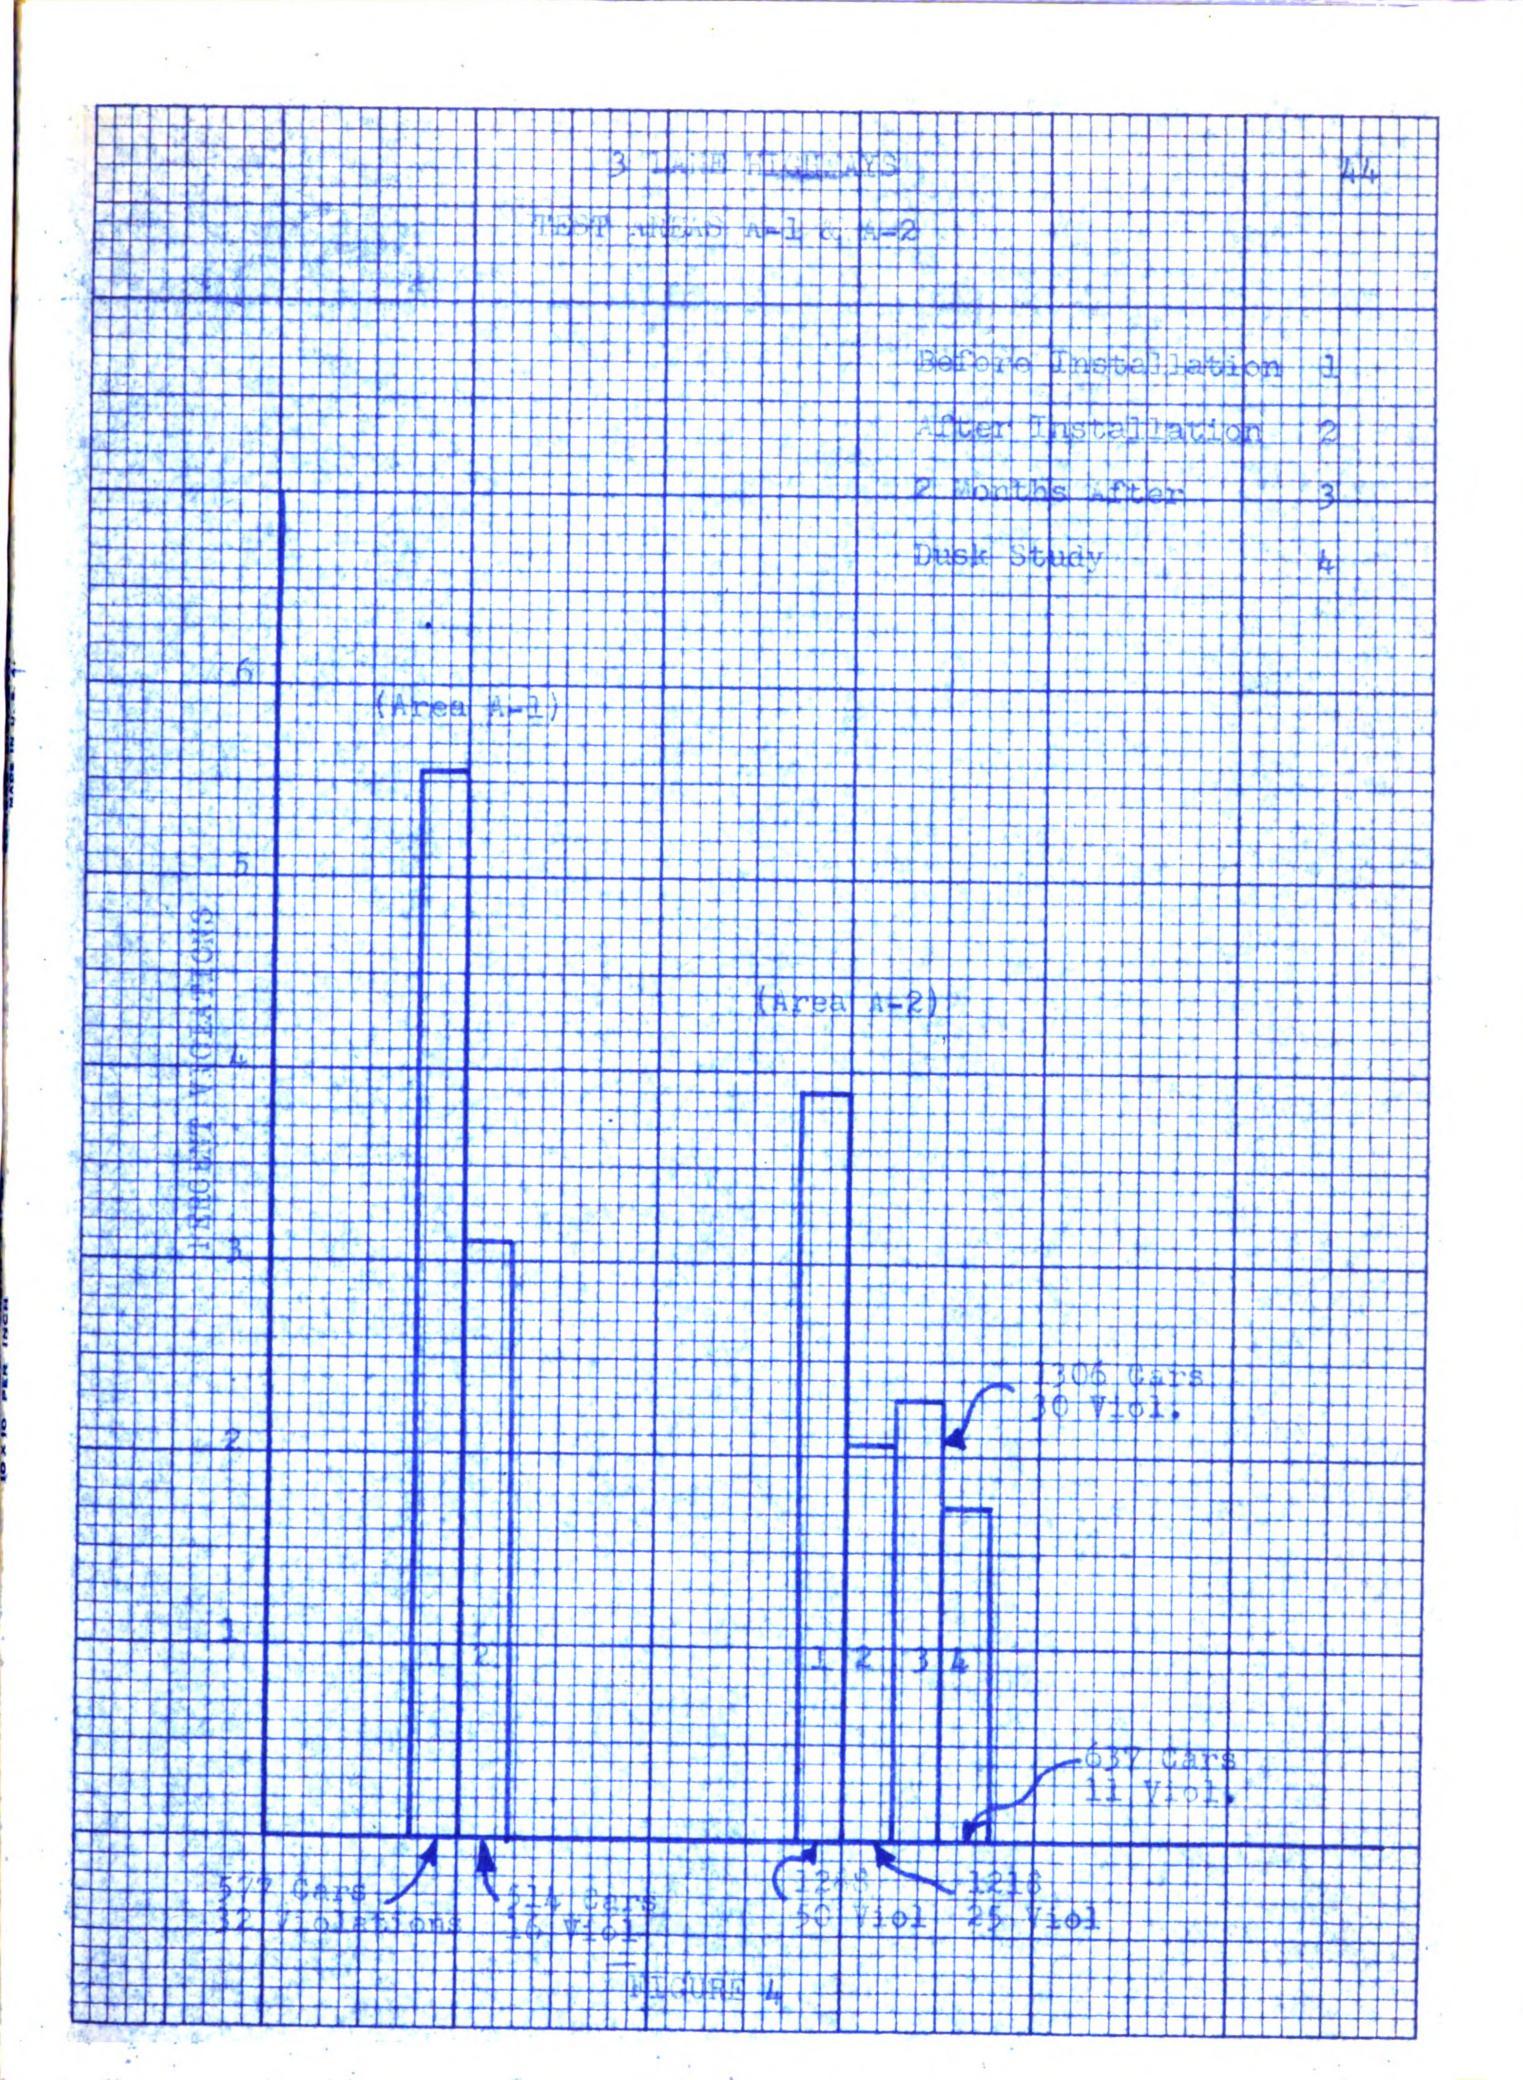
The resultsof the studies conducted on the threelane highways were very encouraging as a whole. In all cases the additional sign caused a reduction in violations of no-passing zones. Reductions ranged from eightcen to fifty per cent of the number of violations reported for the zones with only a single sign installed. (See Figures 4 and 4).
