AQUEOUS CORROSION OF AA-2024 BY ZINC COATED STEEL FASTENERS

A THESIS

Department of Metallurgy, Mechanics & Materials Science 1989

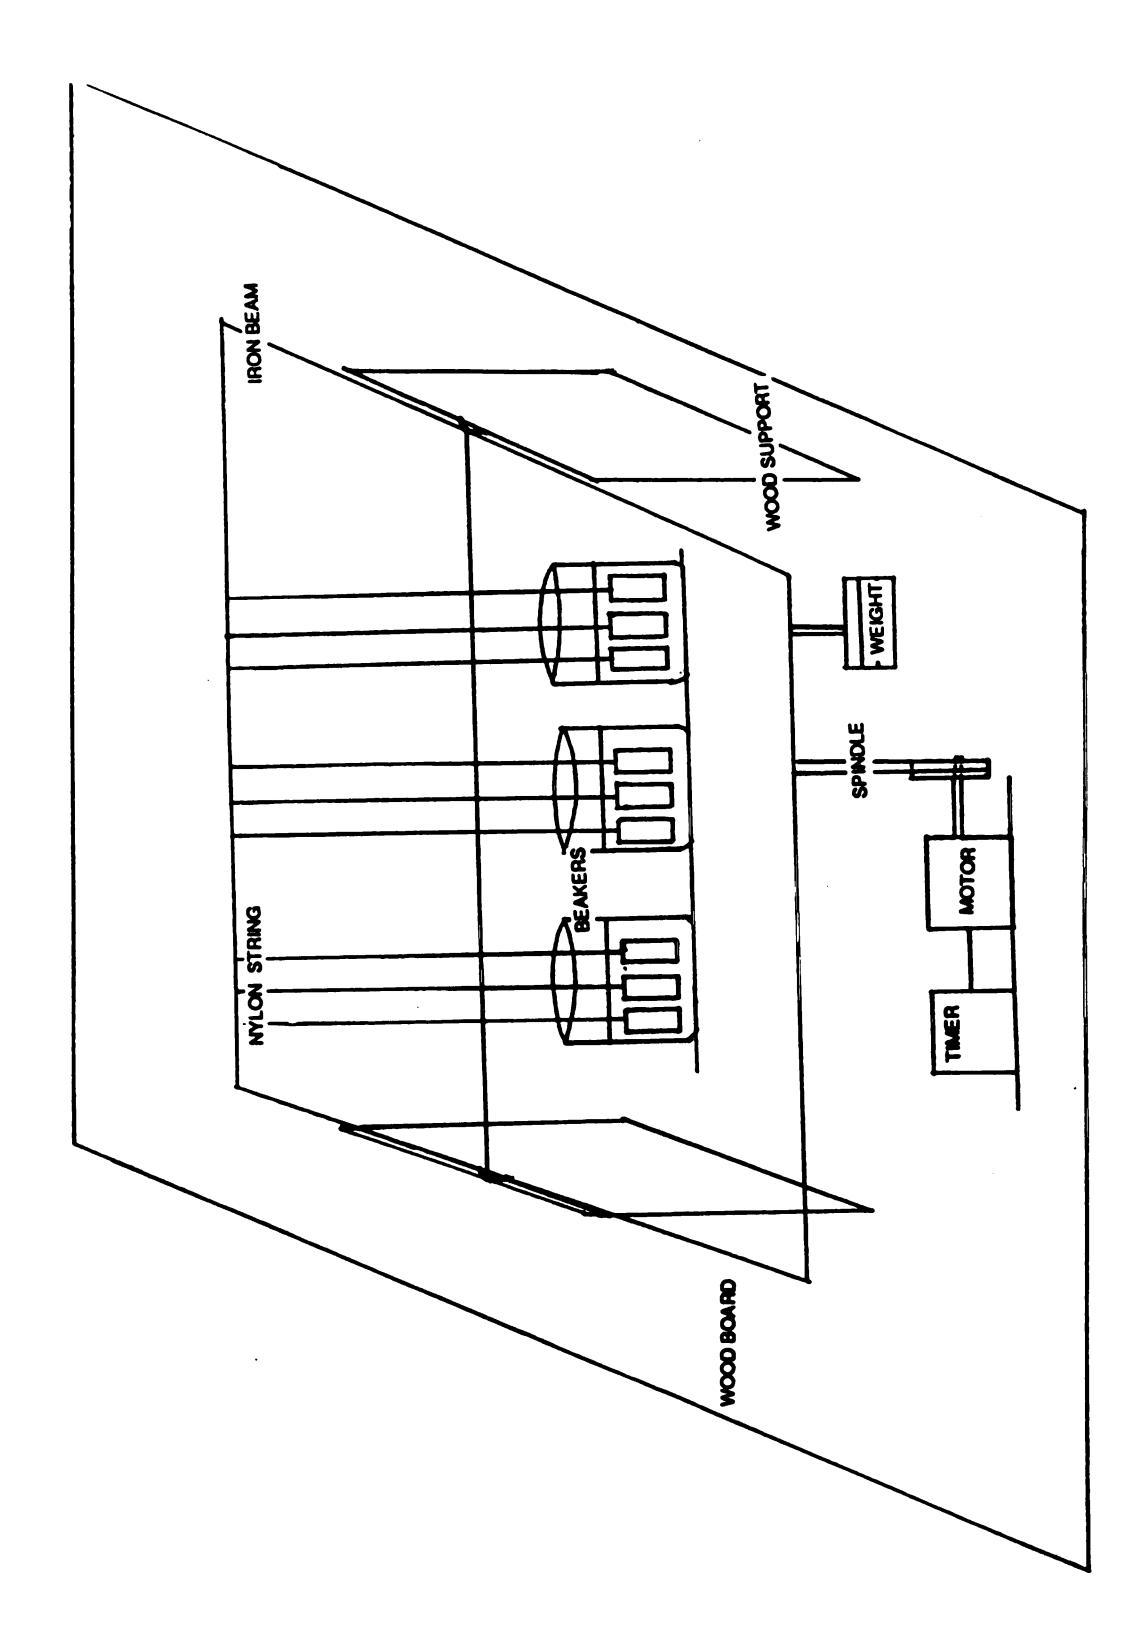
The rate of immersion and removal of the samples from the solution should be as rapid as possible. It was about 15 seconds in this experiment. Fig.1. Experimental set-up for alternate immersion cyclic test

Alternate immersion test is an accelerated corrosion test to predict the performance of a given material and is a representative of certain natural conditions. This test involved 1 hour cycle, inclusive of a 10 minute period in aqueous solution of different cocentration of sodium chloride followed by a 50 minute period out of the solution, during which samples were allowed to dry. The above cycle was repeated for 7 days i.e., 168 hours.

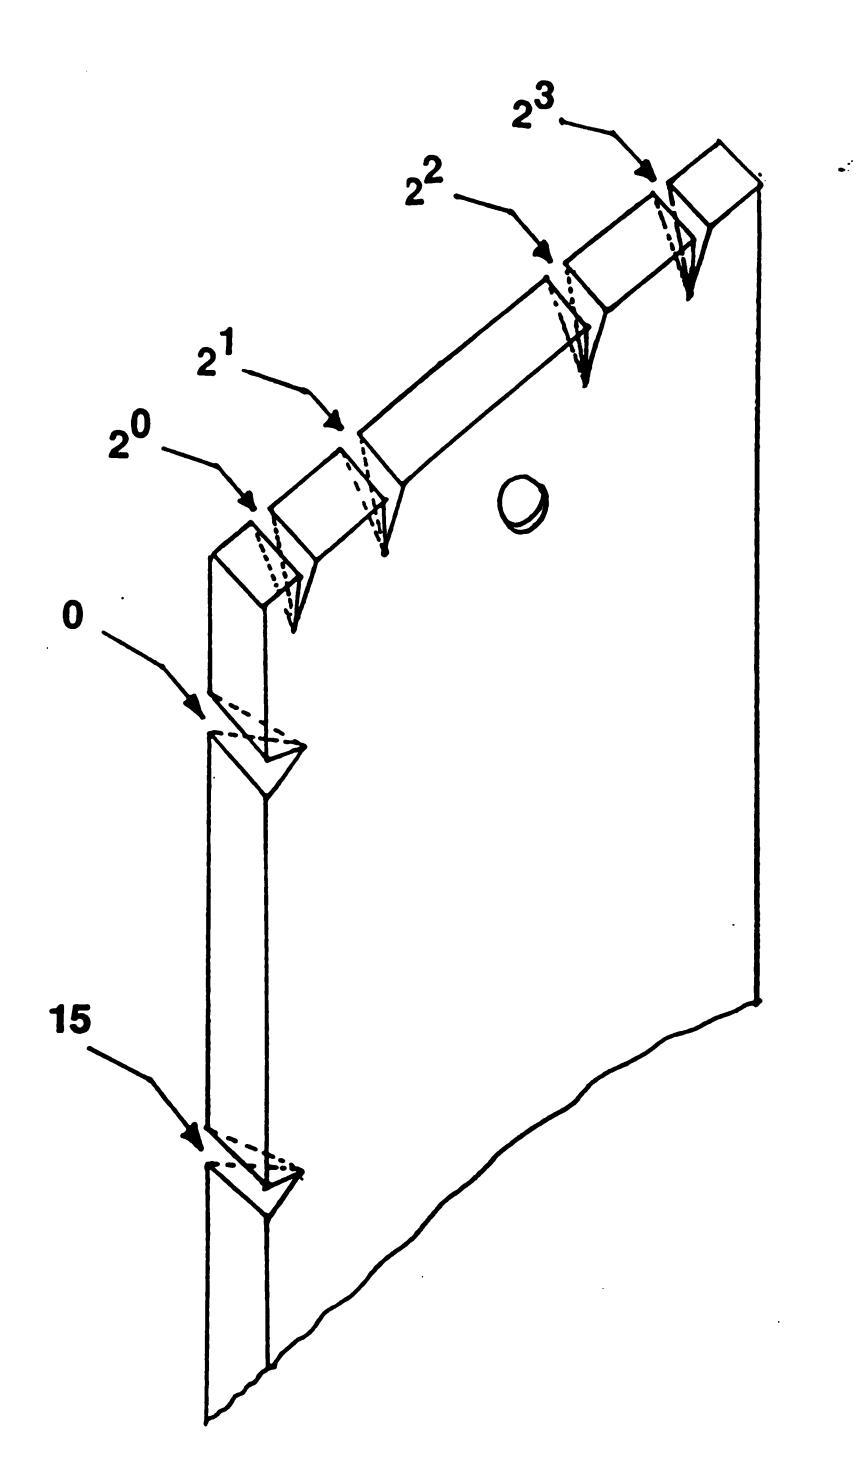
Samples were identified by means of notches made around the edges of the specimen as shown in fig.2. The notches were made in such a way that they follow binary code. A reference notch was made either in the lower or upper corner of the specimen. The value of the upper corner notch was zero, whereas the value of lower corner notch was fifteen. The upper or lower edge notches were assigned the following values based on their respective position

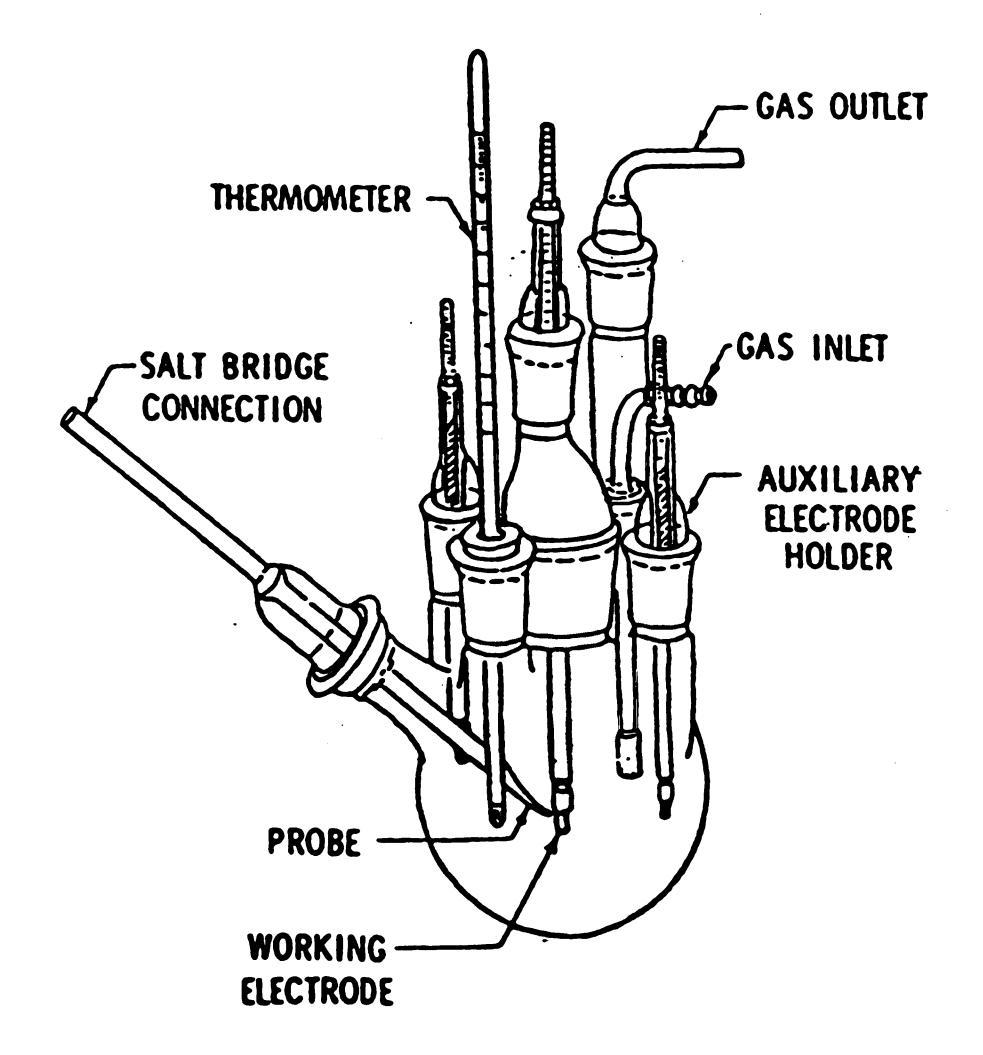
Fig. 3. Corrosion cell for potentiostat experiment [25]

A suitable cell is shown in fig. 3, a round bottom flask has been modified by the addition of various necks to permit the introduction of electrodes, gas inlet and outlet tubes and thermometer. The salt bridge separates the bulk solut-

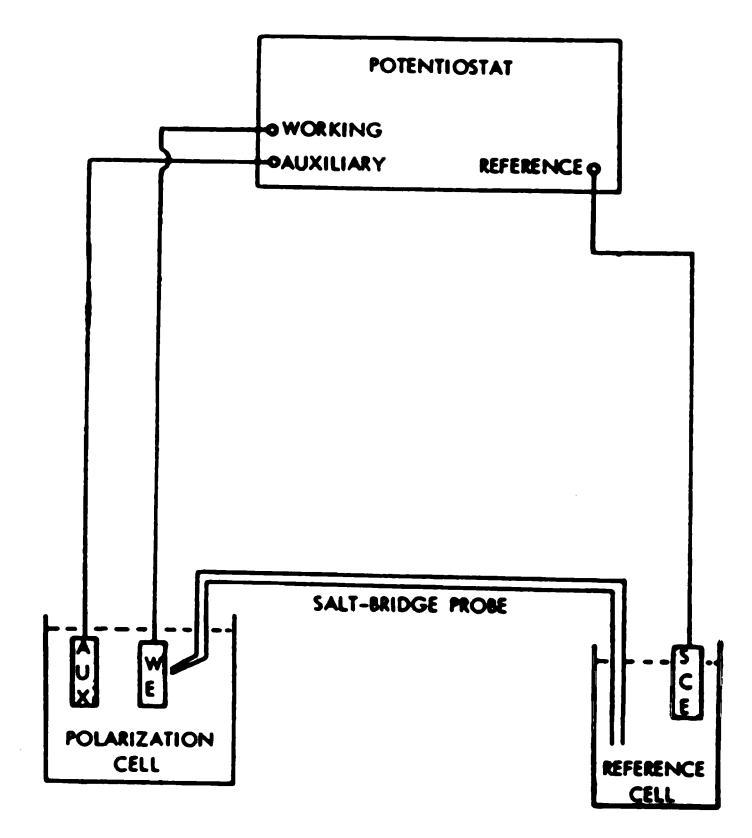
Fig. 4. Anodic polarization wiring diagram [26]

The open-circuit specimen potential was recorded after 55 min imersion. Start the potential scan 1 hour after specimen immersion. The potential step of 50 mV was used every 5 min., the current value was recorded at the end of each 5 minute period. These steps were were repeated until a potential

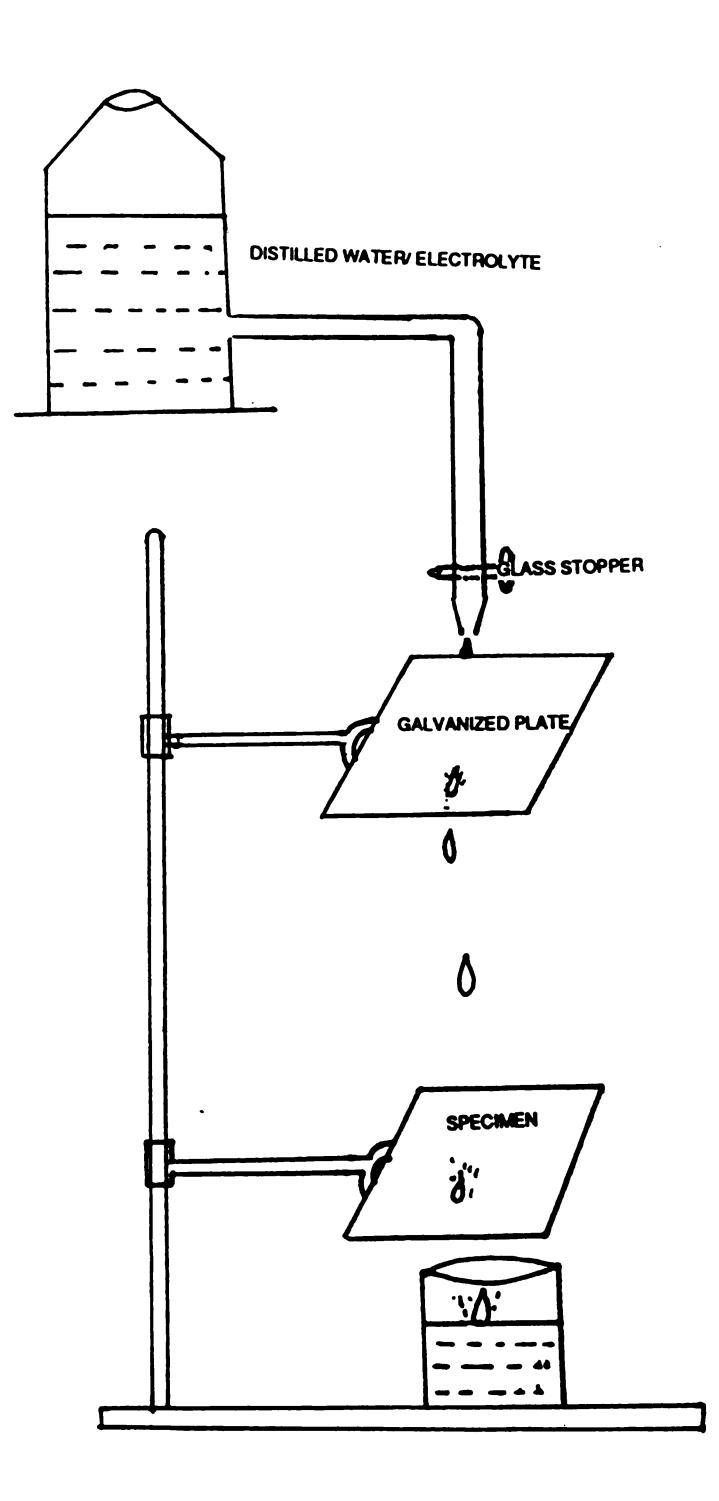
Fig. 5. Schematic diagram for dripping electrolyte experiment

This was a very simple and efficient method to ascertain the compatibility of zinc coated steel fasteners with AA-2024. In this experiment the electrolyte or distilled water was made to fall on the galvanized steel sheet, and then eventually drips on AA-2024 plate. The flow-rate of the electrolyte was regulated by means of a glass stopper. At the end of the experiment aluminum alloy plate was cleaned by chemical means, accurately weighed and the corrosion rate was determined. (Experimental set-up for the experiment is shown in fig.5)

The results from the experiment reflect the same as those of alternate immersion and galvanic experiment. By observing the corroded sample, it is evident that, as the zinc coating is slowly removed, ferrous ions come into contact with aluminum alloy electrode resulting in serious corrosion of aluminum alloy (fig. 16). The experiment conducted with distilled water explains that, after the subsequent removal of zinc ions from the galvanized sheet, ferrous ions are dissolved in water and they cause extensive damage to the aluminum alloy. The weight loss calculations indicate that, a substantial portion of aluminum is removed by ferrous ions. The weight loss is directly proportional to the concentration of the solution employed for the experiment. By observing the table. 7, it is evident that, the corrosion rate increases rapidly with the conccentration of the solution.

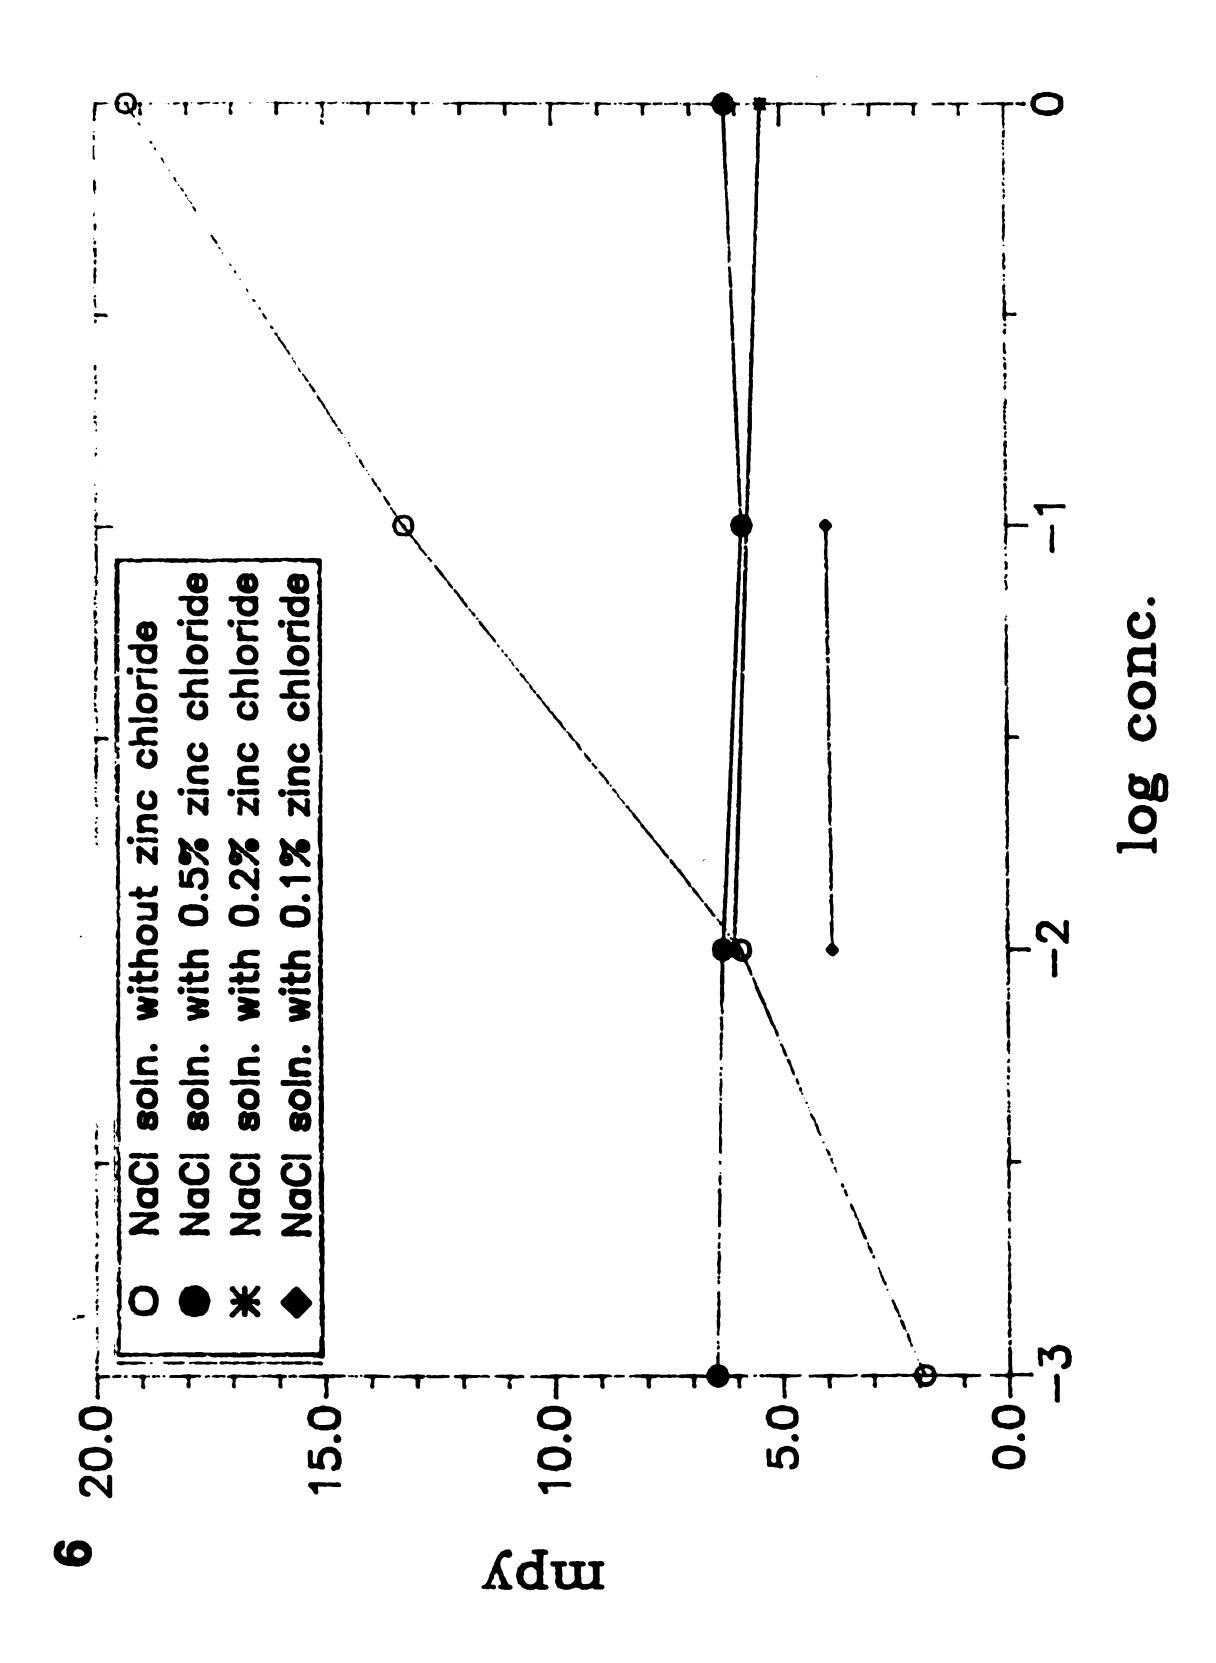
Fig. 6. Effect of concentration of NaCl with/without ZnCl₂ on corrosion

of AA-2024

The reduction factor is large at higher concentration of sodium chloride solution, i.e., zinc ions are helpful in reducing the corrosion rate. This effect is not observed at lower concentration of chloride solutions, because of the presence of chloride ions surpass the inhibition effect.

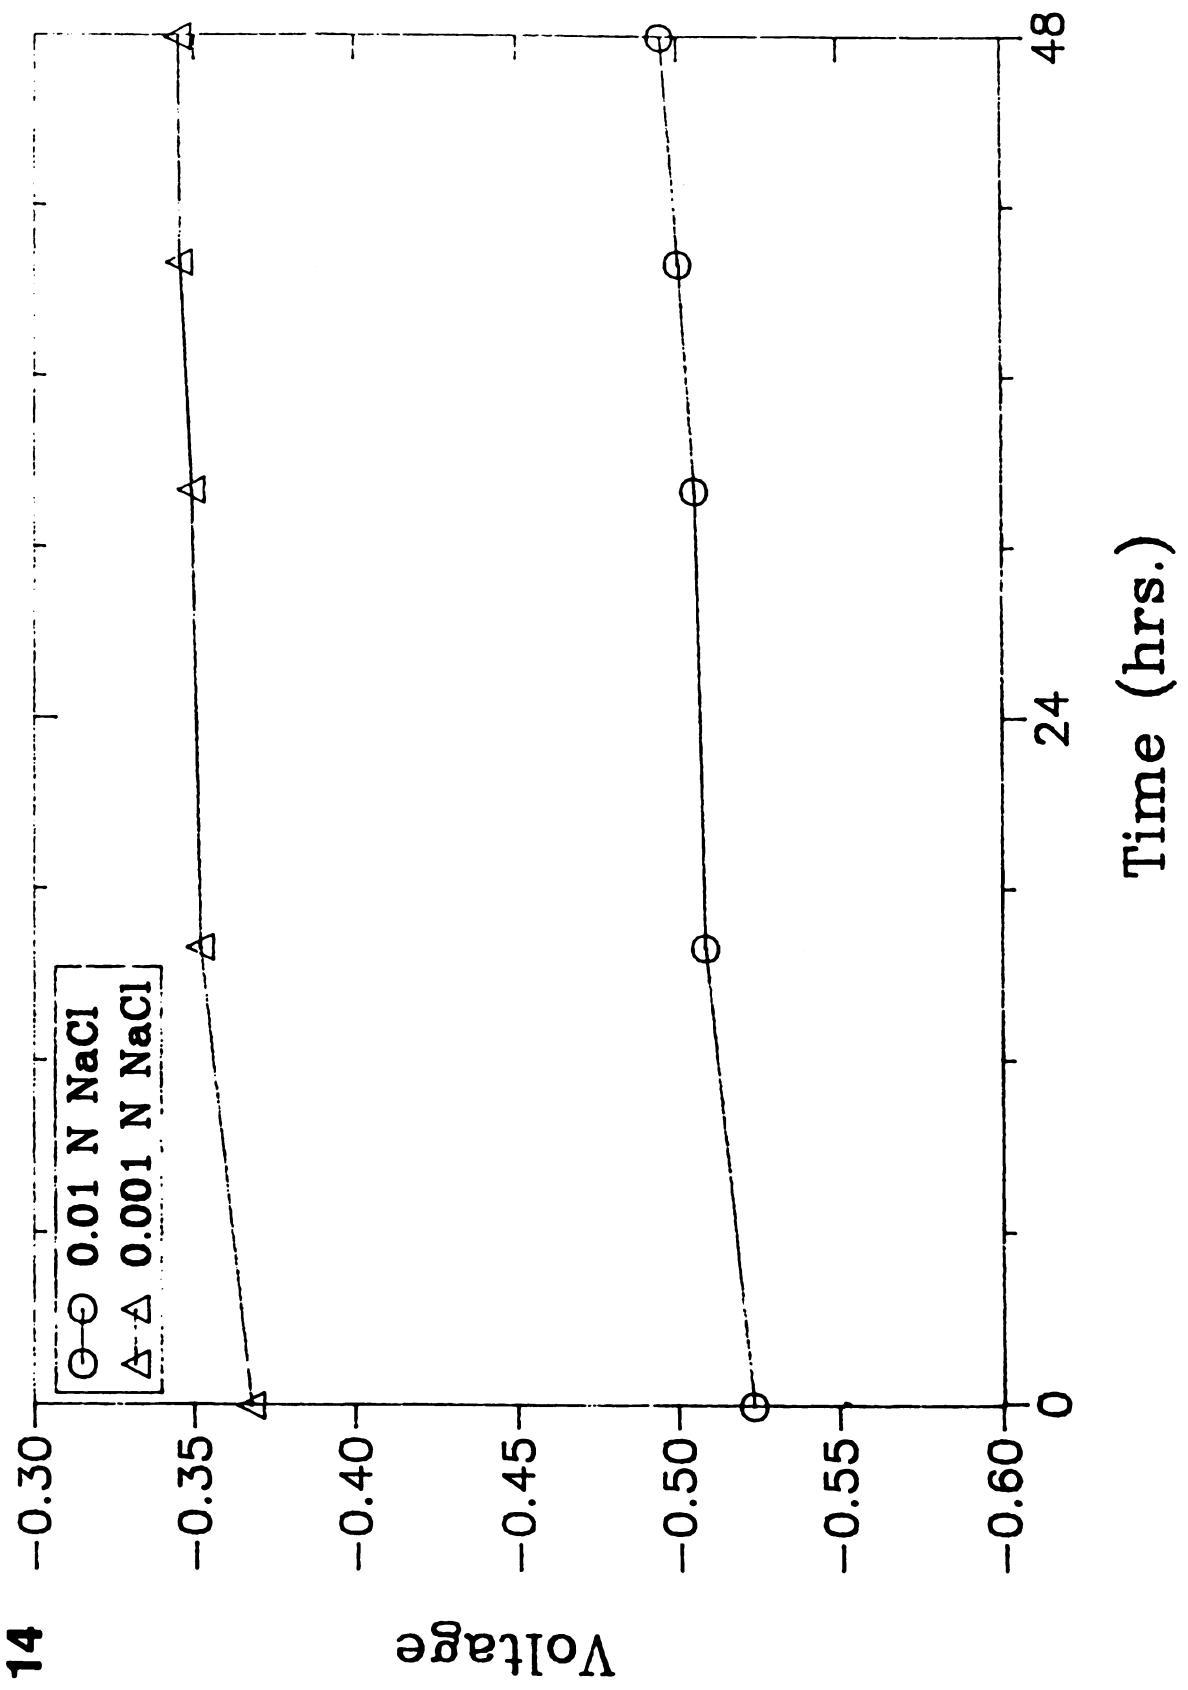
Fig. 14. Time-Voltage plot of galvanic experiment of AA-2024 and galvanized steel sheet maintained at various concentrations of sodium chloride

The results from the galvanic experiment is listed in table 6. As observed from fig.14, the voltage changes with respect to time. At the initial periods, when the alloy is cell anode and galvanized steel sheet is cathode, the value of the voltage is -0.5233V. After 48 hours the voltage reading was -0.498V. The value of the voltage tend to drop and attains a plateau after some time. As the voltage tend to drop, aluminum alloy electrode tends to be more anodic, Whereas the results from the lower concentration indicate that, there is a drop of potential difference, but it is not as steep as it is in the case of higher concentration.

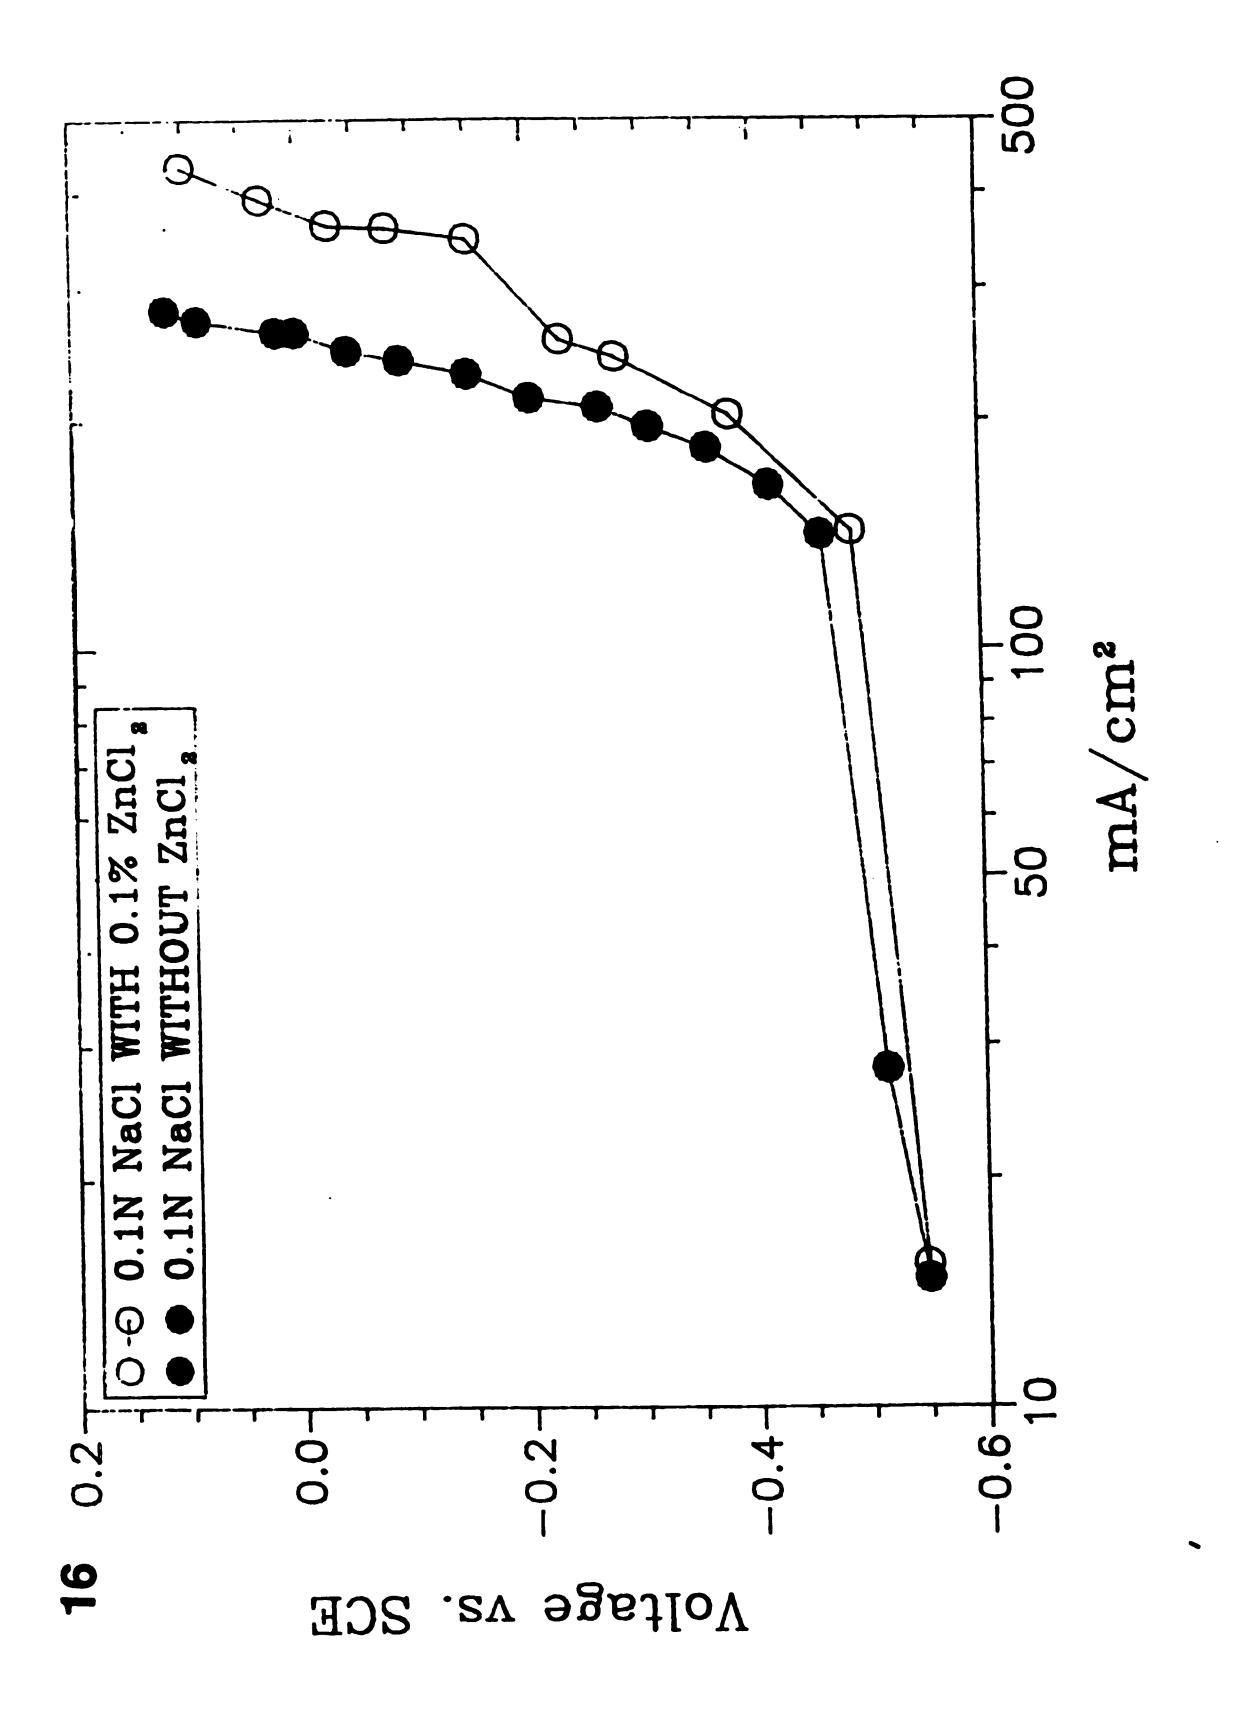
Fig. 16.Anodic polarization curve of AA-2024 with/ without ZnCl₂

maintained at 0.1N NaCl

The slope of the polarization curve is quite same for both solutions during the initial part of the experiment., at current density value of 140 mA/cm², the

tendency of the curves changes. The curve for the solution without zinc chloride becomes more active, which means that zinc ions are helpful in protecting the aluminum alloy.
